doi:10.4317/jced.54049  
<http://dx.doi.org/10.4317/jced.54049>

## Analysis of Surface Characteristics of ProTaper Universal and ProTaper Next Instruments by Scanning Electron Microscopy

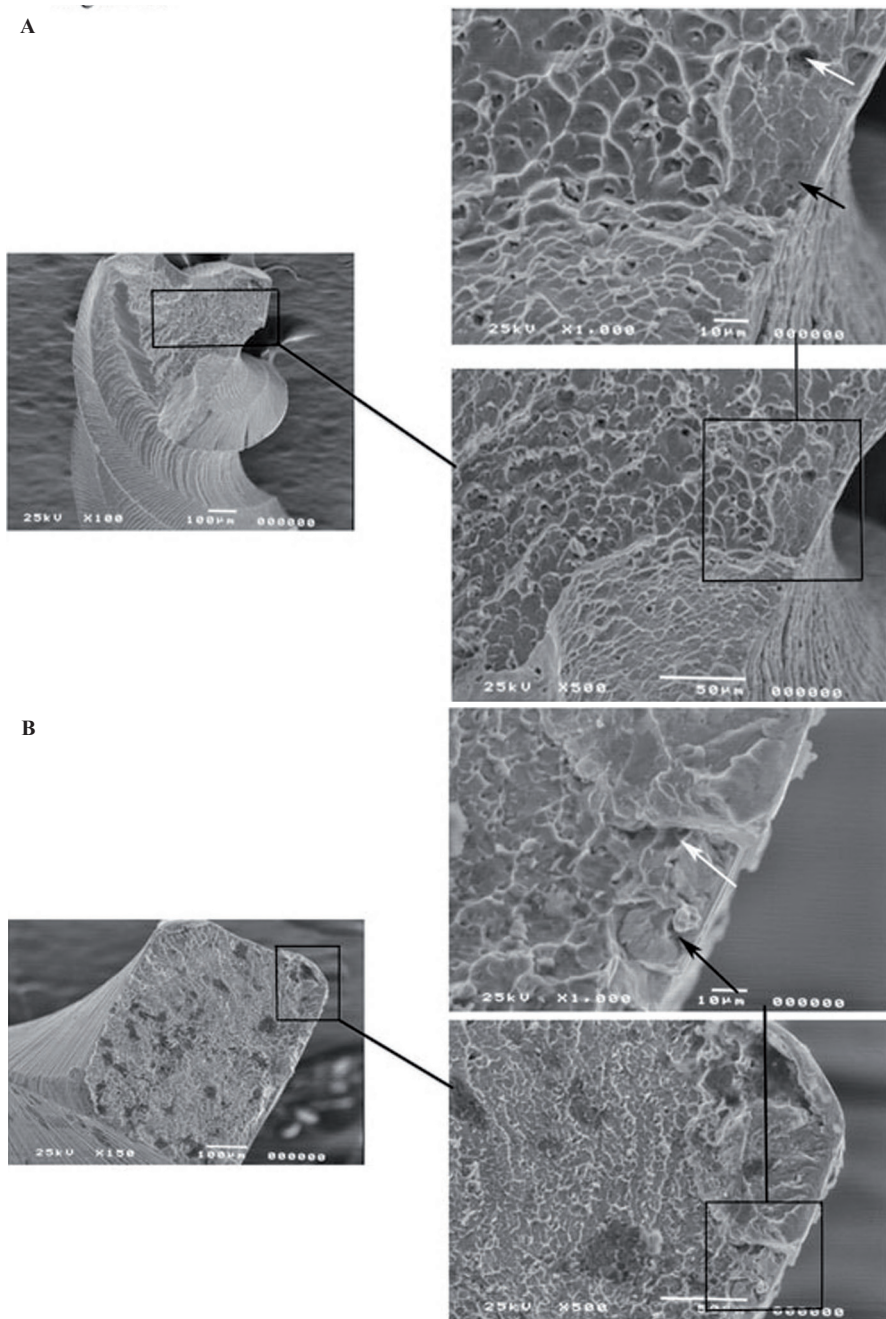
Files from both groups (F3 and X3 files) were subjected to fractures due to cyclic fatigue as described previously (13). The fractured files examined by stereomicroscopy showed signs of both torsional and flexural fracture, according to classification by Sattapan *et al.* (14). However, when these fractured surfaces were examined under the SEM, they demonstrated a ductile fracture associated with a defect within the file. Figures 3A and B are views of the fractured surfaces of an F3 PTU and an X3

**Fig. 3:** SEM images of files fractured by cyclic fatigue. Figure 3A is an SEM image of a PTU F3 file fractured and Figure 3B is an SEM image of a PTN X3 file fractured by cyclic fatigue. The sub-figures show a magnified image of one part of the fracture surface which demonstrates the beginning of the fracture at this inclusion (black arrows) where it progresses to voids within the body of the alloy (white arrows). Then past this point we can see a fast fracture under load, represented by the signs of ductile fracture.

PTN file respectively. The sub-figures show a magnified image of one part of the fracture surface. As seen from the figure both file types showed the beginning of the fracture at the inclusions (black arrows) from where it progressed to voids (white arrows) within the body of the alloy. The start of the ductile fracture was associated

The inclusions within NiTi alloy are assumed to be titanium carbonitrides and NiTi oxides formed during the vacuum melting and casting in graphite cubicles (22,27) (Fig. 4). This process causes slight carbon contamination in the melt, forming the oxide impurities that appear evenly distributed within the NiTi matrix (27). The concentration and distribution of the inclusions has been proposed as a method of assessing the metallurgical quality of the NiTi alloy produced by different manufacturers of rotary instruments (28). However, there was no apparent difference in the distribution of inclusions between PTU and PTN rotary files. The voids and inclusions were distributed evenly within dimples associated with ductile fracture in all samples (Fig. 3). This is an
