# Mind the gap! The Lucent Line Sign: A Pathognomonic Radiographic Finding in Periprosthetic Hip Fractures Around Cemented Polished Tapered Femoral Stems

Joanna L Maggs<sup>1</sup>, Eric W Swanton<sup>2</sup>, Matthew JW Hubble<sup>1</sup>, Matthew J Wilson<sup>1</sup>

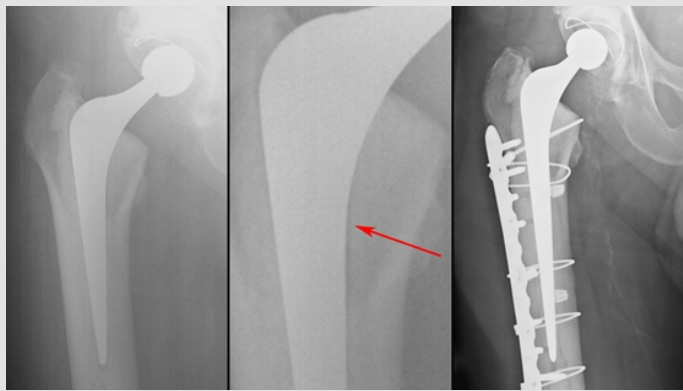
**Figure 1:** Radiographs demonstrating, from the left to right, the initial PPF, a zoomed-in view with an arrow to highlight the Lucent Line Sign, and the hip following revision surgery, of Case 1.

This 80-year-old gentleman fell in the shower whilst visiting a relative in a different part of the country. He sustained a PPF around his 18-month-old THA and was transferred back to our unit in traction. At surgery, the stem was loose and had subsided, preventing reduction. The stem was removed, the fracture reduced and the well-fixed cement mantle bypassed distally to allow for cement-in-cement revision to a long Exeter stem. This was augmented with a 14-hole plate and cables. Two months post-operatively, he was walking with no aids, was pain free, and had a normal gait and a satisfactory range of movement. He continued to function well when last reviewed at 12 years post-operatively (Fig. 1).

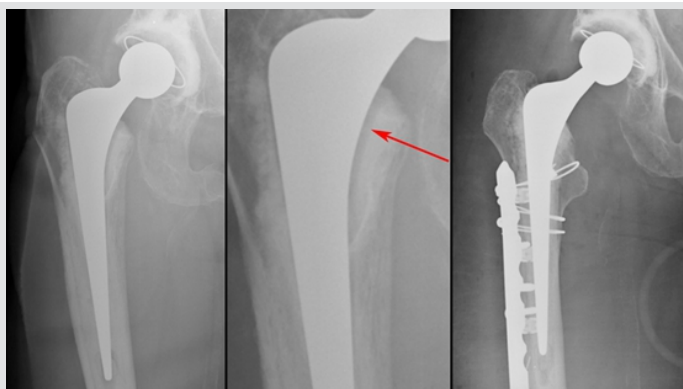
**Figure 3:** Radiographs demonstrating, from the left to right, the initial PPF, a zoomed-in view with an arrow to highlight the Lucent Line Sign, and the hip following revision surgery, of Case 3.

This 87-year-old woman sustained a fracture around a THA that had been previously been revised 10 years earlier for recurrent dislocation. At surgery, the fracture was irreducible due to the degree of subsidence and rotation. Therefore, the stem was removed, the fracture reduced with cables and a cement-in-cement revision undertaken with a standard Exeter stem supplemented with an anterolateral plate (Fig. 3).

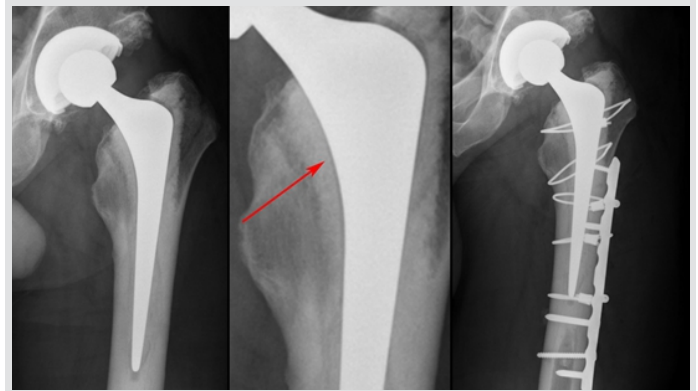
This gentleman had a left THA performed aged 46 for arthritis following slipped upper femoral epiphysis in childhood. Three years later, he fell from his bicycle landing heavily on his left side. He attended the Emergency Department where he was advised to mobilize with crutches and his radiographs were reported as showing no bony injury. A few days later, the patient telephoned the hip team. His X-rays were reviewed and the diagnosis of PPF was made due to the presence of the Lucent Line Sign. He

**Figure 2:** Radiographs demonstrating, from the left to right, the initial PPF, a zoomed-in view with an arrow to highlight the Lucent Line Sign, and the hip following revision surgery, of Case 2.

underwent open reduction and internal fixation of the fracture. At 6 months post-operatively, he felt he had regained full function and had returned to his active lifestyle. Three years later, he continues to manage 50-mile cycle rides and work as a rugby coach (Fig. 2).

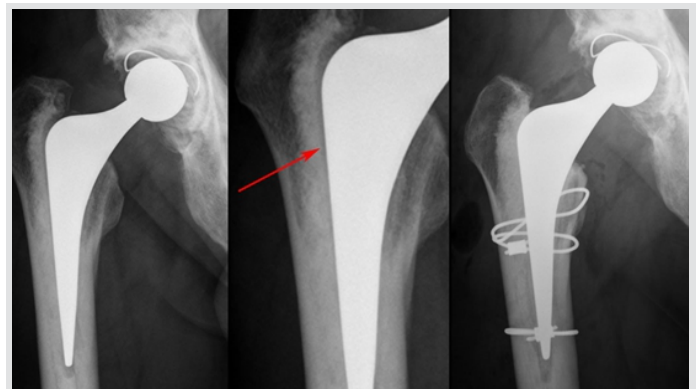
This 72-year-old gentleman fell 2 months following his primary THA. He attended the Emergency Department at the time, but the Lucent Line Sign was missed and he was discharged. He attended his routine post-operative review with the hip team, where the Lucent Line Sign was noted and a CT arranged, which delineated the fracture. Initially, he declined further surgical intervention, but was kept under close review. When his pain persisted, he opted to proceed with revision surgery 8

**Figure 4:** Radiographs demonstrating, from the left to right, the initial PPF, a zoomed-in view with an arrow to highlight the Lucent Line Sign, and the hip following revision surgery, of Case 4.

months following his fall. At the time of operation, the stem was found to be loose, but the fracture was united and the majority of the cement bone interface remained well bonded. Two cables were positioned to support the healed fracture and a new stem was cemented into the original mantle, using the cement-in-cement technique (Fig. 4).
