## Acta Orthopaedica et Traumatologica Turcica

## Fracture of the femoral component after a lightning strike injury: A case report

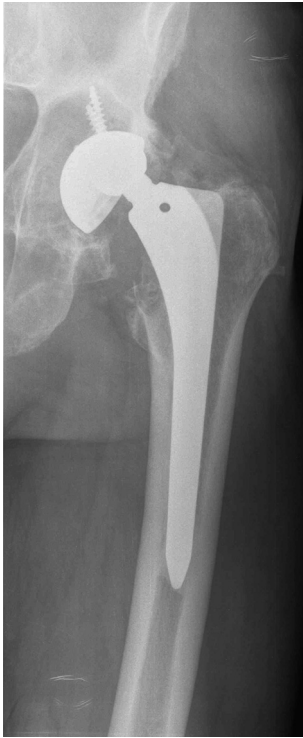
In September 2011 (ten years after primary THA), the patient came to our clinic complaining of hip pain. An important cup asymmetry that indicated wearing of the polyethylene was observed in the radiographic study (Fig. 1). The patient was 185 cm tall and weighed 110 kg (body mass index [BMI], 32.14 kg/m<sup>2</sup>). The patient underwent revision of the acetabular component and an exchange of the polyethylene component. Significant metallosis and loosening of the acetabular component was observed. The selected components for the revision were a 58 mm Trilogy<sup>®</sup> (Zimmer, Winterthur, Switzerland) acetabular shell attached with three (20, 30 and 35 mm) screws with a Trilogy<sup>®</sup> 58/36 cup. The Bicontact<sup>®</sup> stem was stable, thus no femoral stem revision was performed. This stem system was an uncemented titanium coated stem with a metaphyseal support. A correct fixation without any sign of collapse and anteversion were evaluated previously to the decision of maintaining the component. A Bioball<sup>®</sup> (Merete

**Fig. 1.** Anteroposterior radiograph showing wearing of the polyethylene.

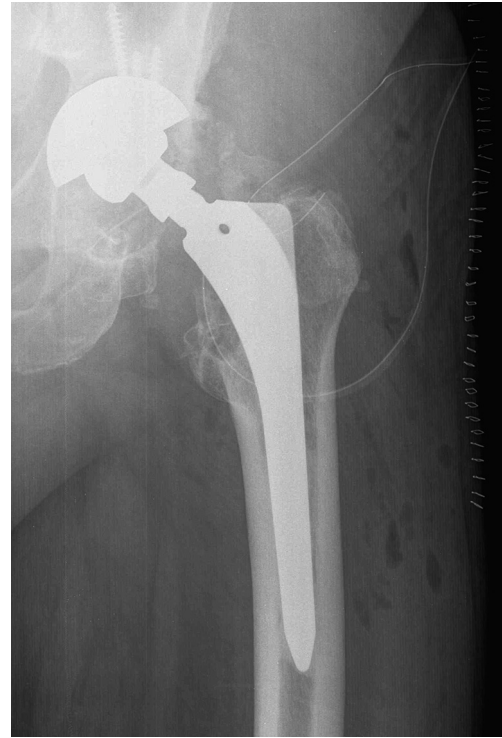
**Fig. 2.** Postoperative radiograph after first revision. A Bioball 4XL was required.

Medical, Berlin, Germany) with a 4XL neck was required to maintain the correct stability of the prosthesis due to laxity with pivoting and external rotation. The Bioball® system consists of different modular neck adapters which allow the surgeon to correct the length and offset of the neck when required. There are eight different sizes between “S” and “5XL” in ascending order, depending on the gap to correct. This implant could be useful specially in those revisions of either stem or acetabular component. Regarding to the case, the most probable cause of this laxity is the placement of the revision cup which is in a high, neutral and horizontal position (Fig. 2). The patient had a normal and uneventful postoperative period and remained asymptomatic for two years. He had a Merlé d’Aubigné Postel of 6.6/6 and a Harris Score of 94/100 at the last control.

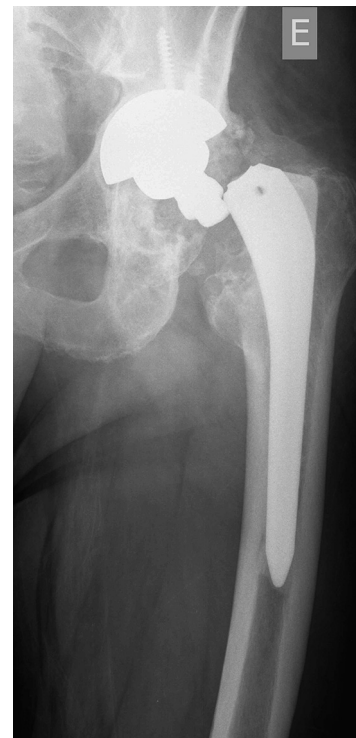
In October 2013 (two years and one month after the revision procedure), the patient was surprised by a storm and was struck by lightning while strolling. He remained conscious and suddenly he was unable to bear weight on the left leg and a deformity on his left lower extremity was detected. His neurovascular status was stable. Plain radiographs demonstrated a displaced fracture through the base of the neck of the femoral component (Fig. 3). The patient underwent revision THA through a posterior iterative approach. A transfemoral osteotomy was required to extract the stem, which presented no signs of loosening. Prophylactic Dall-Miles wiring was done to prevent fractures just under the osteotomy. The selected component for the revision was a modular curve Revitan® (Zimmer, Winterthur, Switzerland) system. It was a 200 × 180 mm stem with a distal locking screw of 36 mm and a metaphysis of 75 mm with 15° of anteversion. The head was a #36 metallic. Finally, the osteotomy was fixed with four Dall-Miles cerclages (Fig. 4). After the surgery, the patient needed two blood transfusions due to postoperative anaemia. The postoperative course was otherwise unremarkable and the patient was allowed partial two-crutch assisted weight-bearing. The patient was discharged with an active range of motion of

**Fig. 3.** Anteroposterior radiograph after the lightning strike. The fracture locates through the base of the neck.

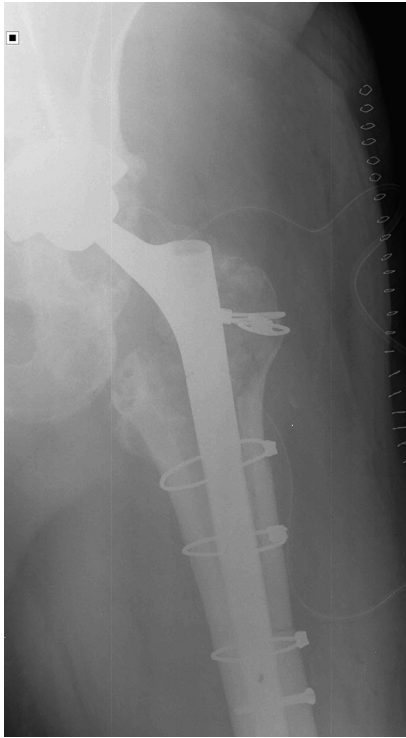
Fig. 4. Postoperative radiograph after second revision with four Dall-Milles cerclages.

A fracture of the stem in a total hip arthroplasty (THA) is an uncommon complication. We report a case of femoral stem fracture in a 55-year-old male patient after a lightning strike. A revision was conducted using a Wagner osteotomy and a revision prosthesis. Dall-Milles cerclages were used to close the osteotomy. The postoperative evolution was satisfactory, with an immediate partial weight bearing, consolidation of the osteotomy after three months and return to daily activity without pain.

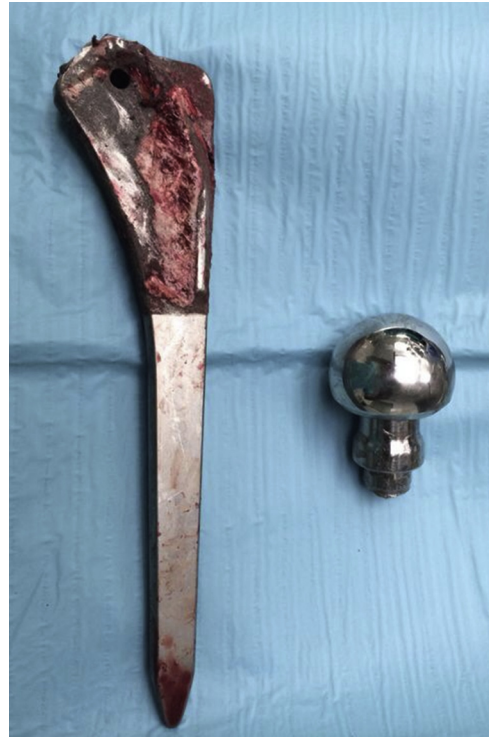
Fig. 5. Macroscopic aspect of the fragments of the Bicontact extracted prosthesis.

There were no signs of loosening or malalignment in this patient. With regard to bone quality, there were no signs of decreased bone mass in neither the radiograph or intraoperatively. However, there were several risk factors in our patient that might have been related to the fracture of the femoral component. They include being obese<sup>14,15</sup> (BMI 32,14 kg/m<sup>2</sup>: obesity class 1), highly demanding physical activity (he had been a shepherd for more than 30 years, walking 9–10 km daily around a mountainous valley) as well as and the length of the femoral neck. The use of a 4XL (the second with greatest length) Bioball® (Merete, Berlin, Germany) neck in the revision of the acetabular component two years earlier implied an increase in the cyclic bending loads during activities because of a larger lever arm. These loads predispose the neck to the formation and propagation of microscopic fracture lines on the implant.<sup>16,17</sup> In this case, the strike was the event that precipitated the fracture of the neck. Until that time, it had never before been reported as the cause of fracture of the femoral neck stem. To prevent this stem fracture, an assessment of the modifiable risk factors is recommended. This is especially true in these patients with no modifiable risk factors in their environment. During the revision surgery, a macroscopic exam of the components was done. The visual inspection of the taper interface revealed dullness and discolouration of the neck just adjacent to the fracture, which suggested corrosion (Fig. 5 and Fig. 6). However, no microscopic

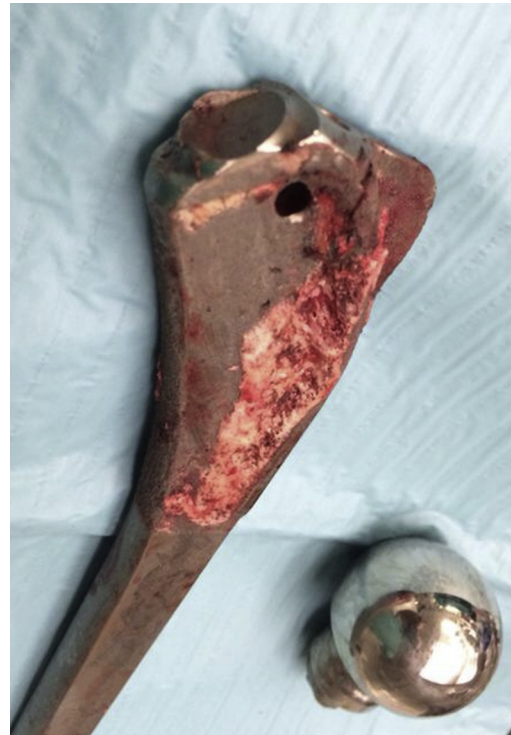
Fig. 6. Macroscopic aspect of the fragments of the Bicontact extracted prosthesis.
