# Research Article

# An Autopsy of Nanofiltration Membrane Used for Landfill Leachate Treatment

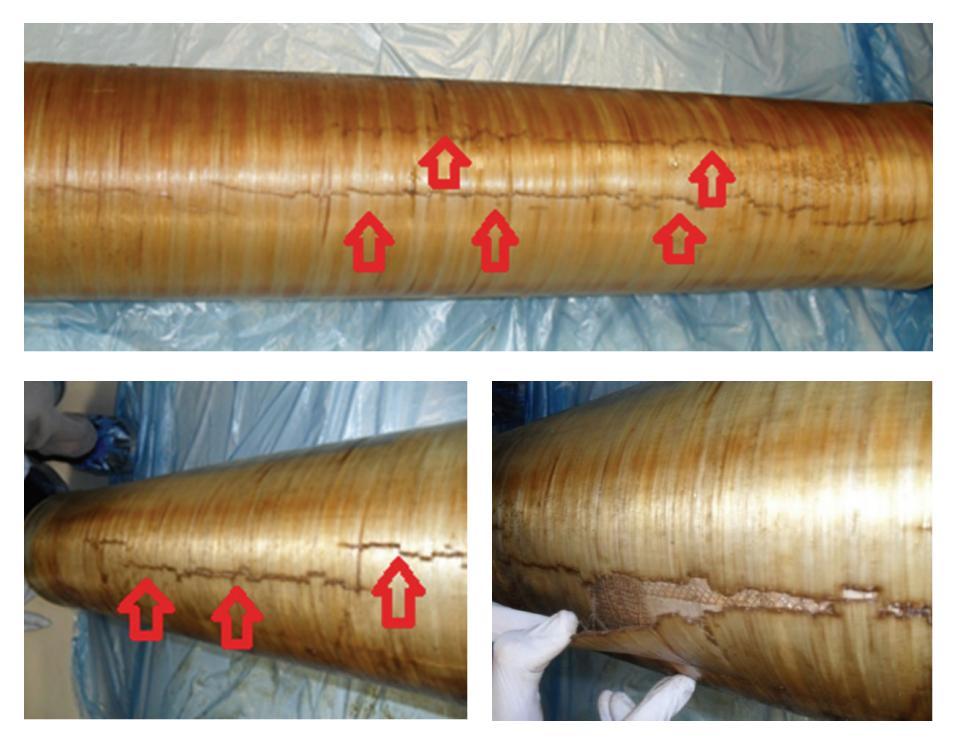
3.1. Physical Inspection. Antitelescoping devices, junction points, and gaskets on the module were intact; however, module outer shell had cracks on it longitudinally as can be seen in Figure 2. This may be related to the high pressure drop between the entrance and exit. Pressure drop originated from fouling may be converted to axial pressure by the module.

This axial pressure may be caused by the longitudinal cracks on the module [16]. These cracks led to deterioration of membrane unity and stability. Because of that, membrane sheets can be damaged or flow can be decreased.

FIGURE 2: Cracked module shells due to high pressure drop (arrows indicate cracks).

(i) Membrane fouling caused pressure drop which caused damage to membrane outer shell and decreased overall system performance. It is important to measure pressure between module inlet and outlet.

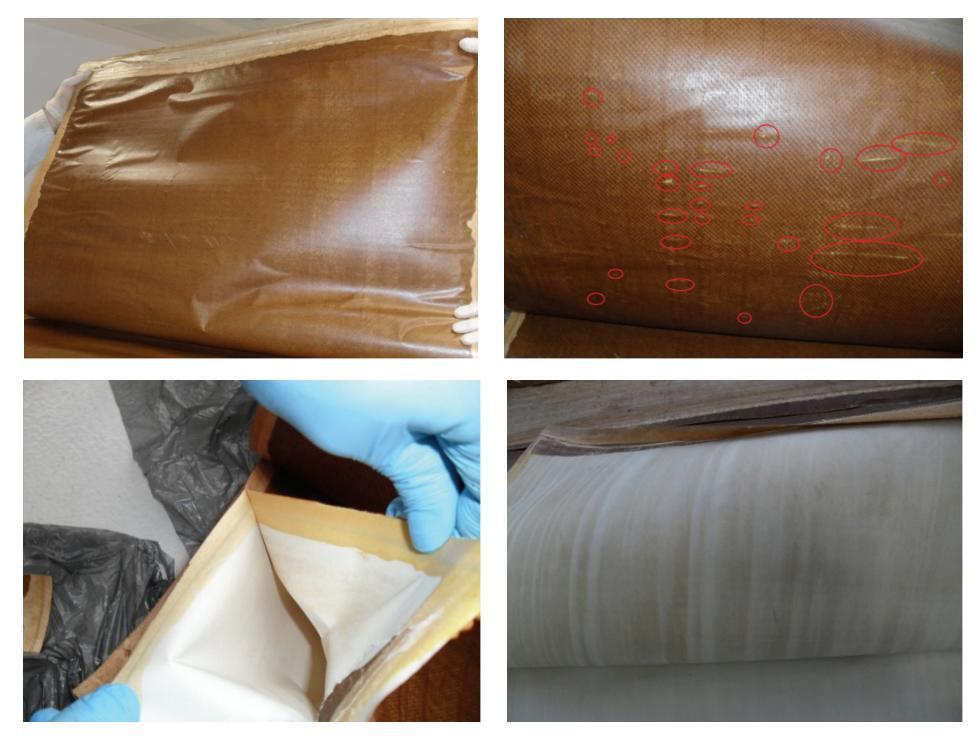
After removing of module outer shell, a brownish colored film layer was observed on each membrane sheet. This was the proof of iron fouling and biofouling (Figure 3). After the inspection of each membrane sheet, the defects on the membranes were detected as can be seen in Figure 3. These defects can be due to the combined effects of cracked shell and high pressure which led to unity and stability losses. Since module was no longer intact, applied pressure may have forced spacers to press the membrane surface. Because of that membrane surface and active layer may be deteriorated. Permeate spacers were discarded from the membrane module for observational analyses. It was seen that permeate spacers had also a brownish colored film layer which may result from damage taken (Figure 3).

FIGURE 3: Membrane leaves and permeate spacer images taken during physical inspection (circles indicate surface damage).

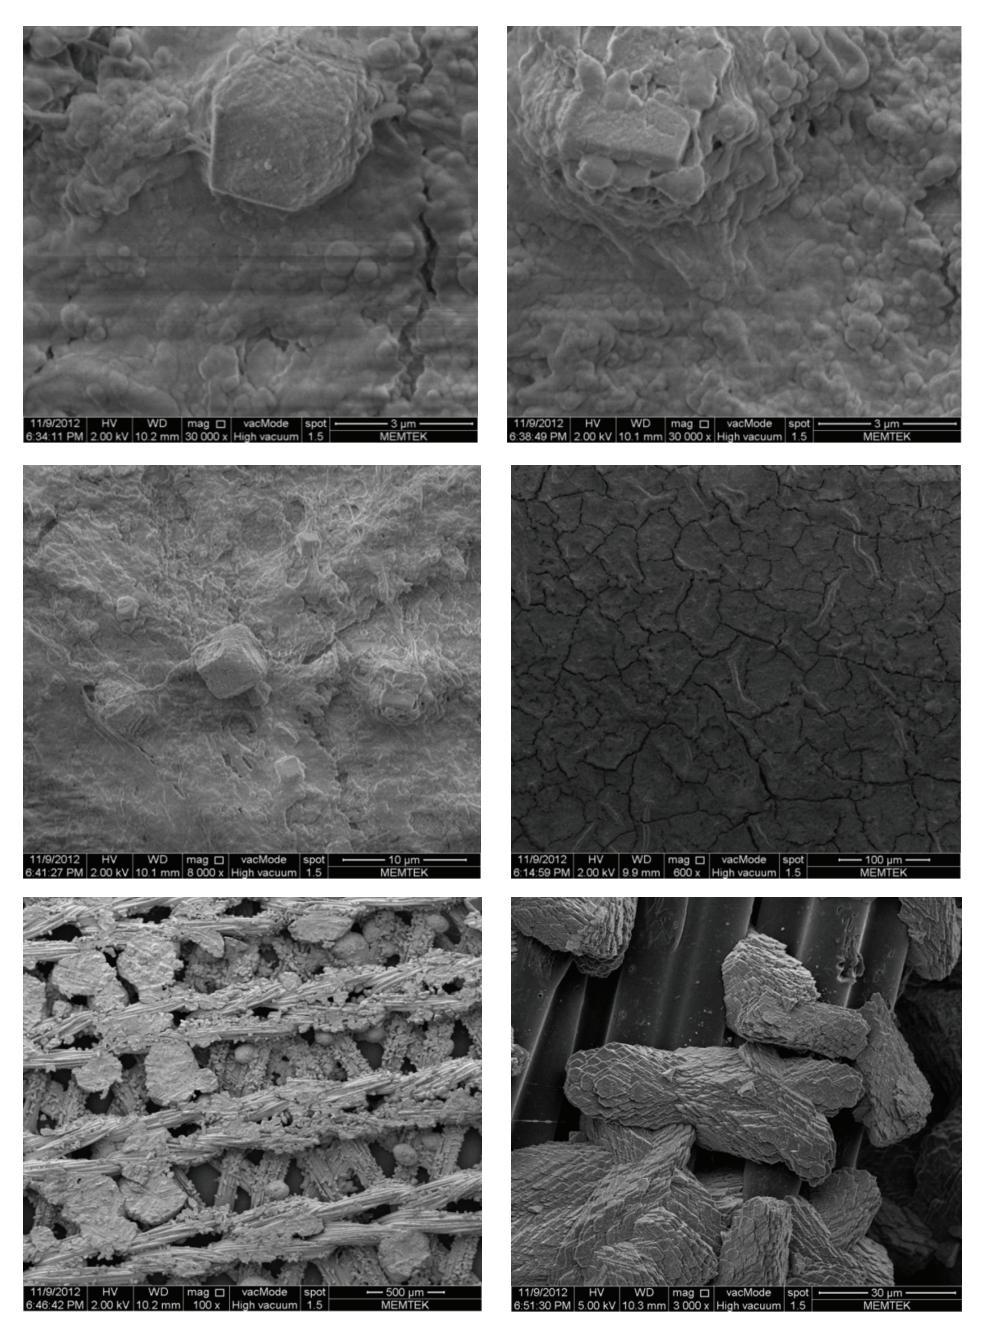
3.2. SEM/EDS Analysis. As seen in Figure 4, significant amount of organic matters was deposited on the membrane surface and a biofilm layer can be clearly seen on the membrane surface. Moreover, scaling formation that resulted from inorganic deposits was observed and it was predicted as calcium carbonate (CaCO<sub>3</sub>) scaling based upon the shape of scaling. Chemical washing effectiveness can be affected by this inorganic scalant entrapped within organic layer.

FIGURE 4: SEM analysis of membranes and spacer.

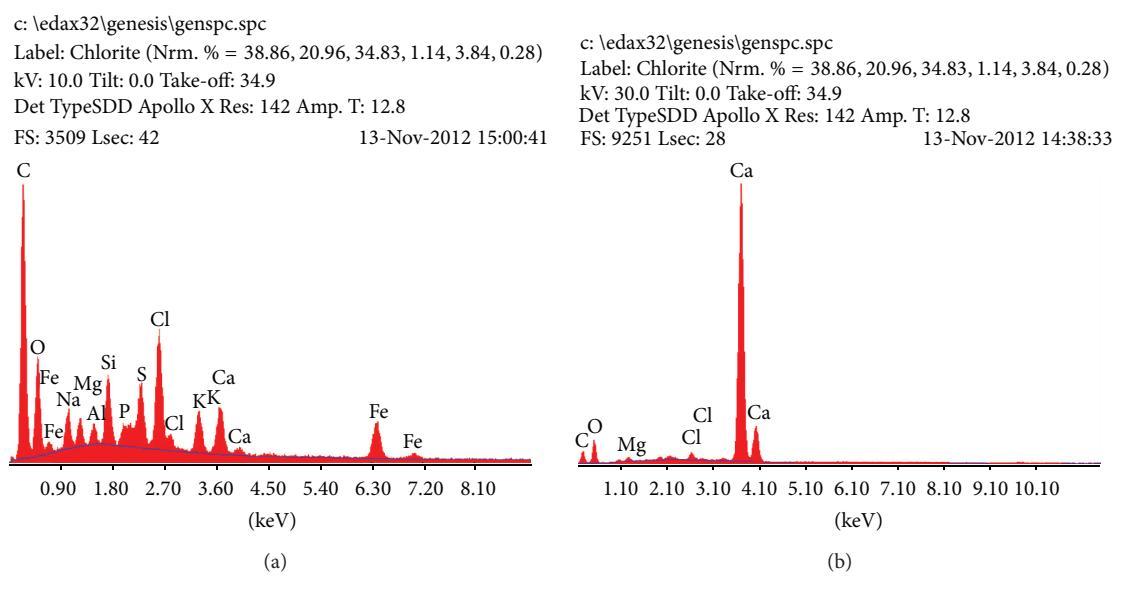
Major foulants found in the membrane and spacer's deposit layer were calcium, chlorine, silicium, magnesium, iron, and sodium according to EDS analysis (Figure 5).

FIGURE 5: EDS spectrums of membrane (a) and spacer (b) surfaces.

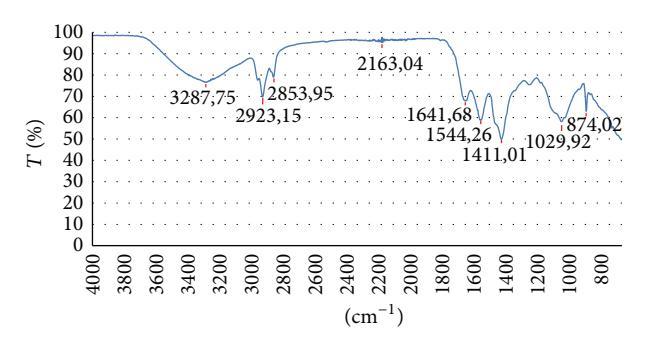
FT-IR spectra of the fouled membrane surfaces were given in Figure 6. Broad absorption peak between 3200 and  $3400 \text{ cm}^{-1}$  indicated the presence of polysaccharides as foulants [17]. The peaks around 1640 and 1540 cm<sup>-1</sup> showed amide I and amide II bonds which show protein presence

FIGURE 6: ATR-FTIR spectra of fouled membrane surface.

[18]. The peaks around  $1030 \text{ cm}^{-1}$  belonged to the C-O bonds which can be an indicator of carbohydrates. FT-IR results validated biofilm layer existence on the membrane surface.

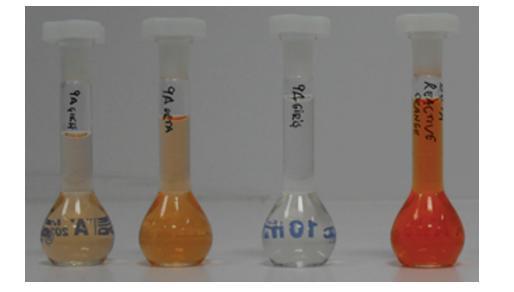
FIGURE 7: Feed dye solutions (right) and permeates collected using membranes taken from three different parts from membrane.

Dye rejection tests were conducted by using 10 mg/L reactive orange dye solution. Three random membrane samples were used in finor dye rejection test. This test aimed to find whether membranes are capable of removing color or not. Therefore, the rate of color removal was not studied in details. After dye filtration, color existed within permeates which indicated poor color rejection. Color existence in permeate can be associated with the damaged active layer on membrane surface. Different permeates obtained during dye filtration were presented in Figure 7.

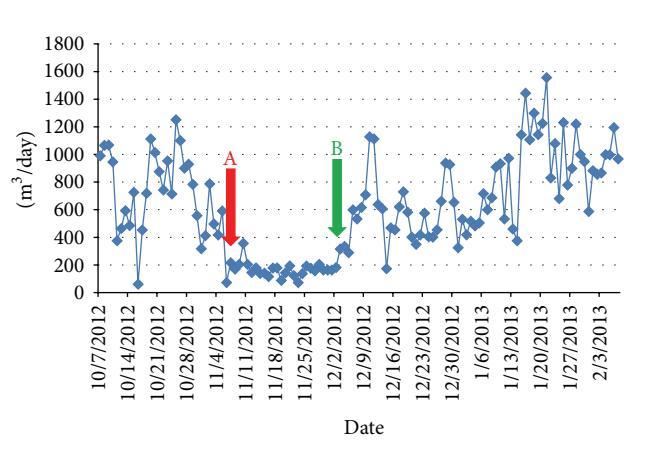
3.5. Problem Diagnosis and Strategies for Increasing Treatment Efficiency. Membrane autopsy revealed that exchanging surface aerators with bottom diffusers increased the oxygen concentration in tank. Increased oxygen amount increased ferric iron formation (insoluble form). Particulate iron caused rapid fouling of the membranes. Also particulate iron may enhance the oxidation of thin film composite (TFC) surface. Loss in the rejection performance of the membranes may occur due to TFC layer oxidation. When membrane rapidly fouled, pressure dropped so permeate amount decreased. Plant operators increased the pressure applied to compensate the permeate rate. However, pressure increase damaged outer shell of membrane module.

FIGURE 8: Flow rate graphic of NF membrane plant (A: when problem started and B: when problem solved).

Performance losses and performance enhancements of the treatment can be clearly seen in Figure 8. In Figure 8, point "A" indicated starting point of the problem whereas point "B" indicated the point where the problem was solved. After the membrane autopsy, and proper problem diagnosis, treatment plant capacity increased.

One of the strategies suggested for increasing the treatment efficiency was the usage of more effective antiscalant against iron. Antiscalant specifications were given in Table 4. In the treatment plant, Vitec 3000 was used as scalant. Suggested antiscalant was Vitec 400, which is more effective for iron and silica scaling.
