Trunnion fracture of a cobalt–chrome fully porous-coated femoral stem: A case report

Mustafa Kavak^D, Akın Turgut^D

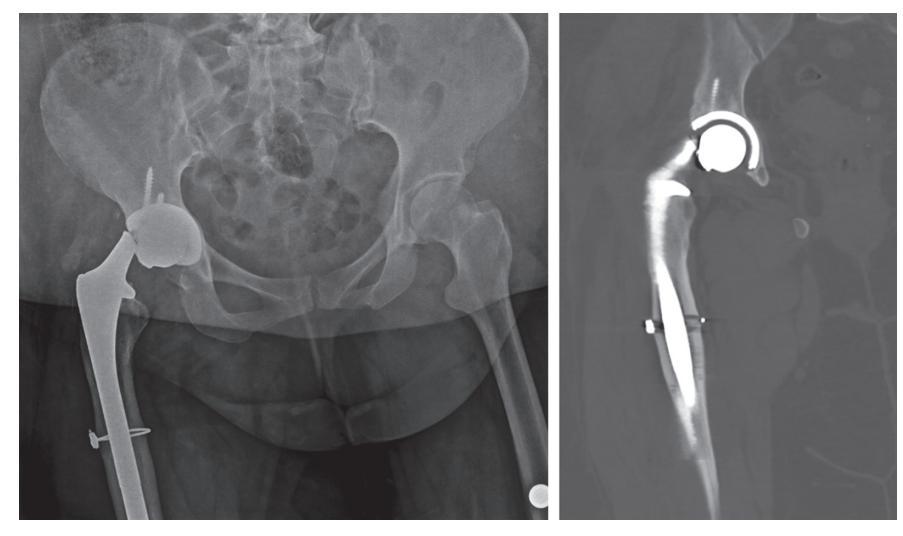
Figure 1. Preoperative radiological image: dissociation of the femoral stem and head.

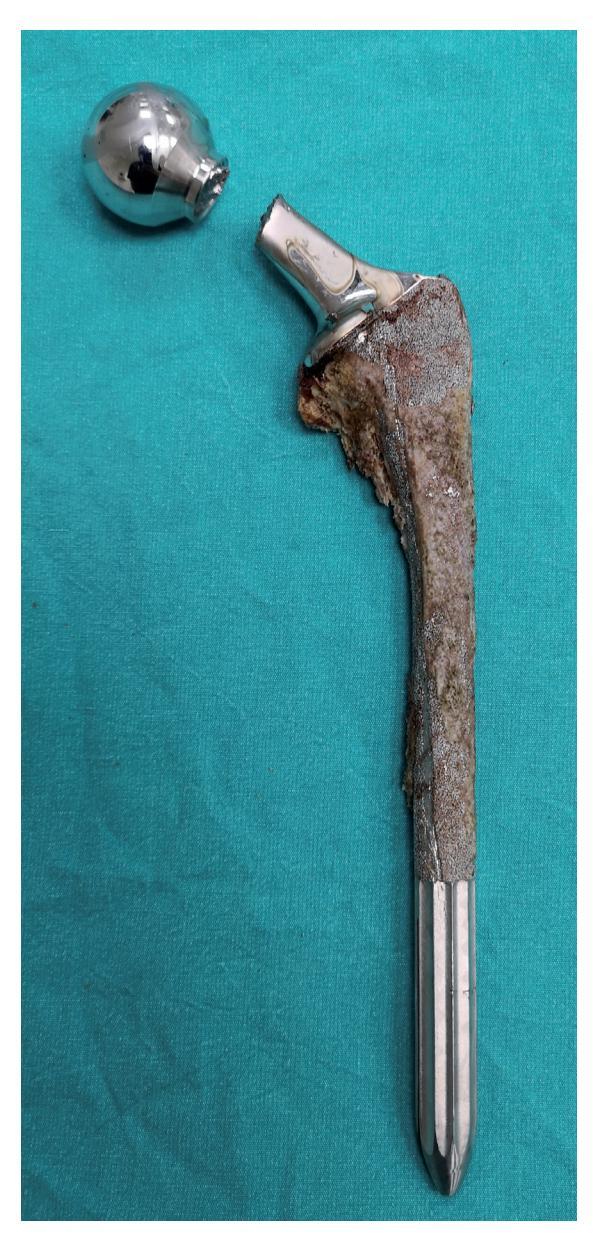
In the revision surgery, we used a posterior approach over the old incision and observed that the neck of the femoral stem was fractured in the trunnion region and the fractured part remained inside the femoral head (Figures 2 and 3). There was no macroscopic finding in favor of infection. We took tissue samples from different regions for microbiological examination but

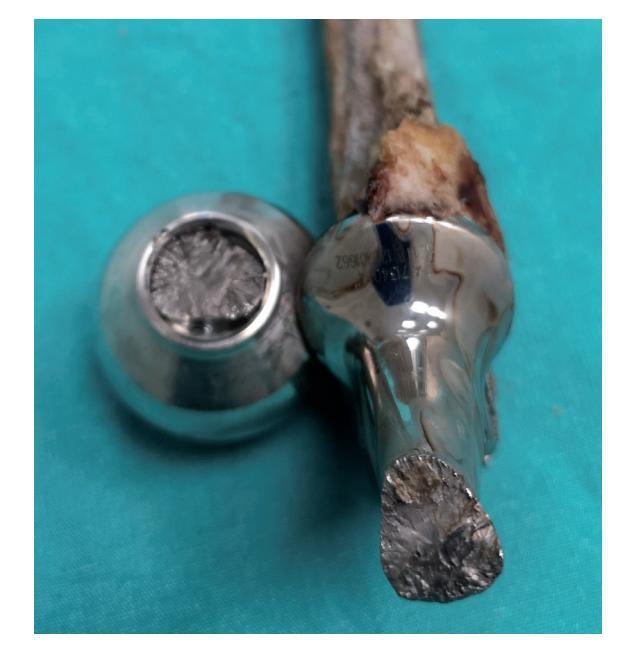
Figure 3. The femoral stem and the trunnion fracture surface.

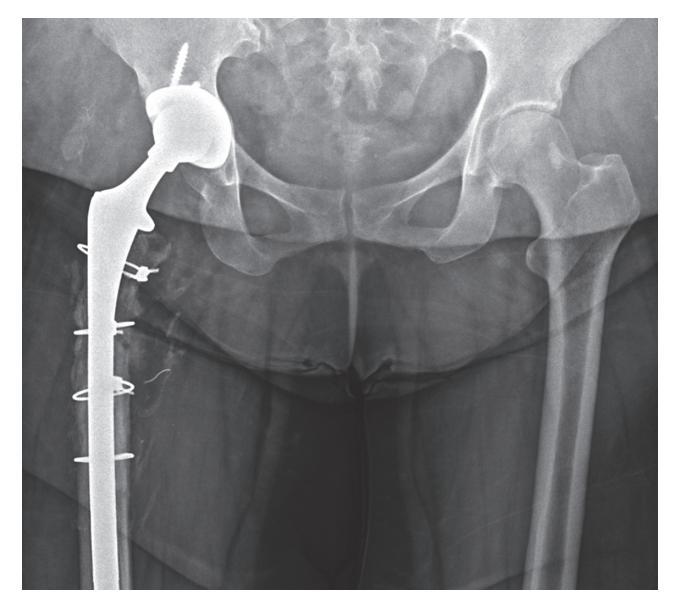
Figure 4. Postoperative x-ray image: revision of the femoral stem and fixation of the trochanteric osteotomy.

observed no bacterial growth in the samples. We revised the eccentric wear seen on the PE liner with highly cross-linked polyethylene. We performed an extended trochanteric osteotomy to remove the well-fixed femoral stem. After cleaning the intramedullary canal, appropriate reamerization, and rasping, the trial stem was placed. Following fluoroscopic control, we concluded that the femoral stem size was appropriate. Then, we evaluated the hip stability and found it to be stable, with normal range of motion. Following the femoral reconstruction where we used a size 14, 260-mm, cementless, bowed, fully porous-coated, cylindrical femoral stem (Echelon[®]) and

a 36-mm +16 femoral head, we fixed the trochanteric osteotomies using 4 cerclage wires (Figure 4). The surgery was performed by the mentor author.
