Misplacement of the tunnel hemodialysis catheter through the left jugular vein to the azygos vein

A case report

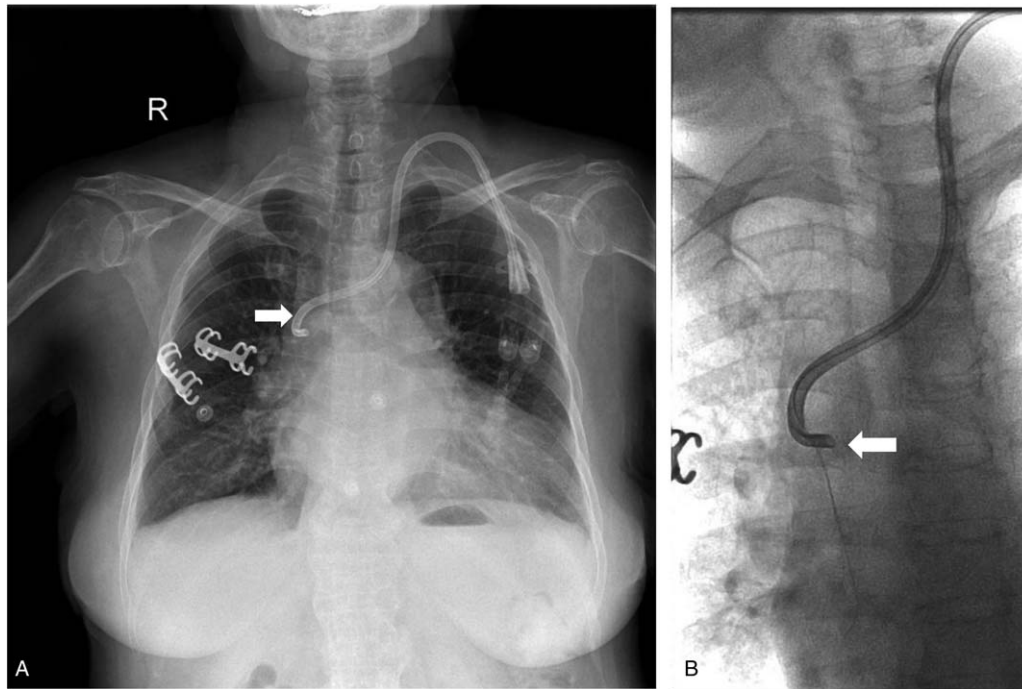
By placing the guidewire into the catheter's venous port as a guide and establishing a new percutaneous tunnel, we successfully placed a new tunnel catheter (14.5 Fr, asymmetric tip, 36 cm) and then got non-pulsatile blood flow. Conventional anteroposterior and lateral chest radiographs were performed to assess catheter tip position following the catheter placement. However, we found that the catheter tip was incorrectly positioned into the azygos vein (Fig. 1A). It was noted that the catheter tip kinked obviously, and inclined medially at the right tracheobronchial angle. This was further confirmed by injection of a contrast agent through the venous orifice of the catheter

Figure 1. Analysis of catheter tip malposition. (A) Chest radiograph showing catheter tip malposition close to the right tracheobronchial angle structure (azygos vein) like a fishhook (arrow). (B) By injecting contrast into the venous port, DSA confirms that the tip of the catheter is placed in the azygos vein (arrow). DSA = digital subtraction angiography.

the risk of catheter tip malposition was significantly higher with the left side insertion.^[1] Therefore, in our clinical practice, chest radiograph is always carried out after central vein catheters placement. We found a sharp connection like a fishhook near the right tracheobronchial angle, which is a constant anatomical landmark^[5] and where the azygos vein opens into the superior vena cava. This phenomenon indicated that the tip of the catheter was mispositioned into the azygos vein. In some cases, venous blood can also be easily aspirated from the azygos veins, which can lead to a clinical impression of proper catheter tip placement. But this could be easily detected by the radiographic technology. After replacing the tip position of the tunneled hemodialysis catheter under DSA (digital subtraction angiogram), we observed that the tip reached the right atrium opening.

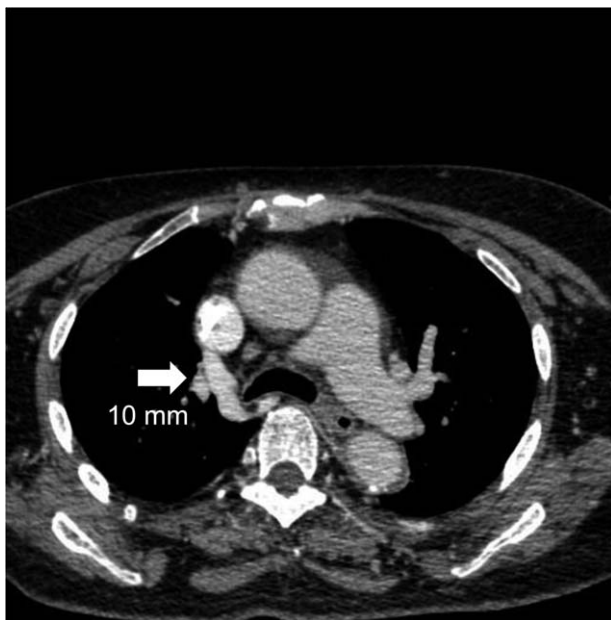
(Fig. 1B). CT scan showed the thickening azygos vein, the ostial size of which had reached 10 mm (Fig. 2). After removing the catheter and replacing it under the DSA (Digital Subtraction Angiography), we finally placed the catheter tip in the proper

Azygos vein is 6 to 8 mm in normal physiological circumstances.^[9] But in our case, its ostial size has reached 10 mm. This has increased the chance of inadvertent cannulation during hemodialysis catheter insertion. Meanwhile, the longer course and more transverse disposition of the left brachiocephalic increase the possibility of malpositioning. Ewa et al demonstrated that with the blind insertion of tunneled hemodialysis catheters,

Figure 2. CT scan of azygos vein. The azygos vein was thickened with ostial size of 10 mm (arrow).

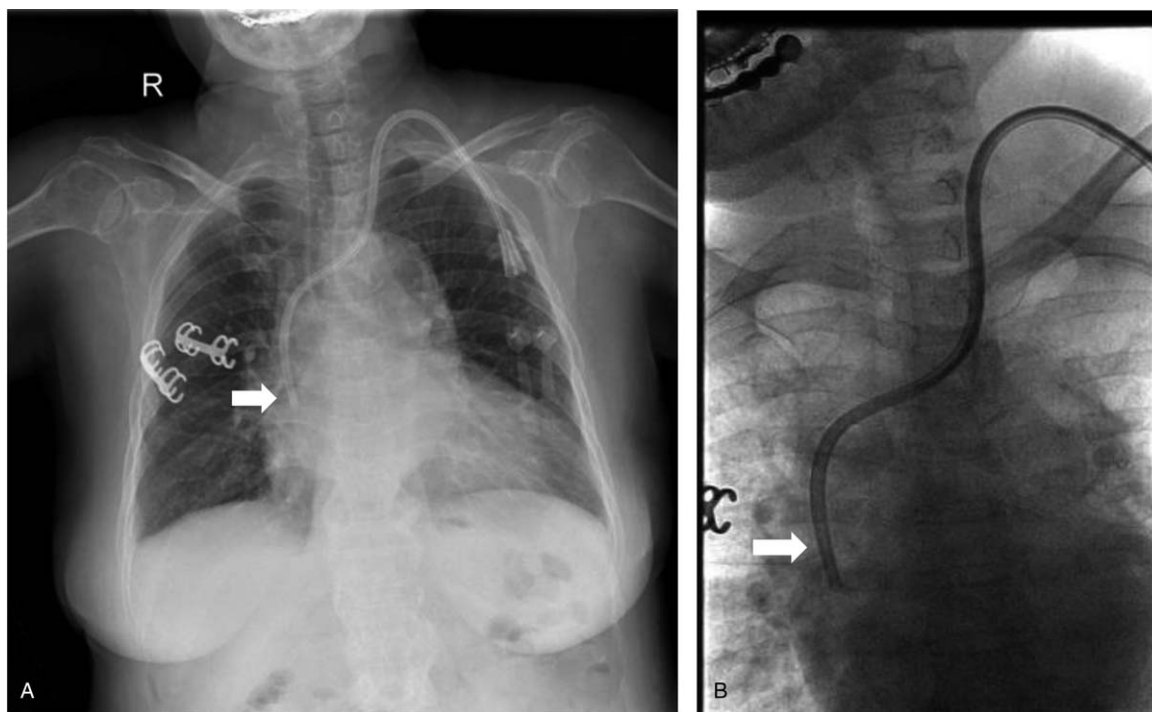
Figure 3. Analysis of catheter tip re-position. (A) Chest radiograph showing catheter tip has reached the correct position in the cavoatrial junction after being modulated under DSA (arrow). (B) DSA shows the hemodialysis catheter after redeployed within the right atrium (arrow). DSA = digital subtraction angiography.

position (Fig. 3). Since the replacement, subsequent dialysis sessions have been successful, with no further flow-related issues.
