Current Status and Issues Concerning Magnetic Resonance Imaging in Patients with a Magnetic Resonance Conditional Cardiac Implantable Electrical Device: A Single-center Study

Yukitoshi Ikeya, Toshiko Nakai, Rikitake Kogawa, Sayaka Kurokawa, Koichi Nagashima, Ryuta Watanabe, Masaru Arai, Naoto Otsuka, Satoshi Kunimoto and Yasuo Okumura

(Intern Med 60: 1813-1818, 2021)

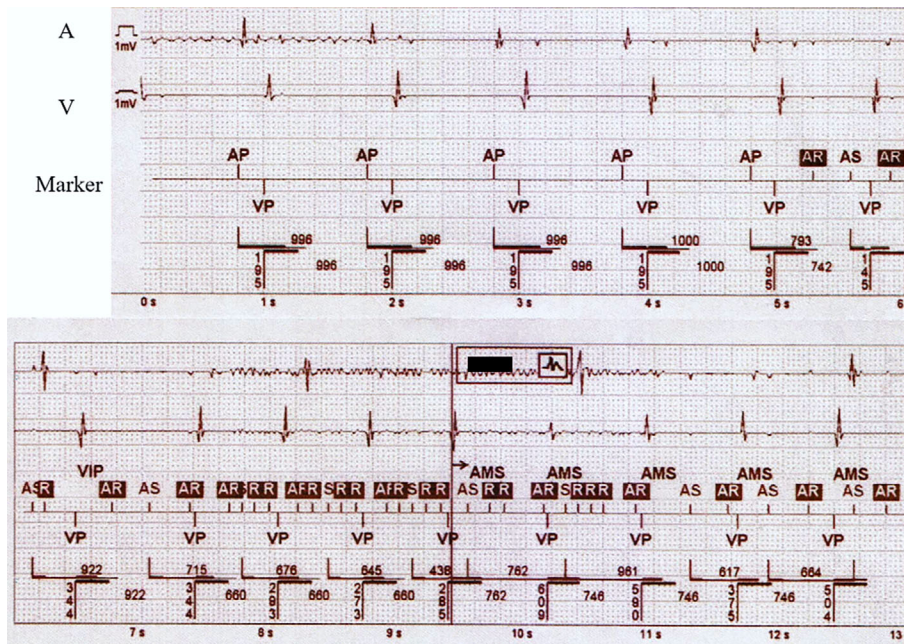
The attending clinical technician contacted the MRI department at the appointed time, and the patient, who had completed the examination and returned home, was called back for a device check. This check identified no problems with measurements, including impedances, sensing, and thresholds, but an automatic mode switch (AMS) event had been recorded, with the timing matching with that of MRI scanning (Fig. 3). The A-pace V-pace mode before the MRI examination had been switched to A-sense V-pace mode during the MRI examination when atrial noise began to be detected, finally switching to V-pace mode at a constant rate with atrial noise being falsely recognized as Af, activating the AMS. Fortunately, V-pace was not suppressed because ventricular noise was not over-sensed. Device checks at subsequent regular clinic visits revealed no abnormalities in impedances, sensing, or thresholds.

Figure 3. Report of interrogation after MRI scanning (Case 1). Intracardiac electrogram revealed the inhibition of atrial pacing due to oversensing of atrial lead b caused by the magnetic field. Recorded events are shown matched to the scanning time. The A-pace V-pace mode was switched to automatic mode switch (AMS) due to the device sensing atrial noise.

time of setting. Among the problem cases, Case 1 was one in which MRI was performed without setting the device to its MRI mode. In this case, the only change was switching to AMS in response to atrial noise; however, oversensing of ventricular noise might have caused a serious event, such as cardiac arrest. Although it was fortunate that no adverse event occurred during the examination or subsequent device checks in patients who underwent MRI without setting the device to the MRI mode, it seems necessary before the examination to not only ask the patient or his/her family verbal questions and to complete a questionnaire but also to reconfirm the physical findings and previous images/records wherever possible, as the responses obtained may not be accurate.

We encouraged the staff at the reception desk to perform reconfirmation and advised the patient to take precautions during future examinations.
