# Two-year follow-up of a mandibular second premolar with a fractured irrigation needle extending beyond the apex: A case report

Endodontic instrument fracture;  
Irrigation needle;  
Mandibular premolar;  
Root canal treatment

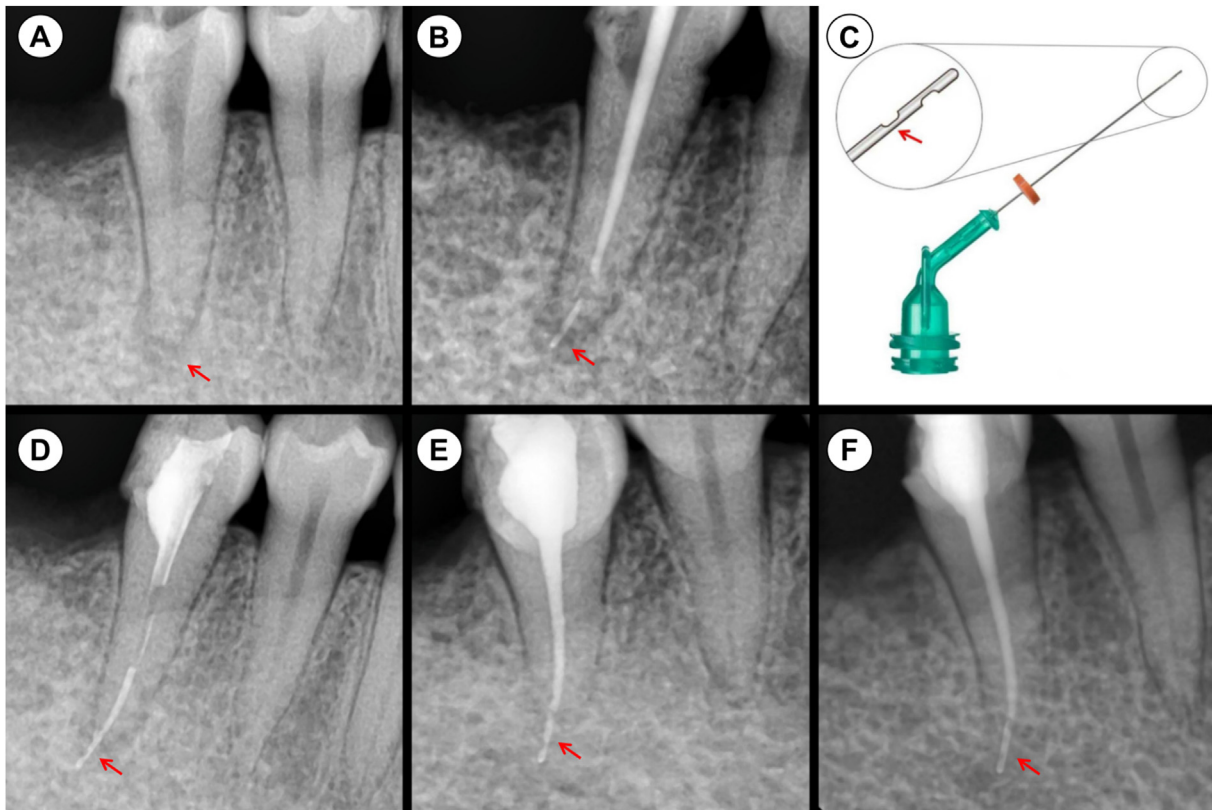
locator. The canal was shaped to #25/.06 using NiTi rotary system, with alternating irrigation using a 31G/27 mm double side-vented irrigation needle with 3 % NaOCl and 17 % ethylenediaminetetraacetic acid (EDTA) solution. Calcium hydroxide paste was introduced into the canal, and the access cavity was sealed with a temporary filling material. One week later, the patient returned. The tooth was re-isolated, and the temporary filling removed. The canals were rinsed with a 31G/27 mm double side-vented irrigation needle and 3 % NaOCl solution. A trial fitting of the master gutta-percha cone revealed a radiopaque fragment in the apex (Fig. 1B). The shape suggested it was the tip of the irrigation needle, confirming an instrument fracture (Fig. 1C). The patient was informed of the fracture and presented with two options: complete the root canal treatment without removing the fractured instrument or opt for surgical intervention. Choosing the former, the canal was soaked in 3 % NaOCl solution and underwent three 20-s ultrasonic irrigation sessions with an ultrasonic tip followed by 17 % EDTA solution. The root canal filling was completed using the continuous wave obturation technique, and a periapical radiograph was taken to confirm good apical sealing (Fig. 1D), and the canal was backfilled with gutta-percha. The restoration was completed with a light-cured composite resin. The patient was advised to observe for two weeks before proceeding with the post-and-core supported full crown restoration. At

**Figure 1** Periapical radiographs of our case of the mandibular second premolar and schematic diagram of the double side-vented irrigation needle. (A) Pre-operative radiograph showing a periapical lesion of the tooth #45 (red arrow). (B) Radiograph of master gutta-percha cone fitting revealing a radiopaque fragment (red arrow) in the root apex. (C) Schematic diagram of a 31G/27 mm double side-vented irrigation needle. The red arrow indicates the needle's weak point and the location of the fracture. (D) Periapical radiograph demonstrating good apical sealing of the fractured irrigation needle fragment (red arrow). (E) Six-month follow-up radiograph revealing complete healing of the periapical lesion of the tooth #45 (red arrow). (F) Two-year follow-up radiograph displaying normal lamina dura around the root apex of the tooth #45 (red arrow).

the 6-month follow-up, the tooth remained asymptomatic. A periapical radiograph showed complete healing of the periapical lesion (Fig. 1E). At the two-year follow-up, the tooth was still asymptomatic, and a radiograph showed normal lamina dura around the apex (Fig. 1F).
