Case report

A case of bilateral hip mechanically assisted crevice corrosion after staged total hip arthroplasty

Carl L. Herndon, MD^{*}, Roshan P. Shah, MD, JD, H. John Cooper, MD, Jeffrey A. Geller, MD

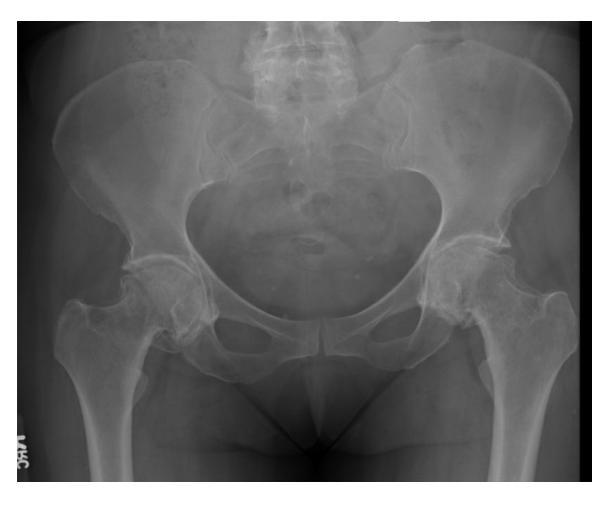
Figure 1. Anterior-posterior (AP) pelvis radiograph upon initial presentation showing bilateral hip osteoarthritis.

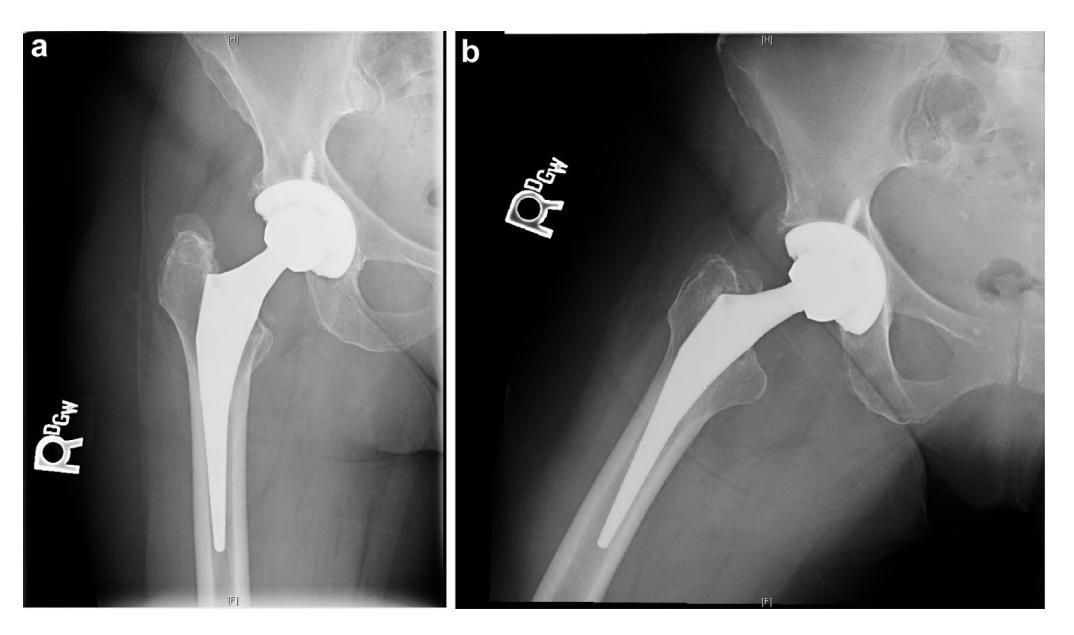
Figure 2. AP (a) and lateral (b) radiographs of the right hip upon presentation approximately 5 years after the initial right THA show no sign of complication.

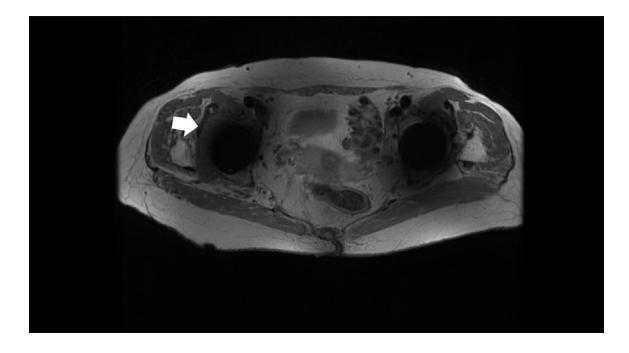
Five months later, she returned after a trial of physical therapy but was complaining of worsening pain and difficulty ambulating. Her left side remained asymptomatic. Laboratory tests were drawn, which revealed an erythrocyte sedimentation rate (ESR) of 51 mm/ h (normal, <20 mm/h), C-reactive protein (CRP) of 27 mg/L (normal, <10 mg/L), serum cobalt (Co) level of 11.4 ppb (normal, <1 ppb), serum chromium (Cr) level of 1.5 ppb (normal, <1 ppb), and white blood cell count (WBC) of $5.7 \times 10^3/\mu$ L (normal, $3.48-9.42 \times 10^3/\mu$ L) with 21% lymphocytes and 70% neutrophils. Magnetic resonance imaging showed soft tissue swelling and a fluid collection near the femoral head of the right hip, in addition to joint space distention on proton density sequences, with no abnormal findings on the contralateral side (Fig. 3).

Figure 3. Axial proton density sequence magnetic resonance imaging (MRI) demonstrates soft tissue swelling and a fluid collection near the femoral head of the right hip, in addition to joint space distention approximately 5 years after the initial right THA (arrow). Note that the left hip appears normal approximately 18 months after primary THA.

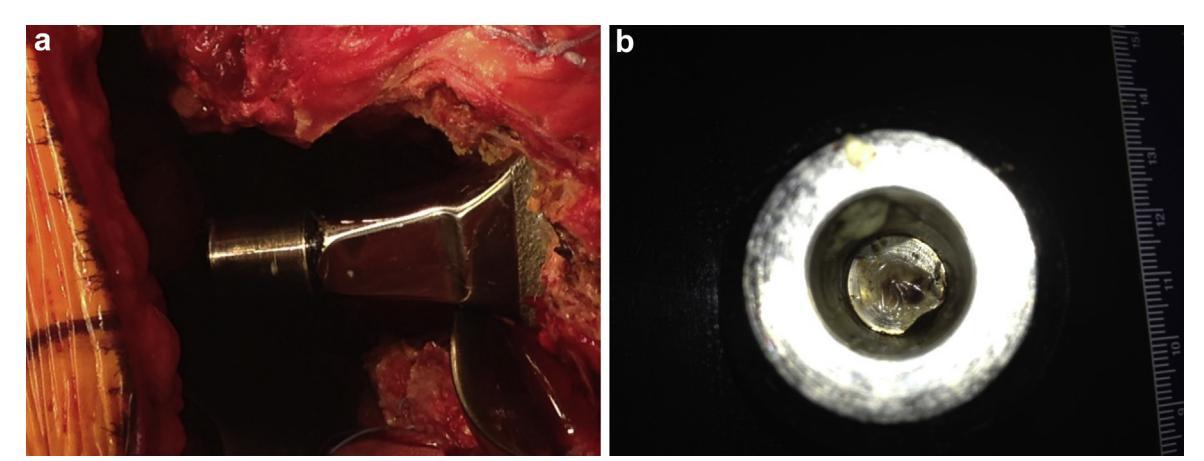
At this point, a diagnosis of MACC and ALTR was made, and she underwent revision THA. Intraoperatively, an extensive amount of necrotic-looking fibrous tissue was noted throughout the hip joint, and upon performing the capsulotomy, a thick, greenish, gelatinous material was encountered. Tissue was sent for frozen section, which demonstrated necrosis but no acute inflammation. There was also a moderate amount of typical black fretting/corrosion debris at the femoral head/neck taper junction and on the trunnion itself (Fig. 4a and b). The joint was thoroughly irrigated, the necrotic tissue was excised, the trunnion was thoroughly cleaned of corrosion debris, a modular titanium taper sleeve was placed, and her bearing surface was converted to ceramic-on-polyethylene material. Final pathology revealed acellular fibrinoid material, chronic inflammation, and necrosis. She rehabilitated from her revision well and had no postoperative complications.

Figure 4. Clinical photographs of the femoral neck trunnion (a) and the inside of the femoral head implant (removed) (b) during revision surgery on the right hip.

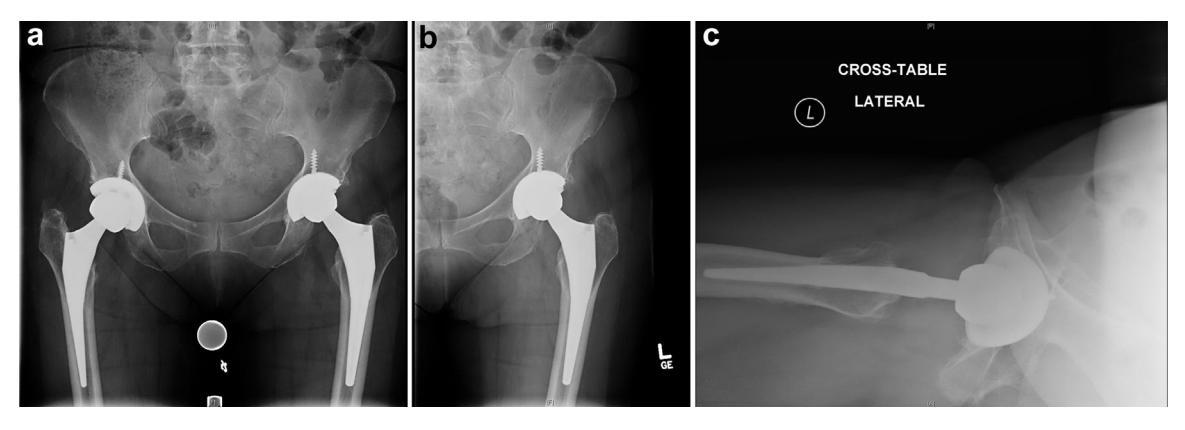
Twenty-one months later, approximately 2 years after her left THA, she represented with similar symptoms in her left hip; the right hip was now asymptomatic. She reported increasing need for pain medication, difficulty ambulating, and the same anterior groin pain as she had on the right side before revision. Radiographs again showed no evidence of hardware failure and no evidence of calcar lysis (Fig. 5a-c). Laboratory results showed an ESR of 83 mm/h, CRP of 66.2 mg/L, serum Co level of 9.8 ppb, serum Cr level <1.0 ppb, and WBC of $8.2 \times 10^3/\mu$ L with 15% lymphocytes and 76% neutrophils.

Figure 5. AP pelvis (a) and AP (b) and lateral (c) radiographs of the left hip upon presentation approximately 2 years from the initial left THA and 21 months after the revision surgery on the right side. No calcar lysis is noted.

pseudotumor surrounding the posterior joint capsule. Again, there was a moderate amount of black fretting/corrosive debris at the base of the trunnion. The left hip was treated similarly with synovectomy, pseudotumor excision, cleaning of the trunnion, and placement of a titanium taper sleeve, and she was again converted to a ceramic-on-polyethylene arthroplasty. Final pathology of this specimen confirmed the presence of acellular, fibrinoid material with evidence of chronic inflammation and necrosis, similar to the contralateral hip.
