Images in Cardiology

Air Bubble Trapped in the Left Atrial Appendage After Occluder Delivery

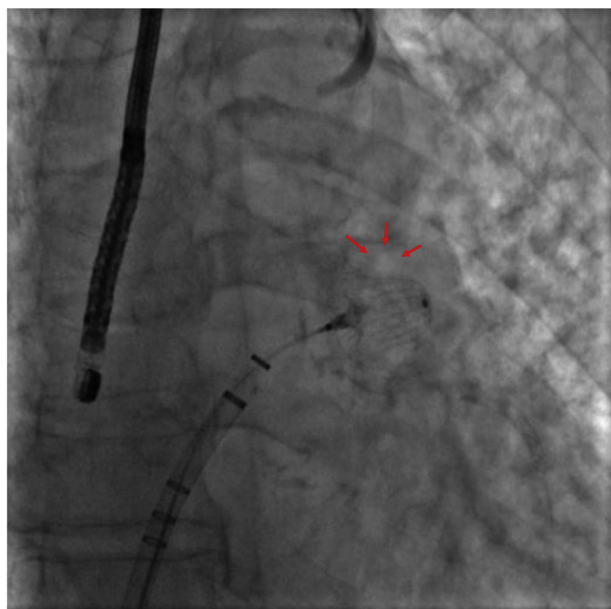
Transseptal access was achieved, guided by transesophageal echocardiography. We then introduced the occluder delivery system into the left atrium, without difficulty. The system was perfused with saline with an autopump. Contrast was injected into the LAA (Fig. 1). After delivery of the device, contrast was injected again. Just after, we clearly visualized an air bubble trapped in the LAA (Fig. 2). We provide a video showing the bubble moving into the LAA (Video 1

view video online). We immediately examined the delivery system and noted that the valve was unclipped from the delivery sheath. We had to push strongly to correctly reclip it. The transesophageal echocardiography did not show any flow from the LAA after device placement.

We finished the procedure and tried to once again unclip the valve, which proved to be impossible. We conclude that the system had a manufacturing defect.

Our patient did not experience an ischemic event in relation to this accident. Forty-eight hours later, we performed an x-ray and noted the spontaneous disappearance of the bubble.

Figure 2. Air bubble trapped in the left atrial appendage. (Red arrows) point the bubble.

- An air bubble trapped in the left atrial appendage can disappear spontaneously.
- Careful examination of the material integrity of the device is needed before starting any percutaneous procedure.
