## Case Report

# Operating Room Fire During Total Knee Arthroplasty Tibial Impaction: A Case Report and Review of the Literature

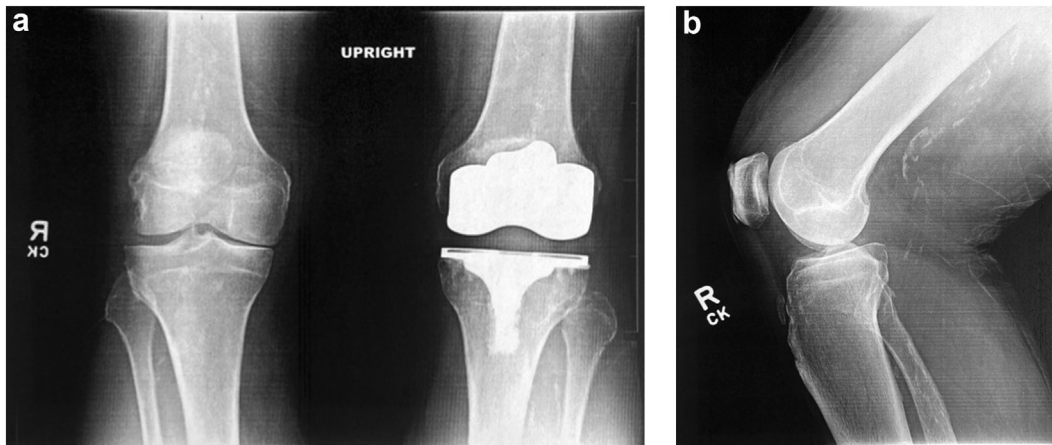
77-year-old male with a history of type 2 diabetes mellitus and bladder malignancy, body mass index of 30 kg/m<sup>2</sup>, with right knee end-stage osteoarthritis was seen in clinic and elected to undergo a primary right TKA after failing nonoperative management (Fig. 1a and b). The procedure was done under neuraxial anesthesia with an adductor canal block, without a tourniquet. Sterile preparation of the right lower extremity was performed with a 2% chlorhexidine gluconate solution. After draping, a second prep was done with additional chlorhexidine gluconate solution prior to applying iodine-impregnated drapes to the right knee. The electrocautery device was placed at the head of the bed sitting in a hard plastic sheath inside a plastic pouch.

**Figure 1.** Preoperative radiographic imaging of the bilateral knees. (a) Anteroposterior view. (b) Lateral view.

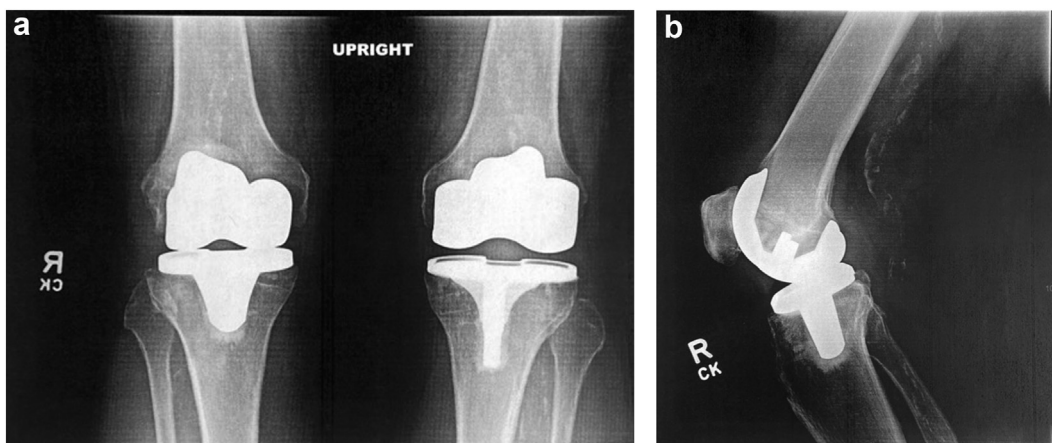
After the cement had cured, the posterior knee tissue was inspected once more prior to insertion of the final polyethylene insert and again found to be without visible damage. There was no blackening of tissue or bleeding in the area. The final polyethylene insert was placed, and the arthrotomy and skin were closed. The fire was disclosed to the patient's family as well as to the patient himself in the recovery unit, and all questions were answered to their satisfaction. The patient was discharged home on apixaban for deep venous thrombosis prophylaxis due to his history of malignancy. At his 2-week follow-up visit, his wound was healing well, and he continued to progress uneventfully. As of 15 months postoperatively, he was doing well with good mobility and minimal pain (Fig. 2a and b).

**Figure 2.** Postoperative radiographic imaging of the bilateral knees. (a) Anteroposterior view. (b) Lateral view.
