Ventricular tachycardia during microdebrider-assisted turbinectomy: An electrocardiographic artifact

Khalid Sofi, Ab Salam Khalid,
Kurdi A. Mushtaq Gilani

Department of Anesthesia, King
Abdul-Aziz Medical City, King
Fahad National Guard Hospital,
Riyadh, KSA.

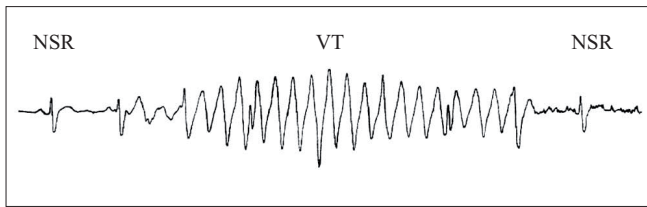
Figure 1: ECG artifact resembling VT during the use of microdebrider; NSR, normal sinus rhythm; VT, ventricular tachycardia

In our case, a Storz Unidrive microdebrider resulted in an EKG artifact resembling VT, the source of interference being a stray current from loose electrical wiring of the microdebrider. All electrical equipments used

intraoperatively are supposed to be grounded to allow any stray electric current to be carried of the ground. However, a malfunction of the equipment results in failure of the grounding of the current as was seen in this case.

was completed without any EKG interference. Patient was extubated, shifted to post anesthesia care unit and remained in sinus rhythm throughout. The Storz Microdebrider was handed over to Biomedical Engineering for necessary repairs and was found to have some loose connections which were tightened and the problem was corrected. The actual rhythm strip of EKG artifact could not be produced due to yet to be installed software for data retrieval, in the new Zeus anesthesia machine from Drager in our department [Figure 1].
