Entrapment of a spline from a multielectrode mapping catheter in the side hole of a nonsteerable guiding sheath, with dislodgement and subsequent suction retrieval of a proximal spline electrode

(Heart Rhythm Case Reports 2022;8:475-478)

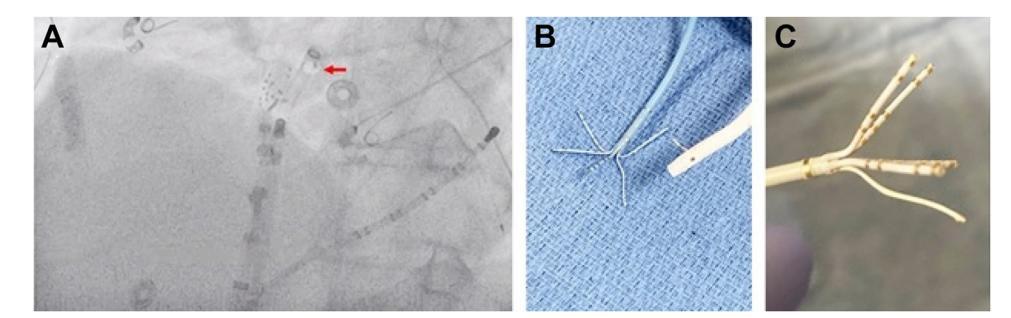
Figure 1 PentaRay spline entrapment. **A:** The spline that was sheared off during withdrawal into the SL1 sheath is visible on fluoroscopy in the left anterior oblique projection (*red arrow*). **B:** With the catheter and sheath removed from the body, the detached spline is visible retained in the SL1 sheath side hole. **C:** Close-up view of the PentaRay catheter with electrodes stripped off of the inferior-most spline.

During mapping, significant interaction was noted between the PentaRay and the tip of the SL1 sheath. The PentaRay was withdrawn into the steerable sheath and removed from the body. On inspection, it was noted that the electrodes had been stripped from 1 of the PentaRay splines, and on fluoroscopic examination the electrodes were noted to be retained in the side hole of the SL1 sheath (Figure 1).

the spline was able to bend such that the shaft of the spline and side hole were no longer coaxial, which then allowed the proximal electrode to be caught in the hole. Traction applied to the shaft of the catheter outside of the body during attempted removal was enough to shear the electrodes off of the spline. Of note, there is 1 prior report where a branch of the PentaRay catheter was entrapped in the mitral valve and a distal portion of the branch was sheared off.⁶ However, the electrodes remained intact on that branch.

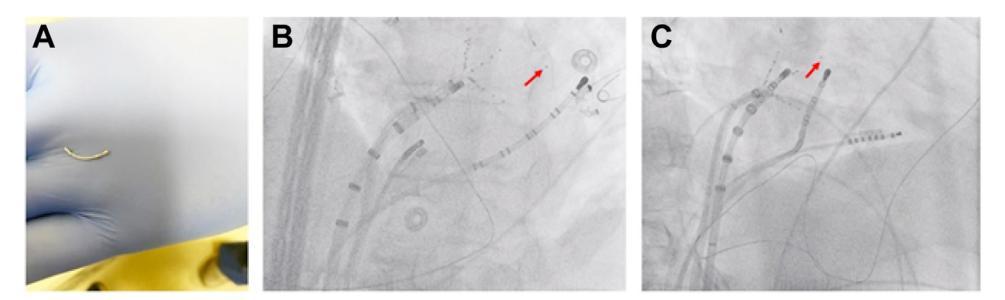
The SL1 sheath was withdrawn to the level of the right iliac vein, and both the sheath and branch fragment were removed over a 0.035 inch Glidewire (Terumo, Shibuya City, Tokyo, Japan). On re-examination of the PentaRay branch fragment, it was noted that the proximal electrode from 1 of the splines was missing. Fluoroscopic examination revealed a retained electrode in the LA, likely entrapped in the mitral valve apparatus (Figure 2).

Figure 2 Dislodged electrode. **A:** With the spline fragment removed from the sheath, close examination revealed the proximal electrode to be missing. **B:** Left anterior oblique fluoroscopic projection with the retained electrode visible in the lateral left atrium (*red arrow*), presumed to be in the mitral apparatus, given its proximity to the tip of the coronary sinus catheter. **C:** Right anterior oblique projection, again with the retained electrode visualized in the anterior left atrium, confirming its position in or near the mitral apparatus.

Our case also highlights the importance of examination of all malfunctioning equipment once removed from the body to ensure all components have been successfully retrieved. As is evident from Figure 2, the retained electrode would have been easily missed on simple fluoroscopic examination, especially given efforts to reduce fluoroscopic exposure during AF ablation. As noted above, the missing electrode was only discovered after direct examination of the damaged spline. This prompted scanning with fluoroscopy and subsequent discovery of the electrode in the mitral apparatus. Given the limitations of biplane fluoroscopy in direct localization of a structure in 3-dimensional space, we used the Vizigo sheath (which can be visualized on the mapping system) and the CartoSound module to identify both the sheath and electrode position in real time. This allowed us to ensure
