IMAGING VIGNETTE

CLINICAL VIGNETTE

Inappropriate Extravascular ICD Shock Due to Wet Car Seat

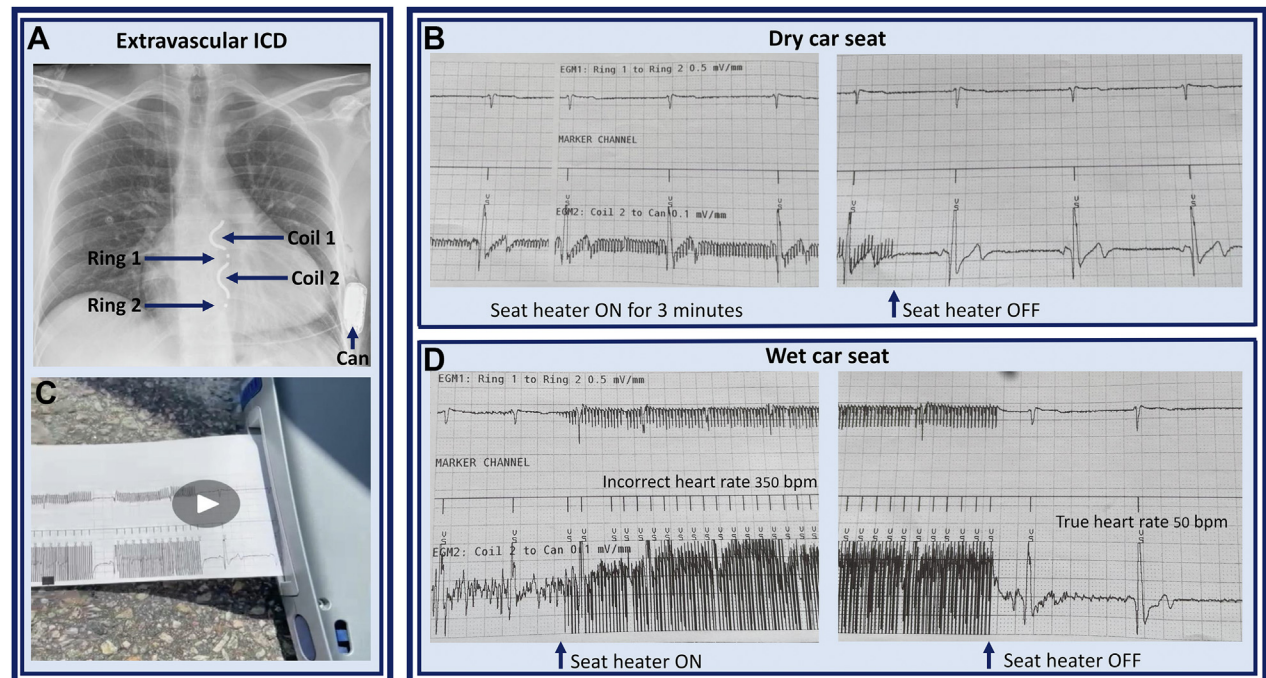
FIGURE 1 EV-ICD and Electromagnetic Interference

A field trip was organized to reconstruct the episode to confirm the source of external electromagnetic interference (EMI). Tachycardia therapy was turned off to avoid new episodes of inappropriate shocks. Sitting in his car wearing dry clothes and with the engine running, a normal electrogram was displayed. Low amplitude noise was observed when the seat heater was turned on but without oversensing (Figure 1B). Tap water was used to moisten the car seats. After re-engaging the seat heater, a gradual increase of oversensing and incorrect heart rate detection equivalent to ventricular fibrillation was observed (Figure 1D).

Dry skin is the major barrier against EMI with an impedance up to 100,000 ohms. However, an extensive decline in impedance to approximately 1,000 ohms is observed on wet skin resulting in values comparable to an ICD lead. Water is a very good conductor of electricity and, in this case, we believe that a complete electrical circuit was established when water soaked all the way into the electric components in the fabric material car seat. Electric malfunction might be a confounder and this car has not been investigated by a certified mechanic. We did, however, see the exact same result in both car seats.

this case report received 6 inappropriate ICD shocks due to EMI. His EV-ICD did correctly interpret the “tachycardia” as EMI. However, the device was programmed to ignore all discrimination algorithms after 3 minutes. The rationale for this safety function is that the ICD might be incorrect in its analyses as 3 minutes of continuous EMI is very uncommon. This function is active by default but may be turned off based on a clinical decision.

(A) Chest x-ray displaying the lead and generator of an extravascular implantable cardioverter-defibrillator (EV-ICD). (B) Intracardiac electrogram (EGM) from the patient's ICD when sitting in a dry car seat. Electromagnetic interference (EMI) is observed on EGM 2 with the car seat heater on but not on EGM 1 which represent the true sensing circuit between the ring electrodes on the ICD lead. (C) Video 1 displaying the abrupt termination of oversensing when the seat heater is turned off. The voice on the video says, in Norwegian, “please turn off the seat heater.” (D) EGM from the patient's ICD when sitting in a wet car seat. EMI is seen on EGM2 with the car seat heater on but now also on EGM1 resulting in oversensing and wrong heart rate detection.
