Taper corrosion: a complication of total hip arthroplasty

Cite this article: *EFORT Open Rev* 2020;5:776-784.

DOI: 10.1302/2058-5241.5.200013

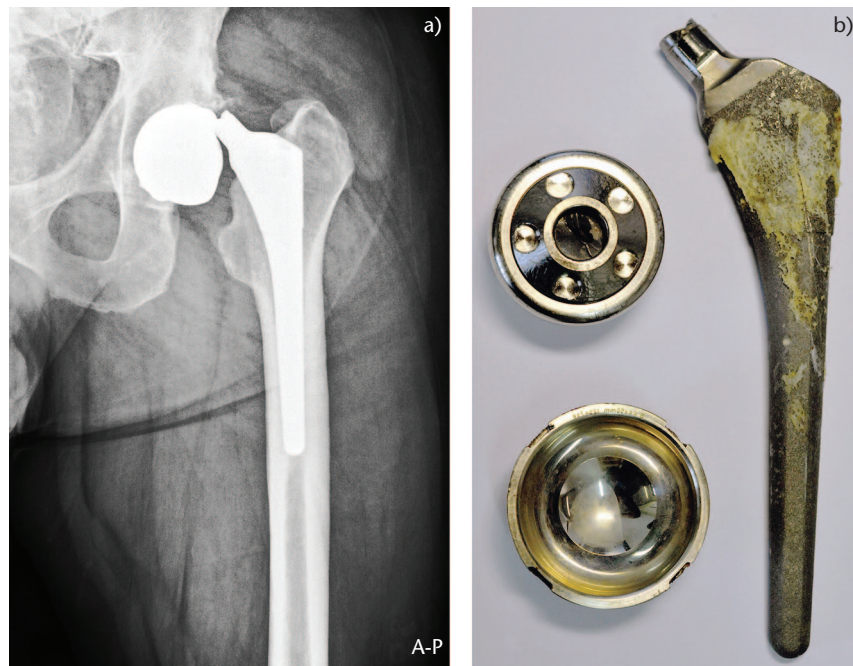
Stem taper fracture as the worst clinical endpoint of taper corrosion has been observed in only one particular MoM design using a Ti-alloy adapter sleeve connector with a Ti-alloy stem (Fig. 3). In this design a high frequency of cold welding between stem and adapter was also observed.²⁰

Fig. 3 (a) X-ray of a stem taper fracture in a Ti-alloy primary stem with a large MoM bearing after four years in situ. This design utilizes a Ti-alloy adapter sleeve to assemble the CoCr-bearing surface to the stem. (b) The explanted components with the broken stem taper inside the adapter sleeve inside the head (courtesy H. Ettema, Isala).

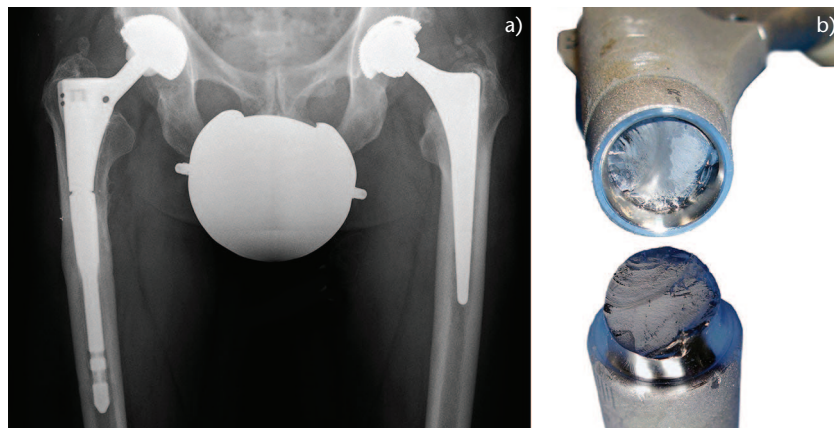
Long and large heads, varus stems and higher offset stems apply higher load to the taper interface and as such exhibit more fretting and corrosion.^{40–47} Fracture of hip revision stems are a ‘good’ example to illustrate this (Fig. 5): Due to the long lever arm of the joint load to the

stem–neck piece taper connection, the risk of micro-movement with consecutive corrosion is clearly elevated, especially under unfavourable loading conditions, ultimately resulting in an elevated rate of taper fracture at the neck piece stem taper.⁴⁸ Similar arguments can explain the higher corrosion problems for dual taper hips.^{49,50}

Fig. 5 (a) X-ray after fracture of a Ti-Ti Revision stem after seven years in situ (courtesy M. Rudert, Würzburg). (b) Fracture surfaces of the broken taper showing the typical split lines of a fatigue fracture.

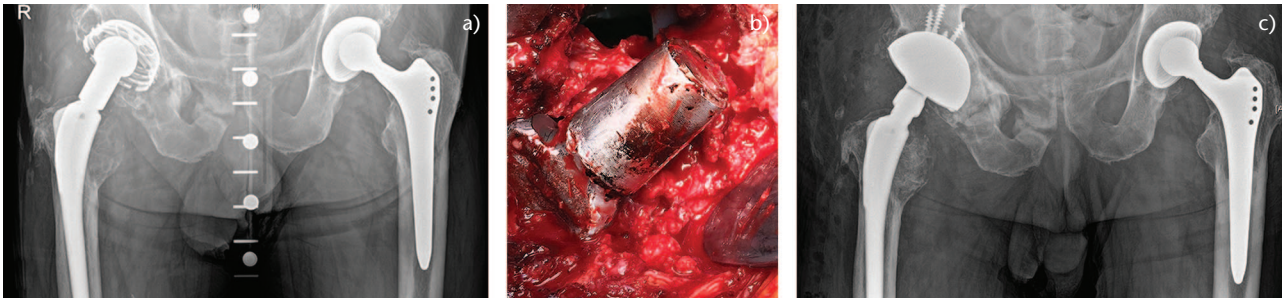
Fig. 6 (a) X-ray of a male patient (76 years) prior the 4th isolated right cup revision in 2019 after original stem implantation with a 32 mm metal XXXL head in 1984. (b) The stem taper showed only light corrosion and minor damage from the multiple revision surgeries. (c) X-ray after the revision with a 36 mm ceramic option XXXL head on the original stem.

even in adverse loading conditions if assembled properly (Fig. 6), but the diameter of the heads should not exceed 32 mm.
