Andrology and Fertility

Malfunctioned and Fractured Penile Prosthesis Caused by Cross Placement: Case Report

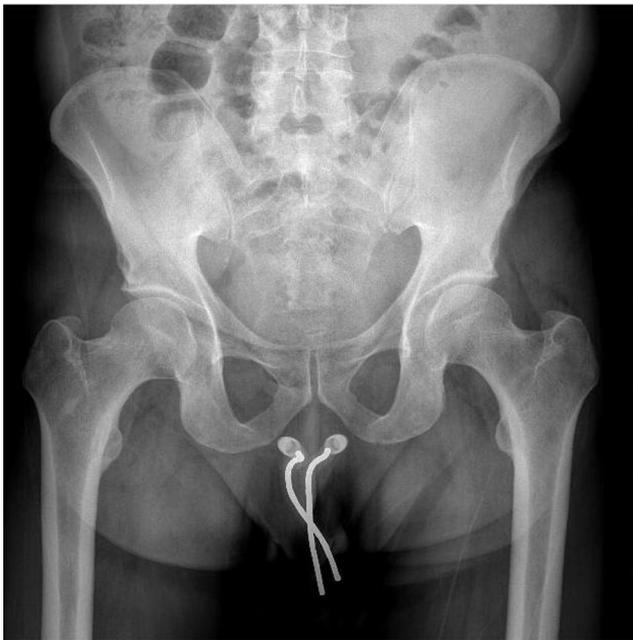
that the prostheses progress crossly and 1 cm distally from the root of the penis. The patient's laboratory values were normal. Pelvic radiography demonstrated that the penile prosthesis has been placed crossly (Fig. 1). The patient was prepared for surgery. A broad spectrum antibiotic treatment was initiated. The patient was operated. It was seen during the operation that the prosthesis placed on right corpus cavernosum has torn the right corpus cavernosum and passed through the left corpus cavernosum (Fig. 2). Furthermore, it was also observed that one of the prostheses was fractured (Fig. 3). The prostheses were removed. Any postoperative complication has not occurred in the patient. He was discharged. The patient was called 3 months later. The patient was prepared for surgery and again implanted malleable penile prosthesis. A penile prosthesis of 17 cm was placed on the left corpus cavernosum and 16 cm on the right corpus cavernosum. The patient who has not displayed any postoperative complication was discharged on the third day.

Figure 1. Preoperative X-ray graphy.

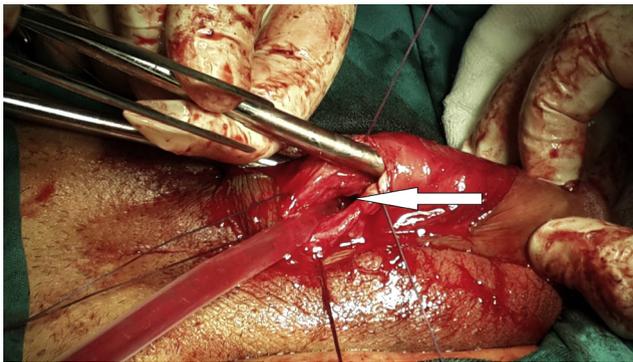
Figure 2. Intraoperative iatrogenic cavernosum rupture.

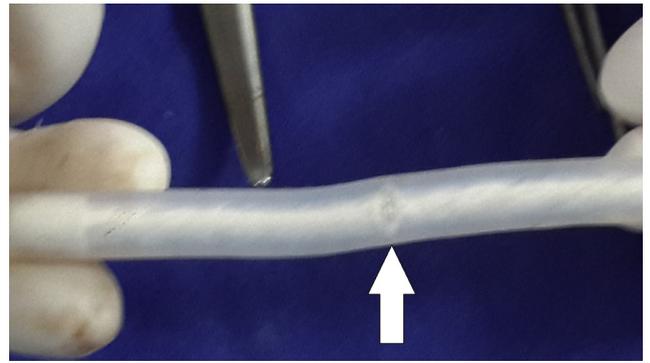
Figure 3. Broken prosthesis.
