CASE REPORT

Inappropriate ICD Discharge Related to Electrical Muscle Stimulation in Chiropractic Therapy: A Case Report

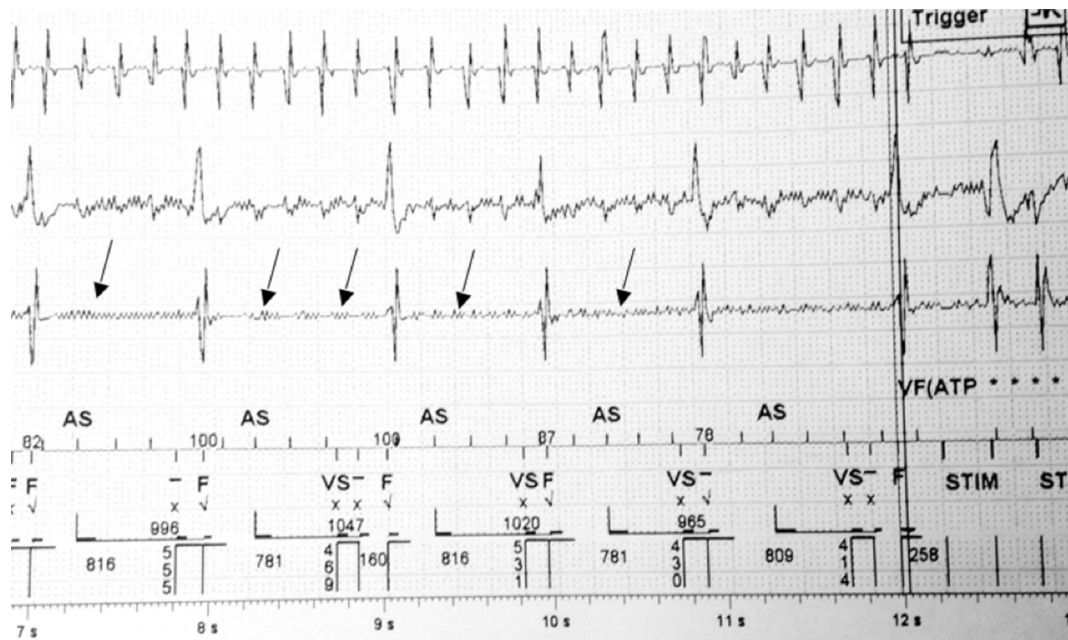
contraction, which may last up to 30 min. To differentiate between skeletal muscle over-sensing (pectoral myopotentials) versus inappropriate discharge relating to electromagnetic interference (EMI), a thorough analysis of the lead strips was performed. We believe external electromagnetic interference is the cause in our case as there is a patient history consistent with an encounter with an EMI source (TENS). In addition, there is noise seen in all sensing channels (Fig. 1), a finding consistent with EMI. In Fig. 3, once the EMI had resolved and there was discontinuation of TENS, noise is absent. On the other hand, skeletal muscle over-sensing (pectoral myopotentials) usually only occurs when there is provocative skeletal isometric exercise involving the upper extremities/abdominal muscles, a scenario not surrounding our patient.

Fig. 1 Interrogation strip demonstrating electrical interference from the low-intensity electronic muscle stimulation. The device senses the interference and attempts anti-tachycardia pacing

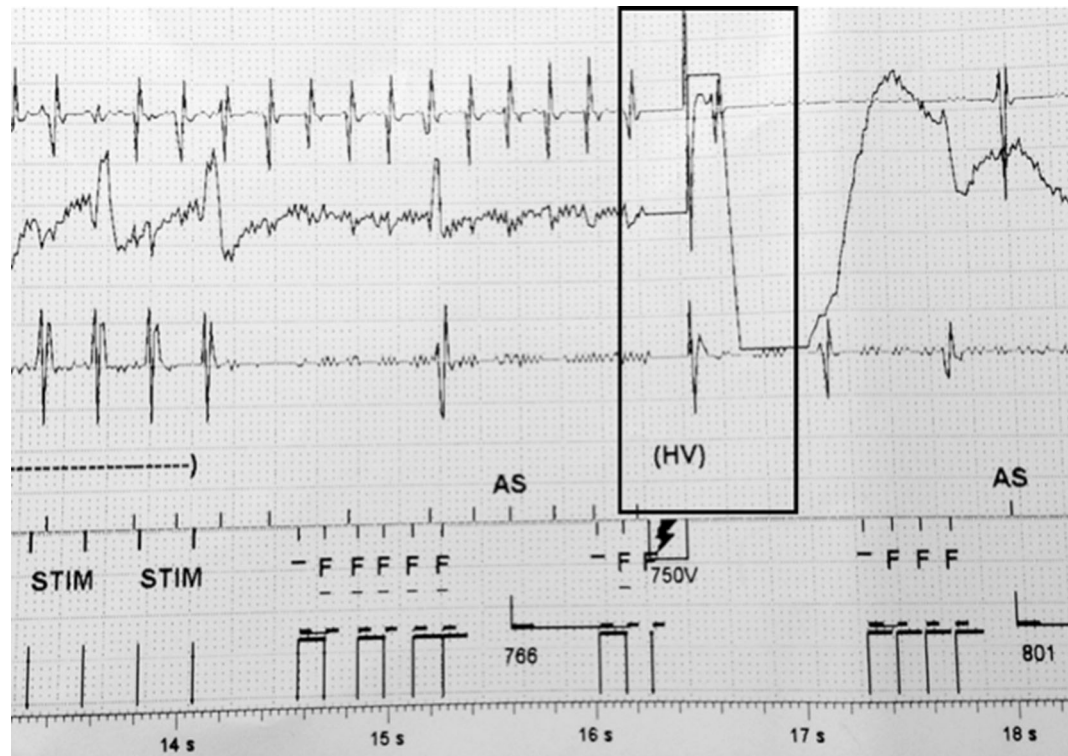
Fig. 2 Interrogation strip demonstrating device delivering anti-tachycardia pacing and shock therapy

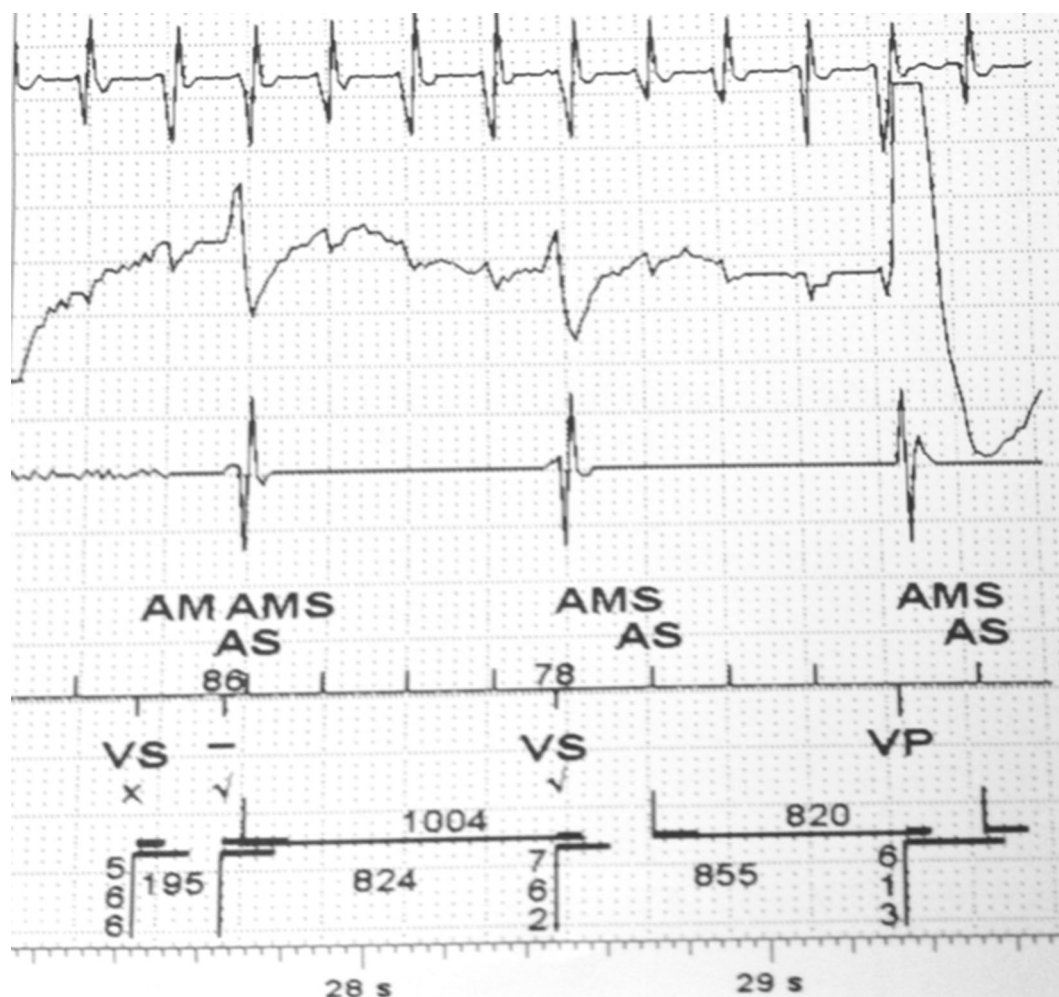
Fig. 3 External interference aborted upon stopping the chiropractic treatment
