Breast tissue expanders and implantable cardioverter-defibrillator: An unusual interaction

Malik Muhammad Khurram Sher Khan, MD,^{*} Malik Muhammad Humayun Sher Khan, MD,^{*} Aaron Tolan, MD,^{*} Darryl Elmouchi, MD, FHRS,^{†‡} Carlos E. Tavera, MD, FACP^{*‡}

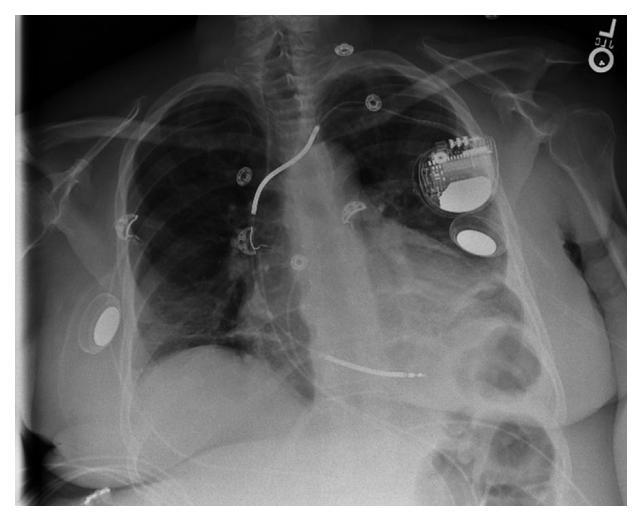
Figure 1 Chest x-ray film, anteroposterior view, showing the relative position of the implantable cardioverter-defibrillator and breast tissue expander.

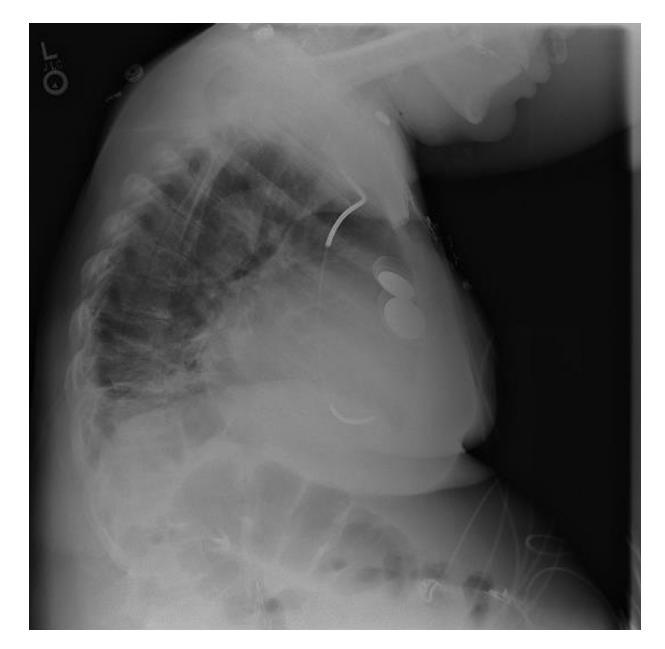
Figure 2 Chest x-ray film, lateral view, showing the relative position of the implantable cardioverter-defibrillator and breast tissue expander.
