# Appropriate Delivery of Antitachyarrhythmia Therapy Despite Magnet Placement Over Implanted Cardioverter-Defibrillator: A Case Report

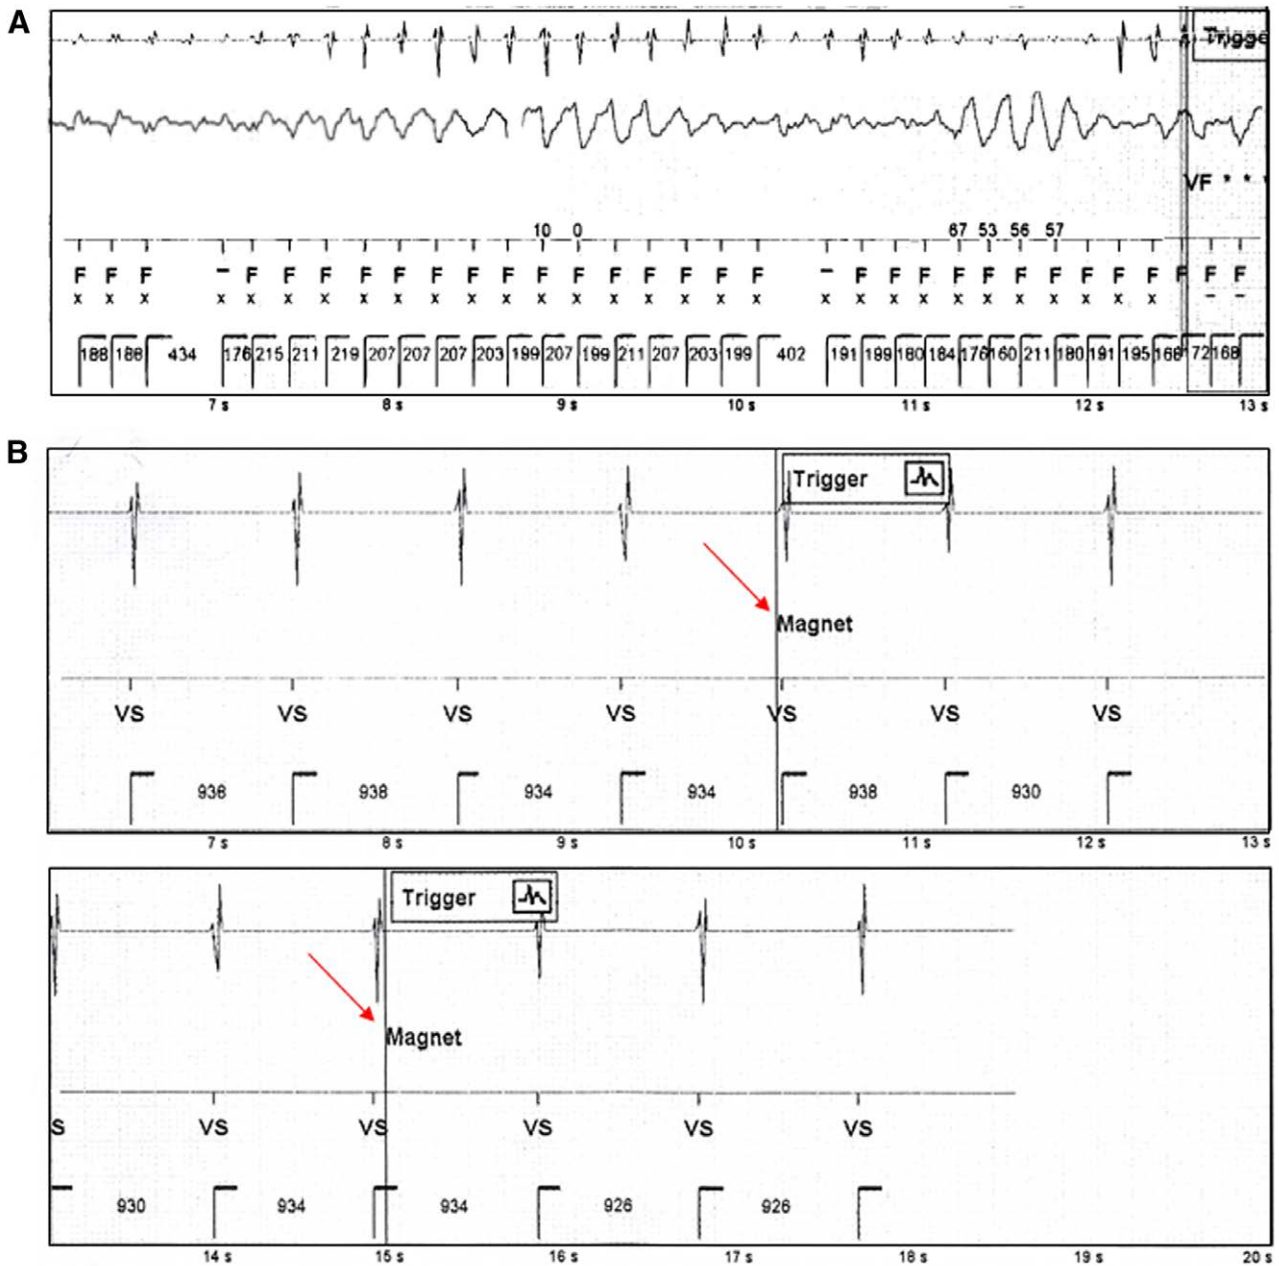
**Figure 1.** Device interrogation. A, Detection of VF and tachycardia therapy. B, Initial magnet detection disabling tachycardia therapies was followed by intermittent periods of device activation. Although the magnet was never removed, magnet response was detected 6 discrete times. The red arrows in the figure indicate 2 distinct episodes of magnet detection separated by approximately 5 s. Since the magnet remained secured in place, repeated magnet detection is most likely related to failure to maintain an adequate magnetic field due to inaccurate placement. VF indicates ventricular fibrillation; VS, ventricle sensed.

The patient was extubated and transported to the postanesthesia care unit. The ICD was interrogated, confirming ventricular arrhythmia and appropriate therapy (Figure 1A). Notably, magnet detection by the device was intermittent (Figure 1B) despite the magnet being secured in position without disruption. A detailed discussion with the cardiac electrophysiology team and Abbott technical services revealed that the cause of this phenomenon was inaccurate placement of the magnet centrally over the device.

In conclusion, we report a rare case of "appropriate" ICD detection and therapy for VF despite magnet placement. This case highlights the importance of accurate magnet placement using the recommended positioning from each device manufacturer. It is important for the anesthesiologist to ensure proper CIED function and obtain CIED-related recommendations before surgery. ■■

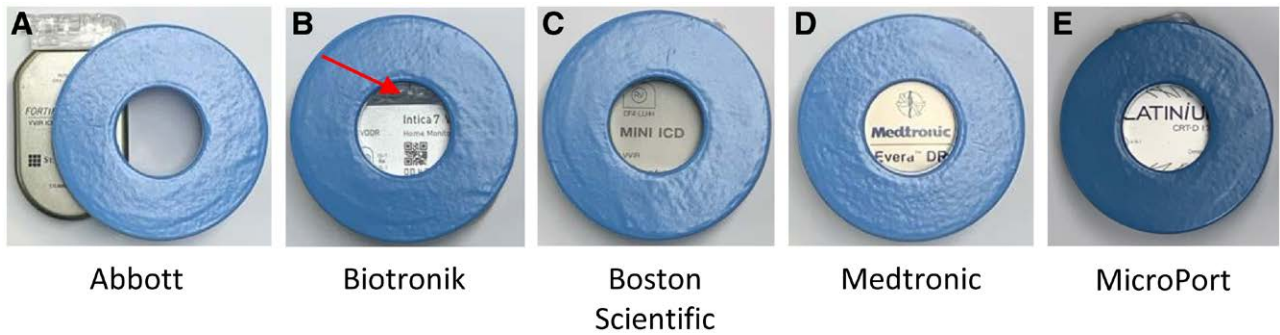
**Figure 2.** Magnet positioning. A, Abbott (formerly St Jude Medical) Fortify Assura DR. The arc of the magnet is positioned over the right or left side of the device. B, Biotronik Intica VR-T DX Magnet is positioned off center with the arc slightly above the housing. The arrow denotes the space between the arc of the magnet and the top of the generator. C, Boston Scientific Mini ICD, (D) Medtronic Evera XT DR, and (E) MicroPort (formerly Sorin) Platinum Magnet centered over the device. ICD, implantable cardioverter-defibrillator.
