## Case Report

# Splinting of Longitudinal Fracture: An Innovative Approach

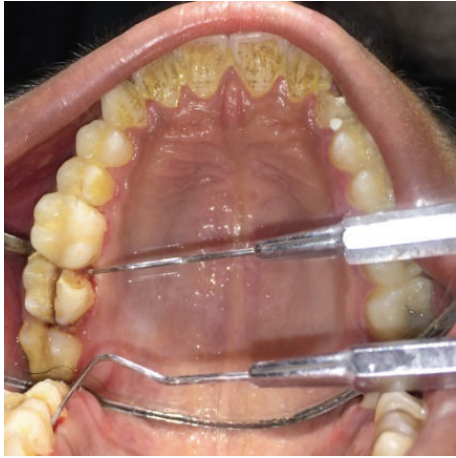
On visual inspection of 27, the fracture line was running mesiodistally involving both the marginal ridges (Figures 2 and 7). The fracture segments cannot be displaced, but they can be visualized by wedging with a probe (Figure 2). There was no dentine between the fractured segments on the pulpal floor. The fracture line had extended subgingivally through the pulp chamber into the furcation area. Exploration of periodontium along the fracture line indicates no sign of periodontal attachment loss, although tooth was tender on percussion and nonvital on pulp testing. An intraoral periapical radiograph revealed that lamina dura of mesiobuccal

FIGURE 2: Preoperative photograph showing split tooth of 27.

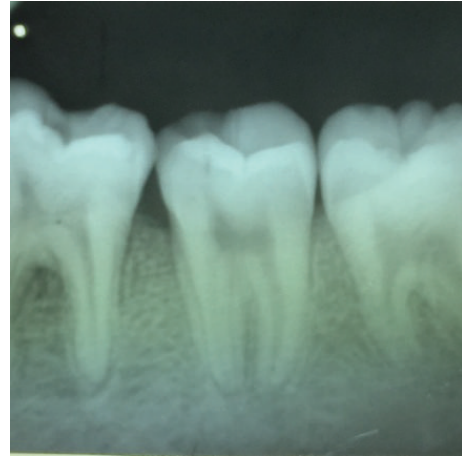
FIGURE 5: Preoperative radiograph of 37.

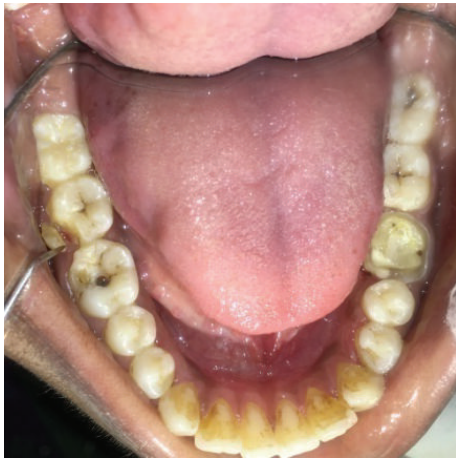
FIGURE 3: Preoperative photograph showing fractured cusps in 37 and 46.

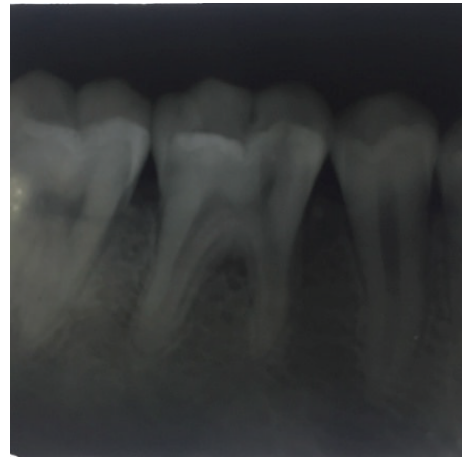
FIGURE 6: Preoperative radiograph of 46.

On examination of the lower right quadrant, there was a fracture of mesiolingual cusp with respect to 46. The fractured segments were not displaced but could be separated by exploration with the probe. Further, the fracture line was extending up to the coronal third of the root surface, without involving the pulpal floor (Figure 9). Periodontium was not compromised along the fracture line and percussion test was negative. Vitality test was positive. Intraoral periapical radiograph revealed fracture line (Figure 6). It was diagnosed as fractured mesiolingual cusp with respect to 46.

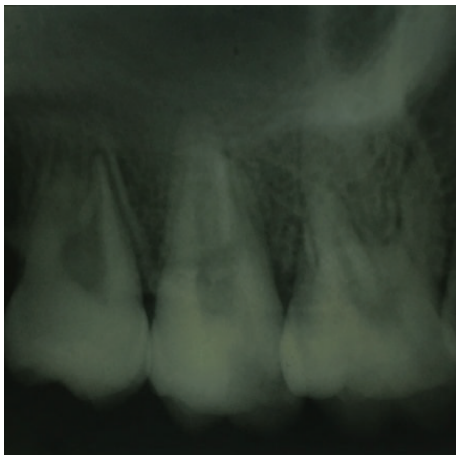
FIGURE 4: Preoperative radiograph of 27.

and distobuccal root was involved. Fracture line was not appreciable on the radiograph (Figure 4). It was diagnosed as a split tooth of 27 involving the pulp floor.

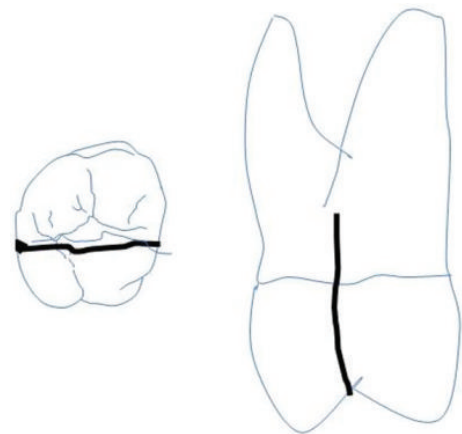
FIGURE 7: Extent of fracture line in 27.

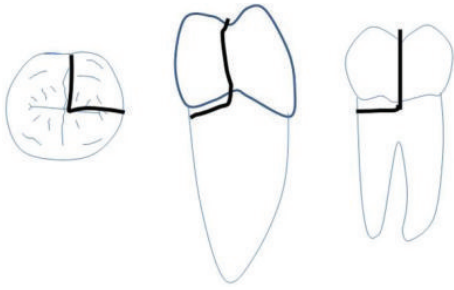
FIGURE 8: Extent of fracture line in 37.

On examination of the lower left quadrant, there was a fracture of a mesiobuccal cusp with respect to 37. The fracture line had both mesiodistal and buccolingual components. It was running cervically from buccal groove towards the centre of occlusal surface and then extending mesially involving the mesial marginal ridge (Figure 8). Both fractured segments were in position but can be visualized by exploring with a probe (Figure 3). Further, the subgingival extent of fracture line was 1 mm below the cemento-enamel junction (CEJ), and it was not involving the pulp chamber. Periodontium was intact along the fracture line. An intraoral periapical radiograph revealed intact lamina dura (Figure 5). The tooth was not mobile and not tender on percussion. Vitality test was positive. It was diagnosed as fractured mesiobuccal cusp with respect to 37, not involving the pulp.

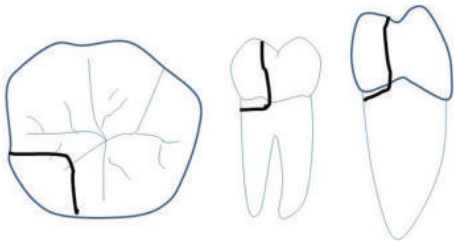
FIGURE 9: Extent of fracture line in 46.

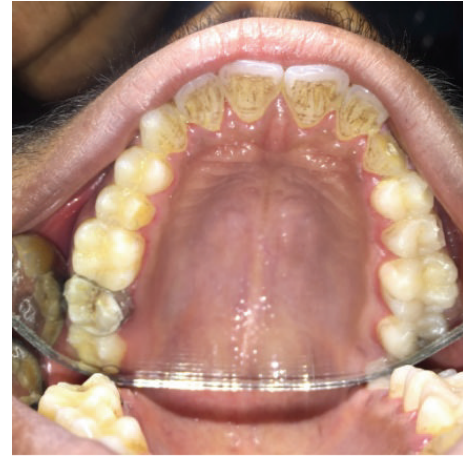
FIGURE 10: Photograph showing stabilization of split tooth with respect to 27 using orthodontic band.

Immediately after the diagnosis, the tooth was stabilized using orthodontic band (RMO 0.180 × 0.005 mm) (Figure 10). In the same appointment, endodontic treatment was initiated. Fracture line was cleaned of any debris with

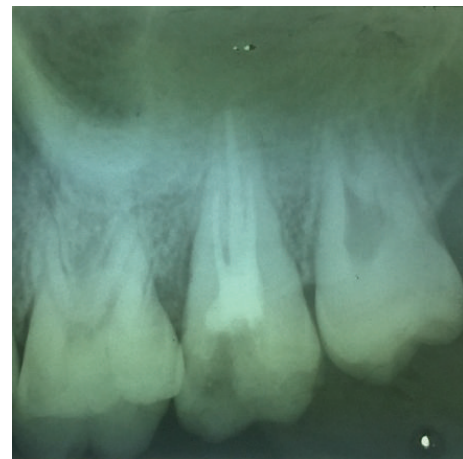
FIGURE 11: Post-obturation radiograph with respect to 27.

30% H<sub>2</sub>O<sub>2</sub> (Shree Sai Chemicals, Ghaziabad, Uttar Pradesh, India). The biomechanical preparation was done using Rotary V-Taper (30/0.04%) (SS White) (Figure 11). Single cone gutta-percha obturation using MTA Fillapex, as the root canal sealer, was completed. Mineral Trioxide Aggregate (ProRoot MTA, Dentsply, DeTrey, Germany) was placed on the pulpal floor at the fracture site where dentine was missing. A wet cotton pellet was placed in the pulp chamber followed by temporary restoration. The patient was recalled after 3 days. In the next appointment, temporary restoration was removed and access cavity was thoroughly debrided with saline and dried. From each canal, 3 mm of gutta-percha was removed with Peeso Reamer size-3 (Dentsply Maillefer, Ballaigues, Switzerland), and preparation was checked radiographically (Figure 12). Three pieces of 1 cm Ribbond (Ribbond Inc., USA) fibre were taken. The root canal orifices were etched and rinsed and bonding agent was applied. Into each of the three canals, 3 mm of Ribbond fibres was inserted and was stabilized in the root canal with the help of flowable composite (G-aenial Universal Flo, GC Corporation, Tokyo,

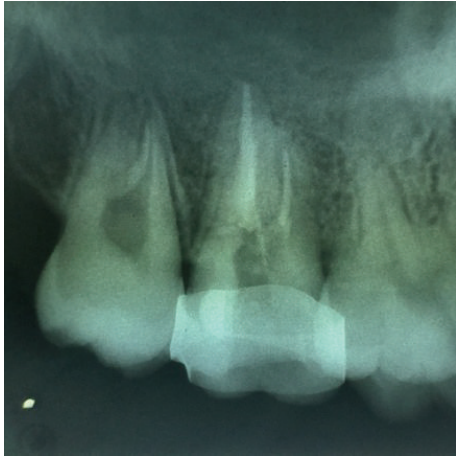
FIGURE 12: Radiograph showing 3 mm of intracanal space preparation with respect to 27.

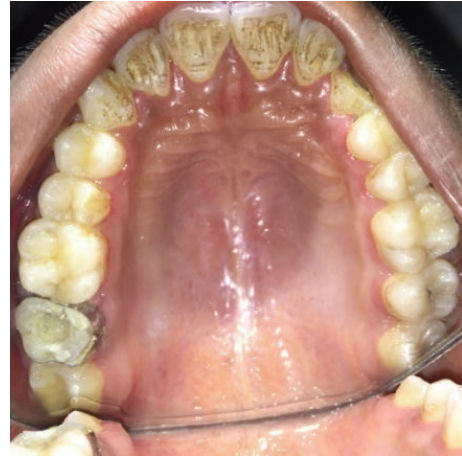
FIGURE 14: Photograph showing meshwork of fibre in the pulp chamber.

Japan) and cured (Figure 13). After curing, around 7 mm of remaining fibres was kept outside the canal orifice. Then, these fibres were spread on the floor of the pulp chamber and intermingled to create a meshwork for the internal reinforcement (Figure 14). A flowable composite was placed over this fibrous meshwork and manipulated slightly with the help of plastic instrument (API) along the buccolingual and mesiodistal directions so as to form a unique composite Ribbond meshwork along the floor of the pulp chamber which was later cured. Subsequently, core buildup composite (Tetric Ceram Ivoclar Vivadent, Germany) was done. After 15 days, the orthodontic band was removed and crown preparation was done. Temporary crown was cemented which was later replaced by metal ceramic crown (Figures 15 and 16).

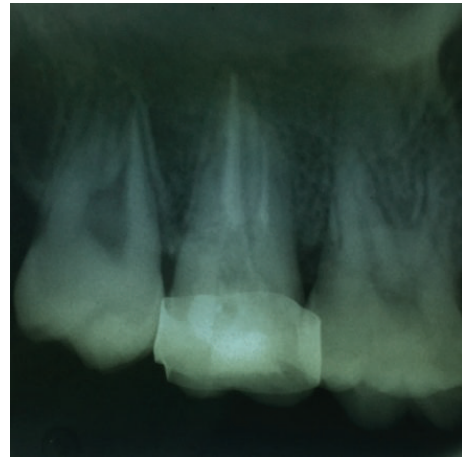
FIGURE 15: Radiograph showing internal reinforcement with Ribbond in 27.

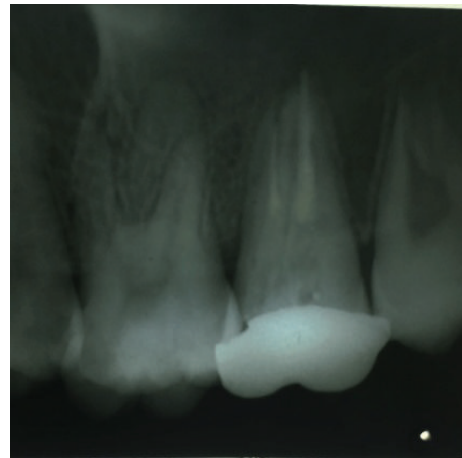
FIGURE 16: Radiograph showing external reinforcement with metal crown in tooth 27.

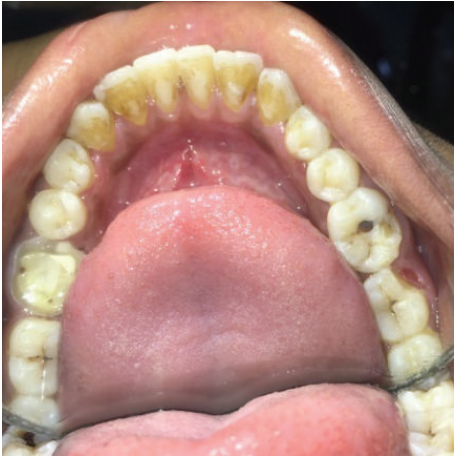
FIGURE 17: Mesiobuccal cusp in tooth 37 removed.

Fractured mesiobuccal cusp in 37 was removed carefully (Figure 17) and tooth preparation was done for class II cast metal inlay with cusp capping. Tooth preparation was extended more apically, and an indirect pattern was fabricated (Figures 18 and 19). Cast gold inlay was fabricated, luted

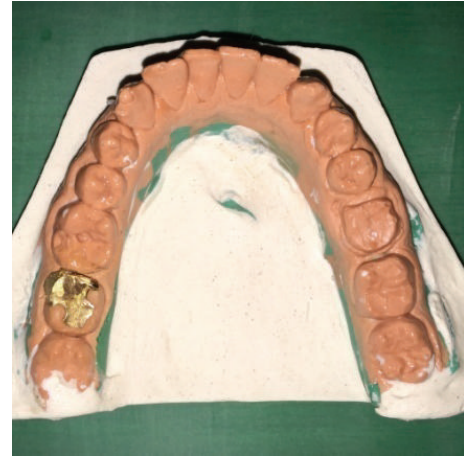
FIGURE 19: Inlay casting try-in on the cast with respect to 37.

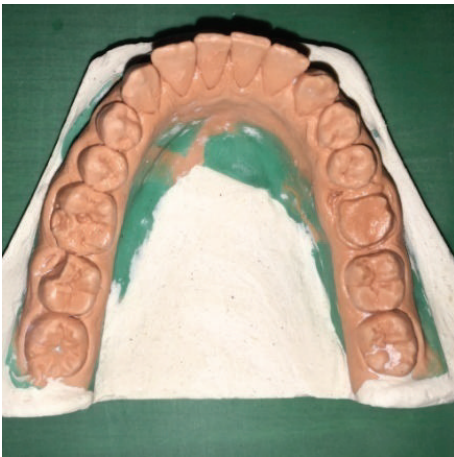
FIGURE 18: Preoperative cast of tooth 37.

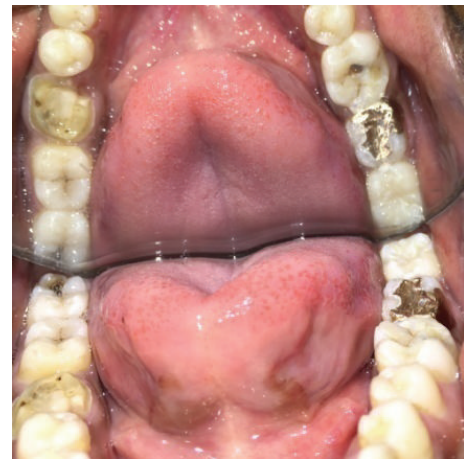
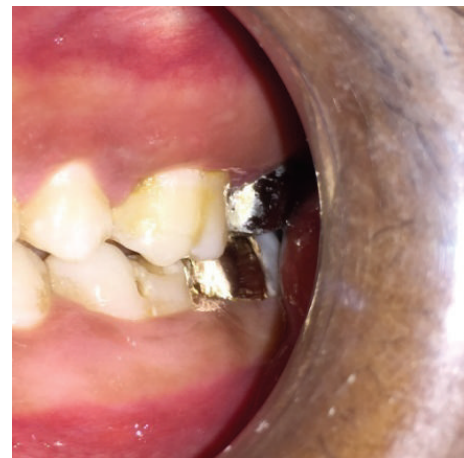
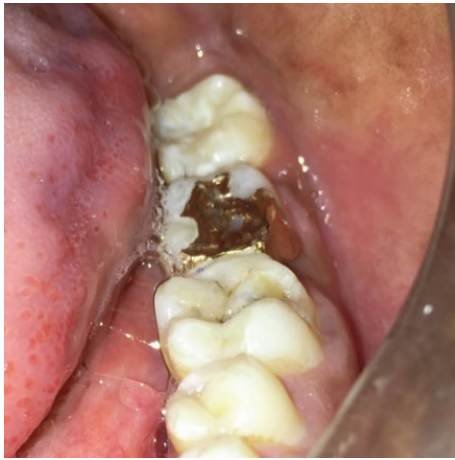
FIGURE 20: Photograph showing inlay luted with respect to 37 (occlusal view).

FIGURE 21: Photograph showing inlay luted with respect to 37 (buccal view).

FIGURE 22: Photograph showing inlay luted with respect to 37 (occlusal view).

using glass ionomer cement type I (GC Corporation, Tokyo, Japan) (Figures 20, 21, and 22), and checked radiographically (Figure 23).

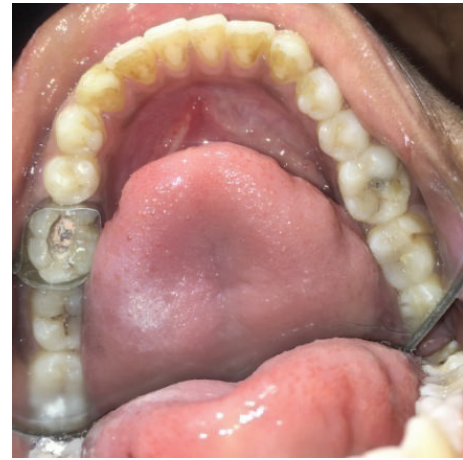
FIGURE 24: Photograph showing stabilization of fractured cusp with respect to 46.

As the fracture line was not involving the pulp chamber in 46 but was extending subgingivally, and tooth was vital initially, the fractured cusp was not removed; instead it was bonded with the help of composite resin and stabilized with orthodontic band (Figure 24). On subsequent appointment, the tooth had become nonvital and a sinus tract had also appeared in its relation. Hence, endodontic treatment was completed (Figure 25). Internal and external reinforcement were achieved in the same manner as mentioned for tooth 27.

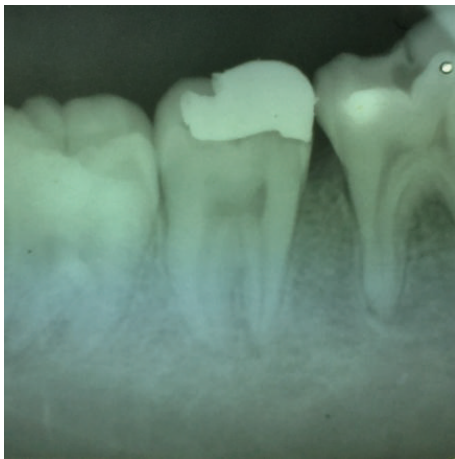
FIGURE 23: Radiograph showing luted inlay with respect to 37.

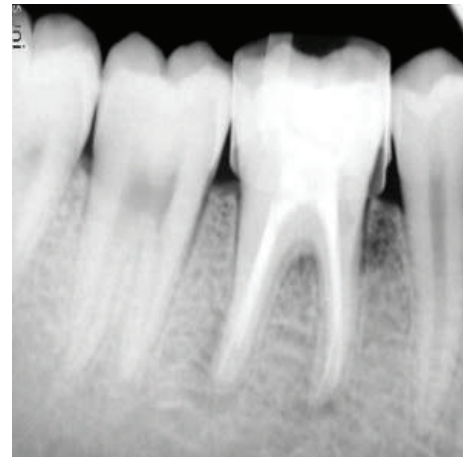
FIGURE 25: Postobturation radiograph of 46.

Tooth 46 was vital and fracture line was not involving the pulp. Hence, initially, fracture segment was reattached with composite and stabilized with orthodontic bands. The tooth was examined periodically. After two weeks, tooth became nonresponsive to vitality test and an intraoral sinus also developed in its relation. So root canal treatment was initiated and completed. The tooth was restored and permanently stabilized by internal and external reinforcement as done for tooth #27.
