Twiddler's syndrome after implantation of baroreflex activation therapy: a case report

Daniel Dalos

Received 5 November 2020; first decision 30 November 2020; accepted 16 March 2021

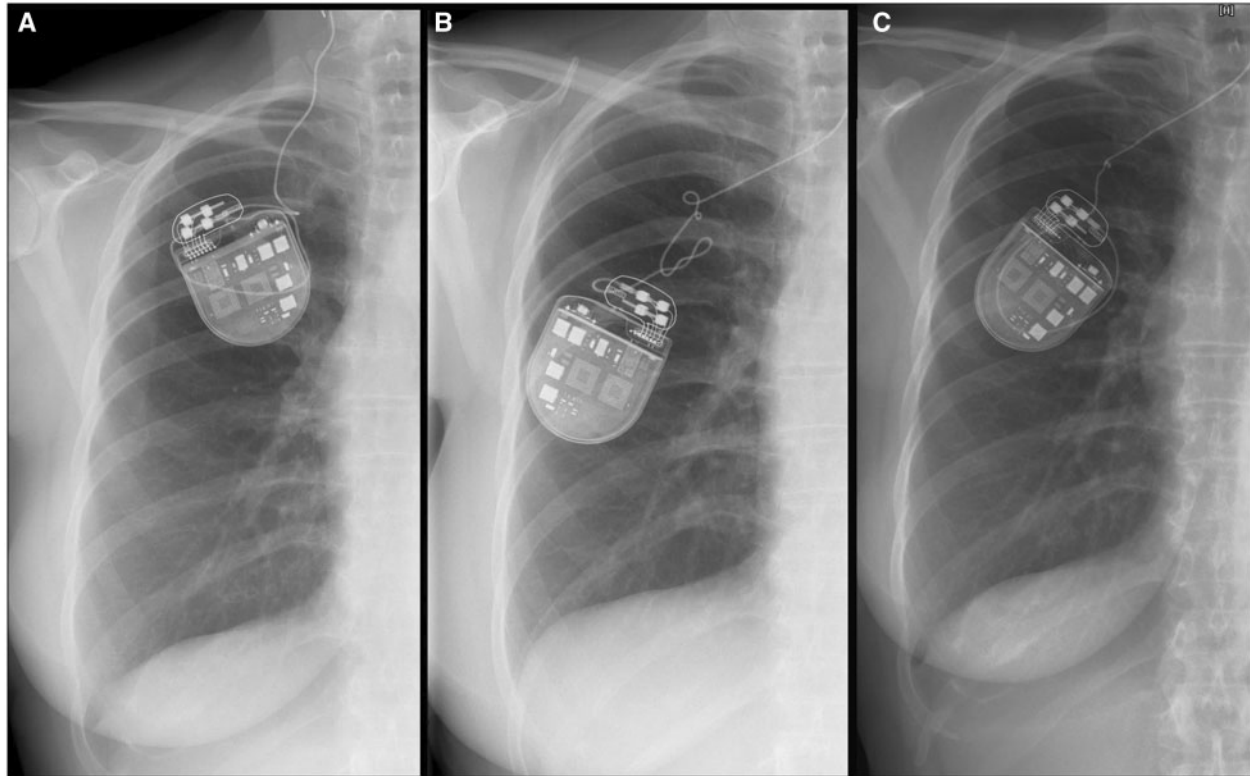
In November 2019, the patient presented with progressive pain at the site of the electrode, which was reproducible on palpation and when the patient turned her head in both directions, which finally resulted in a surgical revision procedure. The existing lead was removed from the right side and a new one was

At the time of the next scheduled outpatient visit 1 week after the procedure, stimulation impedance was below an acceptable threshold indicating lead fracture and, therefore, another surgical revision was unavoidable and was performed in January 2020 (Figure 1C). The existing lead was removed, and the novel one was successfully fixed at the same point at the left carotid bifurcation.

Figure 1 Successful baroreflex activation therapy implantation with a right-sided electrode (A). Twiddler's syndrome and multiple loops of the left-sided electrode (B). Generator and lead position after surgical revision (C). BAT, baroreflex activation therapy.

placed contralaterally at the bifurcation of the left carotid artery. In addition, the generator was removed from the deep origin below the right major pectoral muscle and the same device was re-implanted subcutaneously because of slightly gained body weight (BMI 20.9 kg/m²). A few weeks later, the patient returned again because of painful sensations at the area of the generator and, although any manipulation has been denied, an immediately performed X-ray revealed a twist of the device of 180° around its transverse axis with multiple loops of the lead (Figure 1B). Therefore, pocket-revision was performed in December 2019, and the existing lead was untwisted, but not replaced due to good technical values, and, finally, re-conducted with the generator without any complications.

Twiddler's syndrome may also occur after implantation of BAT devices. Surgical pocket-revision, with an optimized implantation technique, should always be combined with lead replacement in order to avoid additional procedures due to lead fracture.
