## Pararectal Migration of a Malleable Rod: An Unusual Late Complication

Department of Urology, Izmir Bozyaka Training and Research Hospital, Karabaglar, Izmir, Turkey

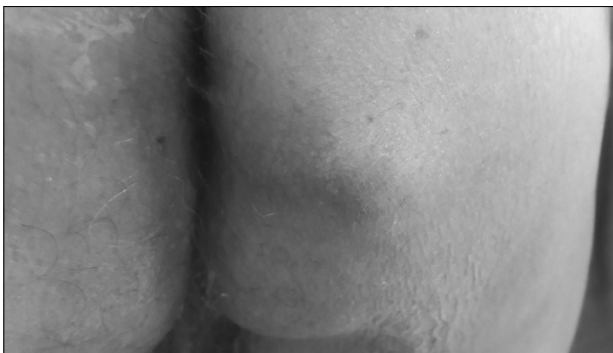
teal skin. He also had other symptoms including pain, pain during defecation, painful sexual intercourse and feeling the tip of the right penile prosthesis at the proximal side of the penis. The patient had a 30-year history of smoking two packs of cigarettes daily. He had no history of diabetes mellitus. He underwent a thorough evaluation and was diagnosed with ED of mixed etiology. He received counseling and conservative treatment with an external vacuum device and intracavernosal injection. Because the patient and his partner had difficulty accepting the conservative treatment, he underwent an operation for MPP placement at the age of 55 years. At week 6 postoperatively after the penile prosthesis operation, the patient had sexual intercourse. There was no pain and he was well satisfied. Ten years after the MPP implantation, the left-sided prosthesis appeared at the urethral meatus due to urethral erosion and was extracted. After the operation the patient continued to have sexual intercourse. Ten years after the extraction of the left-sided prosthesis, the right-sided prosthesis moved backward and the patient could feel the bottom of the prosthesis under the buttock skin close to the perianal area. On physical examination, the right-sided MPP eroded the right corpus cavernosum and moved posteriorly. Upon physical examination there was no penile prosthesis at the left corpus cavernosum as expected. However the tip of the right-sided prosthesis was felt at the proximal side of the penis. The bottom of the prosthesis was felt by touching the buttock skin close to the perianal area (Fig. 1). A rectal examination revealed the right-sided prosthesis at the right side close to the rectum wall. There was no infection. The right-sided 20-cm MPP was re-

**Fig. 1.** A photograph showing the malleable penile prosthesis, which migrated posteriorly, passed close to the rectum wall and reached the skin of the right buttock.

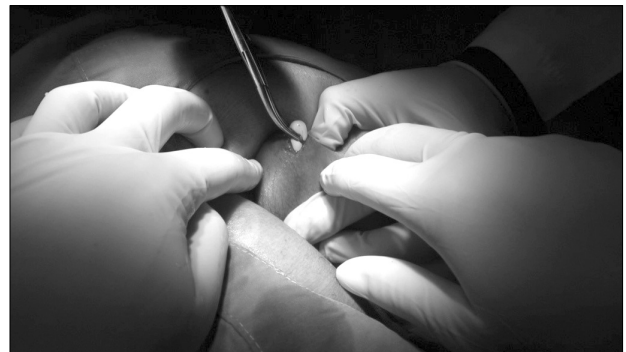
**Fig. 2.** The extraction of the malleable penile prosthesis with a simple surgical procedure.

moved under local anesthesia through an incision in the right buttock (Fig. 2). Upon removal, the penile prosthesis was not found to have any curve deformity (Fig. 3). The skin was closed after hemostasis. There were no post-operative complications. The patient was hospitalized for one day. We prescribed oral fluoroquinolone and anti-inflammatory drugs on discharge.

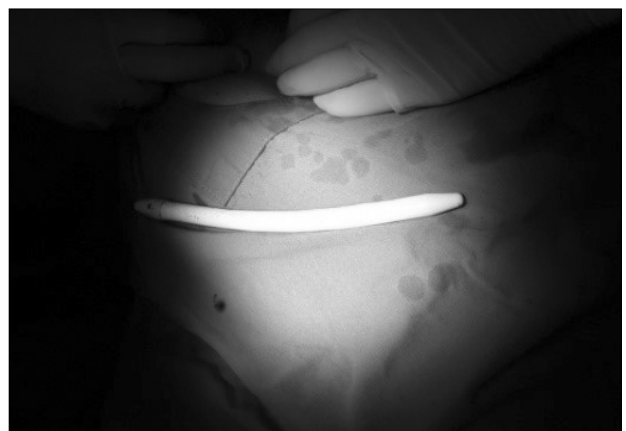
**Fig. 3.** A photograph of the 20-cm straight malleable penile prosthesis which was extracted from the patient's buttock.
