# Skin burn after magnetic resonance imaging in a patient with an implantable cardioverter-defibrillator

Suzette Turner, RN, MS, ANP(c), Sheldon M. Singh, MD

*From the Sunnybrook Health Sciences Centre, Toronto, Canada.*

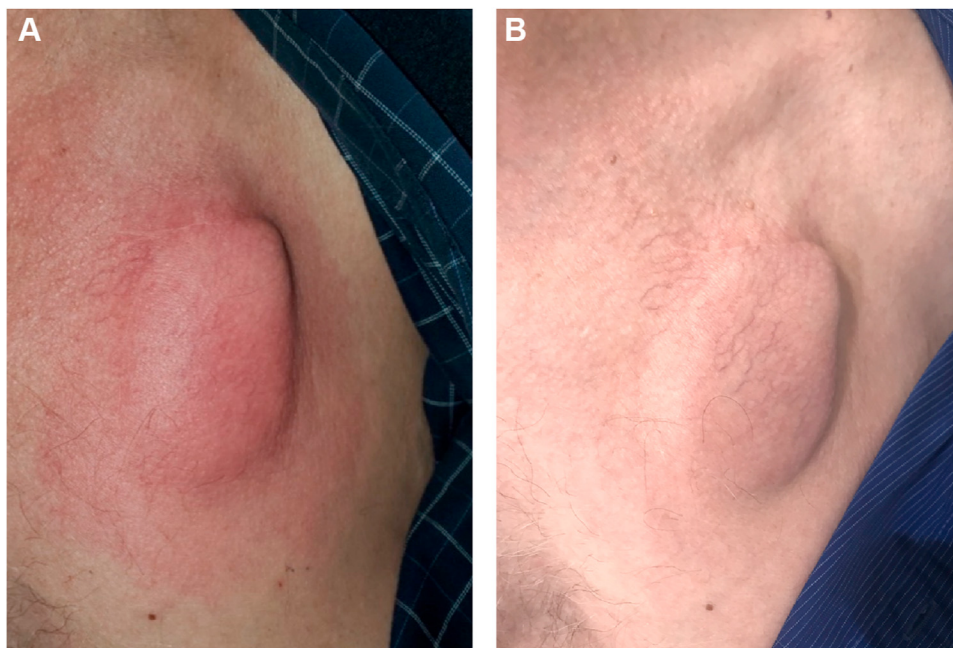
An 82-year-old male patient with an MRI-conditional Boston Scientific dual-chamber implantable cardioverter-defibrillator (ICD) (generator model number D433 Resonate EL; atrial lead model number 0673 Reliance; ventricular lead model number 7842 Ingevity) presented with gait instability. He underwent a 1.5 Tesla brain MRI to rule out a subdural hematoma. Interrogations pre and post MRI were unchanged. Two days later erythema and warmth on the skin directly above the ICD generator was noted (Figure 1A). Fluctuance at the site and fever were absent.

repeated 7 days later. The skin findings resolved 14 days later without intervention (Figure 1B).

The observed skin findings are consistent with a skin burn temporally associated with the recent MRI. It is noteworthy that this occurred in the absence of perturbations to pacing and sensing. We speculate the limited subcutaneous tissue adjacent to this patient's device, its protuberance, and the size of his ICD may have caused the skin burn.

The mechanism of thermal injury with an MRI-conditional device is complex and likely related to radiofrequency fields.<sup>1</sup> Although the properties of materials used in MRI-conditional ICDs minimize skin burns, unexpected heating may result in thermal injury at the ICD generator site.

**Figure 1** A: ICD pocket 2 days post MRI. B: ICD pocket 14 days post MRI.

Collaborative reporting of unexpected findings such as pocket burns to the CIED manufacturer, MRI and CIED department is necessary to foster patient safety.
