## Electromagnetic Interference in a Private Swimming Pool Case report

Indian Pacing and Electrophysiology

# Sandia Iskandar, Madhav Lavu, Moustapha Atoui, Dhanunjaya Lakkireddy\*

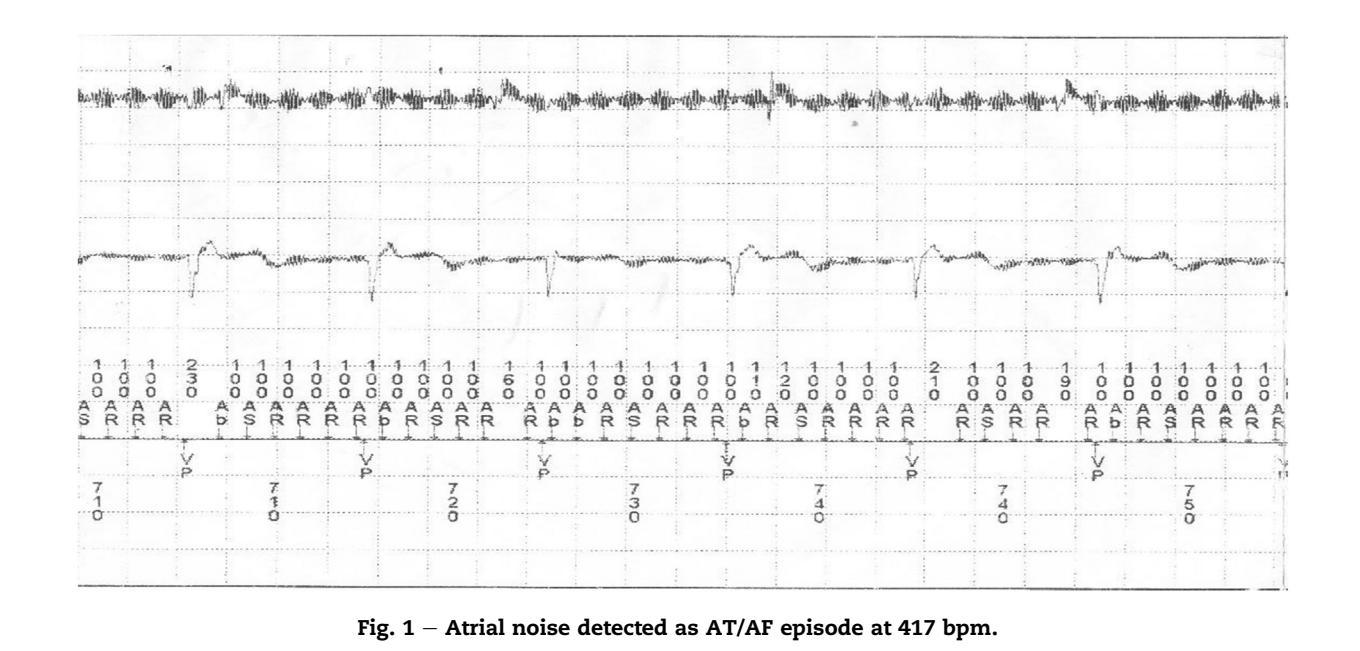
Device interrogation reported 3 ventricular high Non Sustained (NS) rate and 5 Atrial fibrillation/Atrial Tachycardia (AT/AF) episodes from 4 days ago. One of the episodes (Fig. 1) showed a high frequency signal at a cycle length of 100 msec in the atrial lead, described as an AT/AF episode. There were also brief episodes of noise sensed in the right ventricular lead (See Fig. 2). At the time of the patient spending time in the

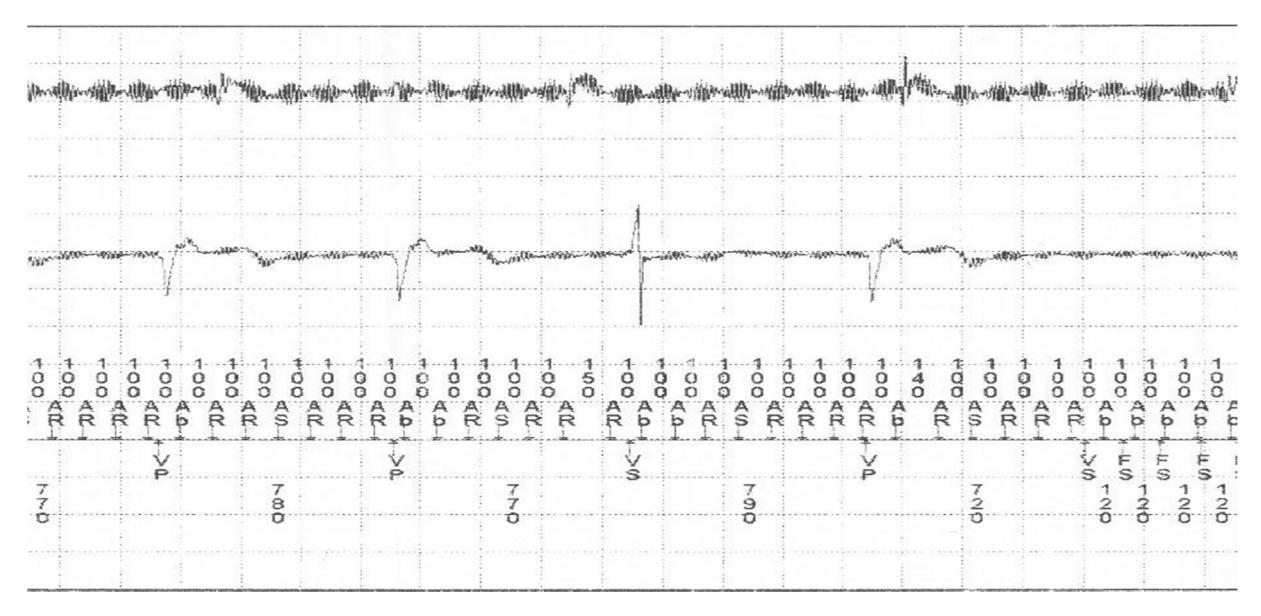
Fig. 2 – Both Atrial and ventricular noise detected. Ventricular noise is detected as High rate NS episode with ventricular rate of 500 bpm.

We performed some isometric exercises in the clinic and we did not see any noise on the A lead. The last impedance of the A lead was 494  $\Omega$  showing a stable trend, therefore no chest X-ray was performed as we did not suspect lead fracture. Upon further inquiry into the incident, we noted that this noise was detected while he was only inside the swimming pool. The patient reported that the swimming pool he was in had underwater lights. We then deduced that the most likely cause of the EMI was a flow of electric current in the water.

Our patient was advised to avoid the swimming pool and to have the pool company investigate the current and reinsulate any underwater wires. No further EMI episodes and mode switches were detected by remote telemetry. Our case suggests that the Incidence of EMI in the swimming pool may be more common than reported and that patients receiving CIED implants need to be made aware of swimming pools as potential sources of EMI.
