Bailout clipping of a leaflet perforation during mitral transcatheter edge-to-edge repair using a larger clip size: a case report

Department of Cardiovascular Medicine, Kurashiki Central Hospital, 1-1-1, Miwa, Kurashiki, Okayama 710-8602, Japan

Received 22 March 2023; revised 14 August 2023; accepted 30 August 2023; online publish-ahead-of-print 8 September 2023

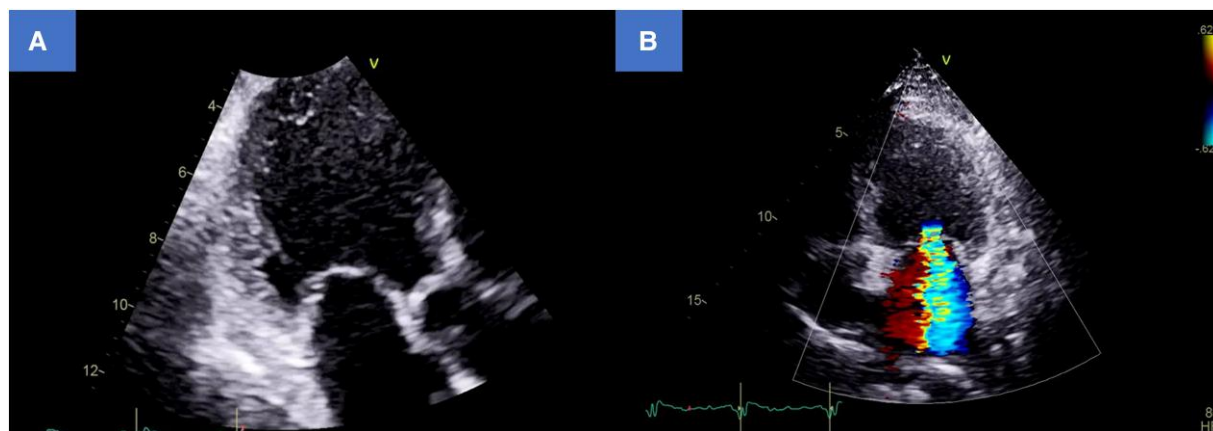
Figure 1 Pre-operative transthoracic echocardiography. Severe mitral regurgitation with tethering of the posterior mitral leaflet. (A) Apical three-chamber image, tethering of the posterior mitral leaflet. (B) Apical four-chamber image.

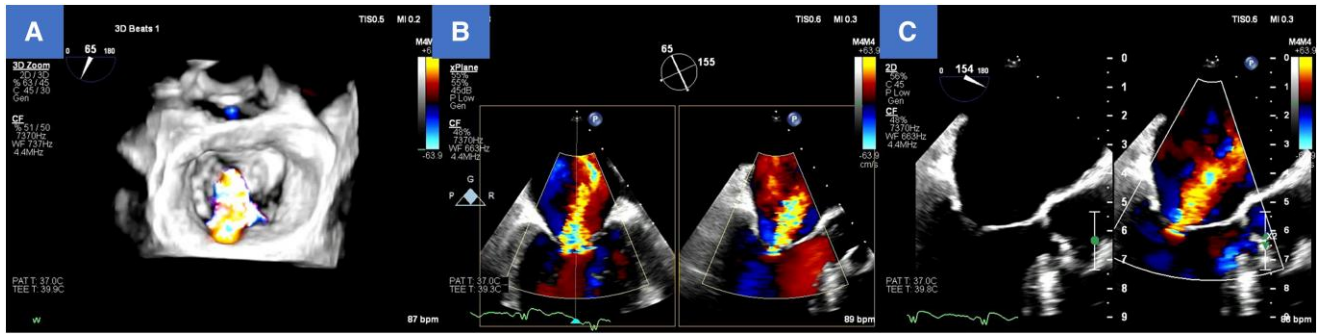
Figure 2 Pre-operative transoesophageal echocardiography. (A) Three-dimensional image of the mitral valve showing a central jet from A2–P2. (B) Wide regurgitation jet slightly lateral to A2–P2. (C) Posterior mitral leaflet was tethering, PML length around 8 mm.

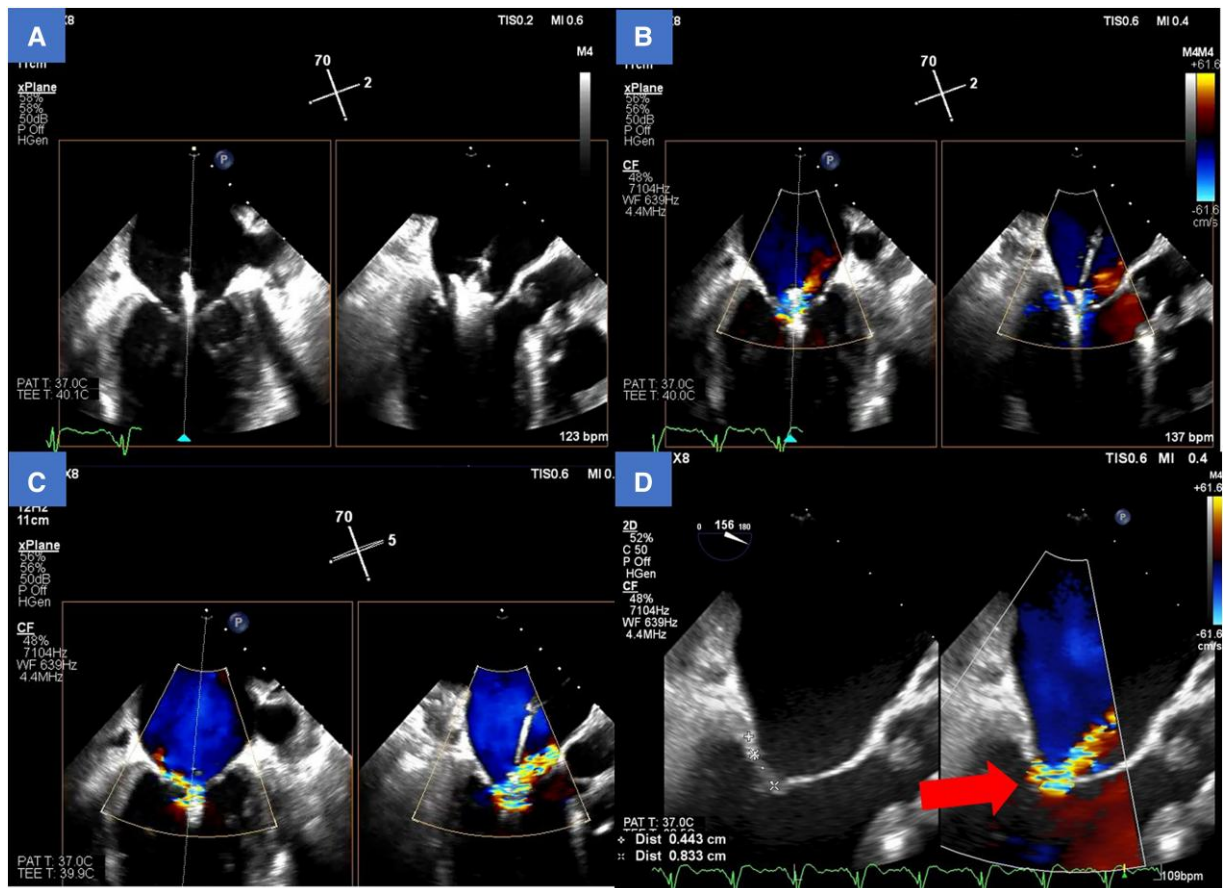
Figure 3 Intraoperative transoesophageal echocardiography until valve leaflet injury was recognized. (A) Positioning the NTV clip in line with central jet. (B) Mitral regurgitation decreased while the clip arm was closed. (C) Once the clip was completely closed, a new mitral regurgitation suddenly appeared. (D) The new eccentric jet came from the mid-portion of the posterior leaflet, indicating leaflet perforation caused by the clip arm. The distance from the tip of the posterior leaflet to the perforation site was around 8 mm.

A2–P2 and inserted into the left ventricle. After confirming that both leaflets were on the clip arm, we dropped gripper down. The MR jet dramatically decreased while the clip was closed but suddenly appeared upon completely closing the clip arm (Figure 3). After opening the clip again, valve

leaflet evaluation using TEE revealed a new eccentric jet coming from the mid-portion of the posterior leaflet aside from the initial central jet, indicating leaflet perforation caused by the NTW clip arm. We discussed subsequent strategies such as bailout clipping, medical therapy, and bailout surgery. Although performing bailout clipping was associated with potential risks of worsening the leaflet injury and mitral stenosis, our team ultimately decided to perform bailout clipping owing to the lack of alternatives, as the patient already had medical therapy-resistant heart failure despite having IABP with a prohibitive surgical risk. Accordingly, we removed the NTW clip and inserted the XTW clip to cover the perforated portion with its longer clip arm. As the distance between the tip of the posterior leaflet and perforation site was approximately 8 mm, we intended to grasp the posterior annulus and leaflet to prevent further tension on the perforation site. During the procedure, we put the ‘+ knob’ and turned the guide catheter clockwise to grasp a significant portion of the posterior annulus. After confirming that the tip of the clip arm was positioned more posteriorly to the leaflet perforation, we dropped the gripper down and slowly closed the clip, following which MR decreased to mild with no eccentric

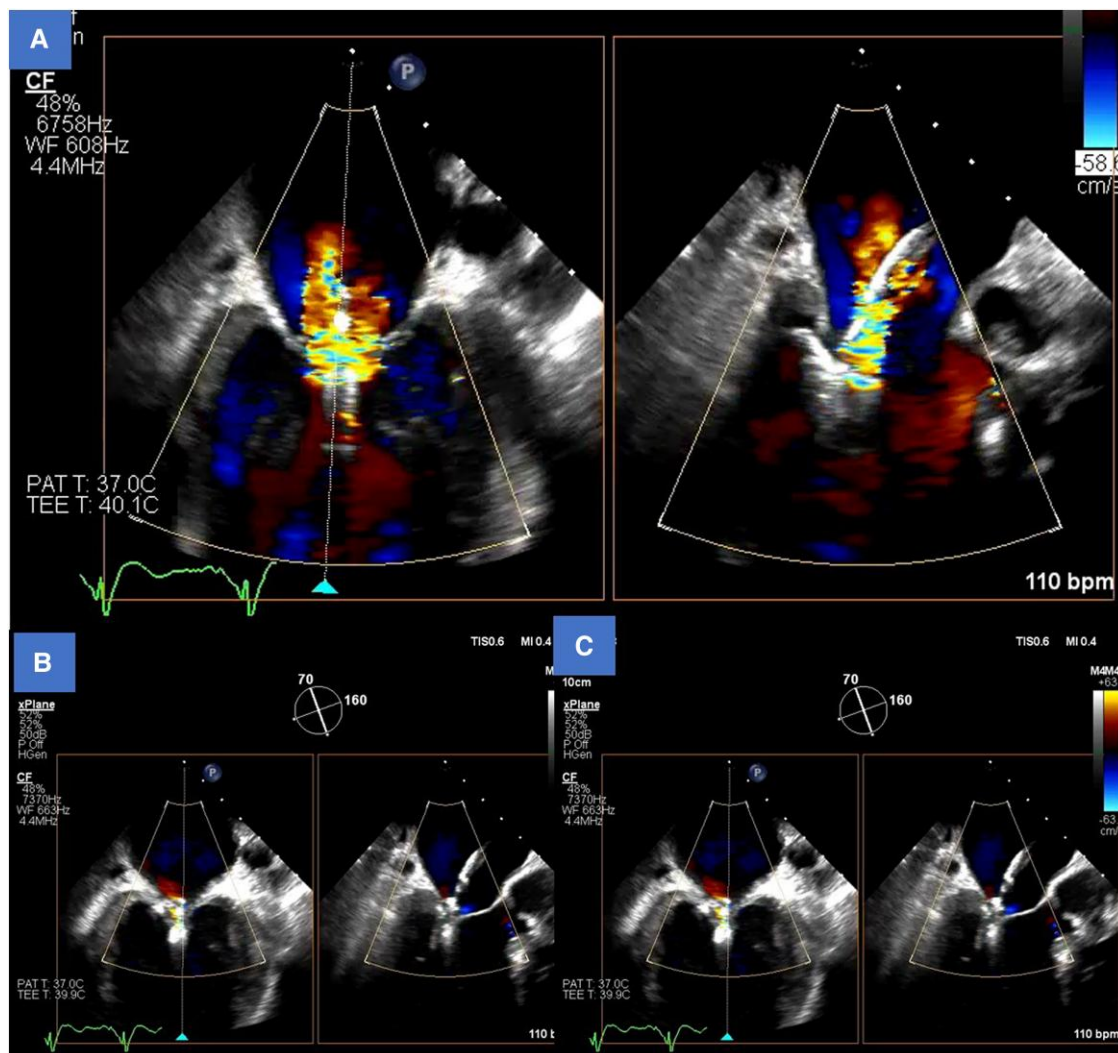
Figure 4 Intraoperative transoesophageal echocardiography after recognizing valve leaflet injury. (A) Delivery of the XTW clip to the previously grasped portion, confirming that the tip of the clip arm was positioned more posteriorly to the leaflet perforation before grasping the leaflets. (B) After fully closing the clip, the mitral regurgitation decreased to mild. (C) Final transoesophageal echocardiography showed mild mitral regurgitation and no stenosis.

MR was observed on TEE. After releasing the XTW clip, the final TEE showed mild MR, no eccentric jet, and no apparent mitral valve stenosis (Figure 4). After the procedure, her haemodynamics improved considerably. The IABP was removed the next day, and the patient was weaned off catecholamine a week after the procedure. Post-operative TTE also showed improvement in mild MR. The patient was ultimately discharged to a nursing home 28 days after the procedure. She received follow-up medical care by a primary care physician. However, she died for heart failure eight months after discharge.

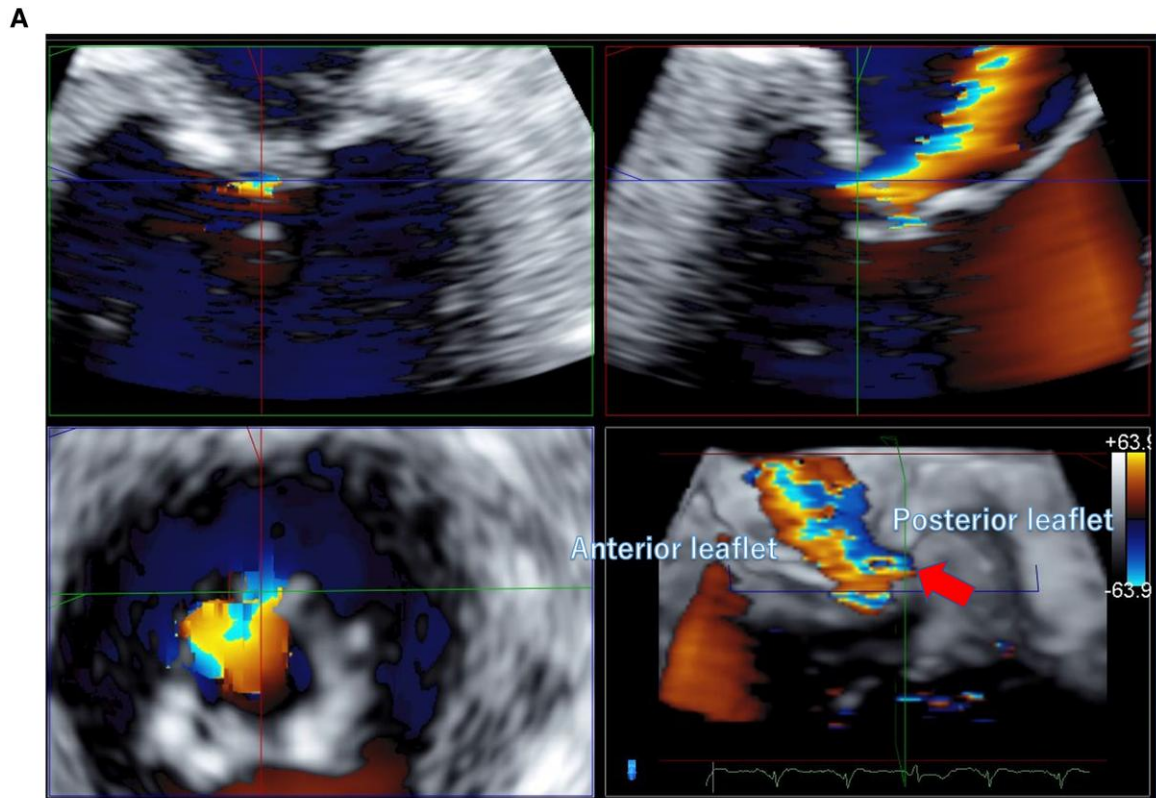
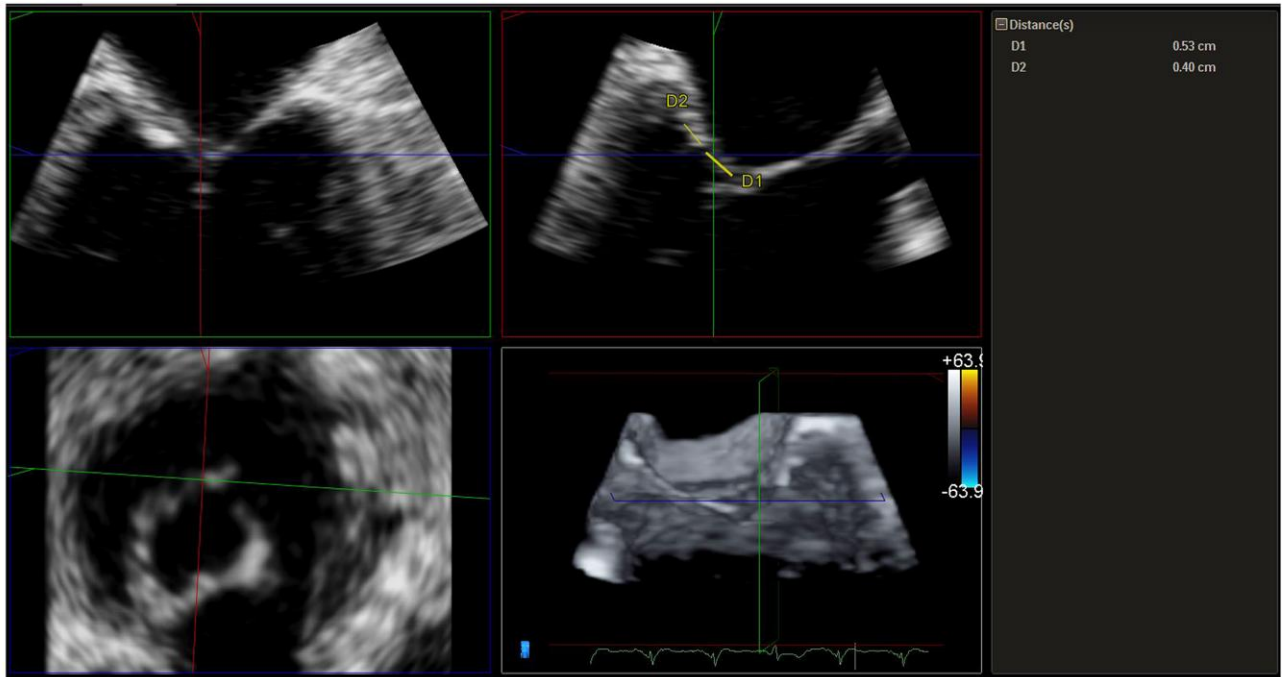
Figure 5 Three-dimensional multiplanar reconstruction image at the time of leaflet injury. (A) Regurgitant blood flow from the middle portion of the posterior leaflet (arrow). (B) The distance to the injured part was 5.3 mm from the leaflet tip and 4 mm from the base of the posterior leaflet.

The tip of a clip arm creates tension on the leaflet, potentially injuring the leaflet tissue by grasping, especially in thin or fragile leaflets or those with mitral annular calcification. To prevent leaflet damage, surgeons should avoid multiple grasping and slightly advance the clip towards the ventricular direction during careful and slow clip closure.^{3,4} In our case, the leaflet injury occurred at the mid-portion of the posterior leaflet during the first grasping. In the EXPAND registry, all patients with leaflet injury exhibited 3+ or 4+ MR and resulted in mitral valve surgery and/or death. Therefore, cardiac team discussions are required to determine the appropriate treatment of the leaflet perforation. Although surgical treatment is the most common approach for leaflet injuries, we decided to implant an additional clip given the extremely high surgical risk.

No optimal bailout strategy has yet been established for leaflet tears and perforations. While a few case series have reported that plug closure was effective for the clip-related tears, some issues were presented, such as frequent haemolysis and device embolization after the plug implantation.⁵ Transcatheter mitral valve replacement with or without cutting the leaflet attached with the clip is another option for patients with TEER failure.⁶ However, there are still some technical issues associated with transcatheter mitral valve replacement such as left ventricular outflow tract obstruction, valve durability, leaflet thrombosis, and access site. In addition, there is still less experience with transcatheter mitral valve replacement in native valves compared to valve-in-valve and valve-in-ring cases. Therefore, it should only be considered in selected patients who exhibit anatomical suitability. In the current case, an XTW clip was used to cover the damaged area of the posterior leaflet. On TEE, the distance from the tip of the posterior leaflet to the perforation site was around 8 mm, whereas the length of the XTW clip arm was 12 mm, theoretically suggesting that the perforated area can be completely covered by the XTW clip. Considering that additional clipping could worsen the leaflet injury, a comprehensive assessment of the leaflet is crucial to determine whether the injured portion can be covered using the additional clipping. During the procedure, the distance between the tip and injured part was approximately 8 mm. However, it was difficult to measure the distance directly in line with the injury site in the long-axis image. Therefore, we retrospectively examined the three-dimensional (3D) image obtained via multiplanar reconstruction (MPR). The 3D MPR image clearly showed that the MR PISA from the middle portion of the posterior leaflet was separated from the original MR, indicating leaflet perforation (Figure 5A). We also found that distances to the perforation site from the leaflet tip and base of the posterior leaflet were 5.3 and 4 mm, respectively (Figure 5B). Therefore, it seems reasonable to infer that the leaflet injury was caused by the tip of the XTW clip, probably because of the excessive tension on the insufficiently inserted posterior leaflet. Although not performed at the time, intraoperative 3D MPR could have helped in understanding the detailed anatomy of leaflet injury during TEER procedure. Surgeons should confirm that the perforated portion is just above the clip arm and that tip of the clip arm is positioned more posteriorly to the perforation before dropping the gripper down.
