CASE REPORT

Insights into guidewire related complication during HotBalloon ablation in patients with atrial fibrillation: What should we know?

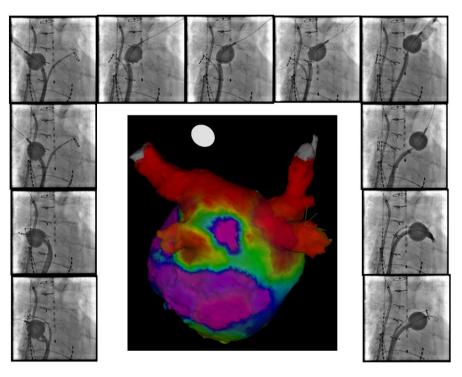
FIGURE 2 Fluoroscopic image in the anteroposterior view. The HotBalloon positioning at each site is shown. Central panel: Electroanatomic bipolar voltage mapping in the posteroanterior view after the HotBalloon ablation. Red color shows low voltage area <0.04 mV, indicating electrically silent area created by the HotBalloon ablation. Note that, all pulmonary veins and the roof line were successfully ablated

mapping system (Figure 2), however, the floor line was not created due to hemoptysis. The computed tomography of the chest showed that the consolidation in the left lower lobe was suggestive of pulmonary hemorrhage (Figure 1). Her hemoglobin level decreased from 12.0 g/dL to 8.7 g/dL, however, she needed no blood transfusion. She had no recurrence of hemoptysis and apixaban was restarted the next day after the procedure. The patient was discharged 6 days after the procedure without any sequela. The
