ECG interference due to nasopharyngeal temperature probe masquerading as ventricular tachycardia - A case study

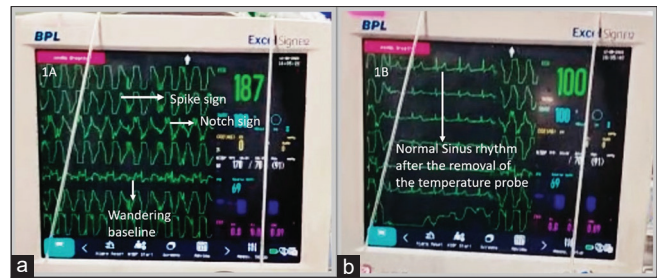
Figure 1: (a) ECG interference mimicking ventricular tachycardia with spike and notch sign. (b) Normal sinus rhythm after the removal of the temperature probe from the nasopharynx

Signals unintentionally produced in one device have the potential to be transmitted to another through a patient by a phenomenon called capacitive coupling.^[1,2] In the absence of proper grounding, an electrical current is generated in an isolated circuit of monitoring devices such as those for urine output or core temperature, which passes through the patient and is conducted to the cardiograph leads as an artefactual trace.^[1,2] It manifests as a peak, notch, and sinus sign on the ECG and wandering baseline that mimics monomorphic VT [Figure 1a] in a backdrop of normal haemodynamic parameters.^[1,2]
