A New Solution to a Rare Problem of Implantable Cardiac Device Hypersensitivity

Rana Al-Zakhari¹, Safa Aljammali¹, Ryan Isber², Angela Grigos¹, Nidal Isber³

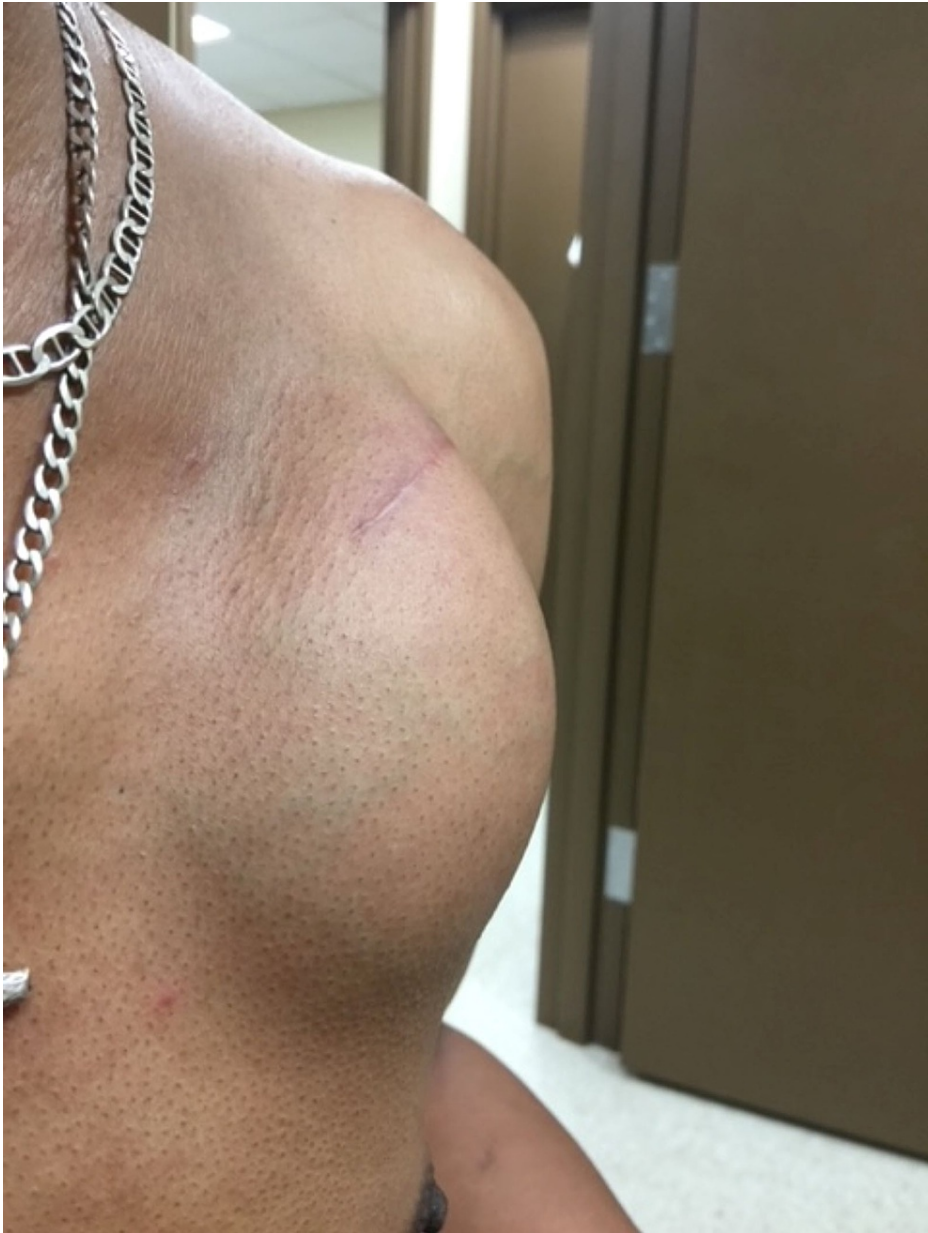
The patient is a 60-year-old African American male who survived cardiac arrest due to ventricular tachycardia which necessitated the need for a dual-chamber ICD. Placement was without any complications. However, three weeks later, the site of the device developed swelling, with tense fluctuating fluid accumulation (Figure 1). No other local signs of infection were present, such as erythema, tenderness, or increased warmth of the skin. There were neither systemic signs nor any symptoms of infection, such as fever, tachycardia, or leukocytosis. Over the course of the next three months, the pocket was aspirated twice, drawing 140 cc of fluid each time (Figure 2). However, within 12 to 24 hours of each aspiration the fluid re-accumulated to the same degree. Pocket fluid analysis revealed white blood cell count of 1215/mL (88% was lymphocytes) (Table 1). Numerous blood and fluid cultures, gram stains, and acid-fast bacilli stains returned negative (Table 2). The lack of infective organism and the rapidity of fluid accumulation strongly suggested a diagnosis of ICD hypersensitivity. Skin patch test revealed sensitivity to nickel. The only reliable treatment was the removal of the system component. It was then decided to remove the ICD system and to implant a gold-plated generator. During the procedure, inspection of the pocket after removal of the fluid revealed no signs of infection. The attempt to implant a new lead that was compatible with the gold-plated generator was not possible due to subclavian vein thrombosis. Due to worries of complications, such as pneumothorax, the procedure was aborted, and right-side device implantation was planned for a later date. Meanwhile, during this attempt, an antibiotic-coated envelope was used to entirely coat the ICD generator, to prevent device-tissue interaction. The antibiotic envelope consisted of the antimicrobials minocycline and rifampin and therapeutic levels eluted into the ICD pocket site. Follow-up at one week, four weeks, and three months showed no re-accumulation of fluid. The patient continued to be completely asymptomatic and the patient did not receive any systemic antibiotics.

FIGURE 1: ICD pocket site swelling

This case demonstrates that fluid accumulation, unresolved after repeated aspiration, could be indicative of hypersensitivity reaction to a component of the ICD such as nickel, as in this case. Entirely coating the device with an antibacterial envelope is an effective way to treat this complication.

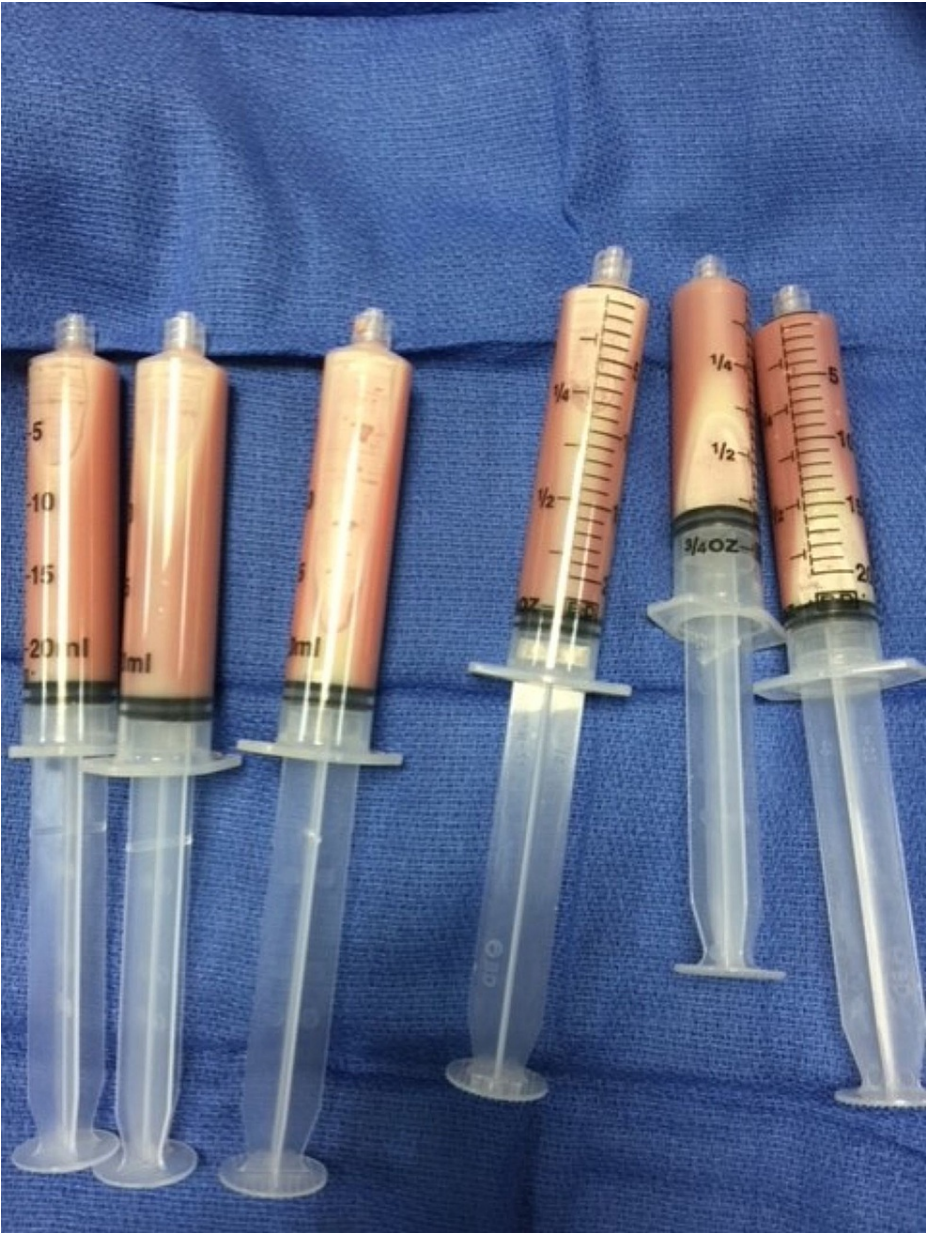
FIGURE 2: ICD pocket fluid aspirate

ICD Pocket Fluid Aspirate Parameters	Results
Fluid WBC	1215/ μ L, 88% lymphocytes
Fluid glucose	102 mg/dL
Total protein	3.6 g/dL
Fluid albumin	2.4 g/dL
Fluid LDH	124 U/L
Fluid amylase	44 U/L
