Case Report Analysis of a Cementless Femoral Stem Neck Fracture Using Scanning Electron Microscopy and the Finite Element Method

Hirokazu Takai 💿, Daisuke Nakayama, Masatoshi Murayama, and Tomoki Takahashi

Department of Orthopaedic Surgery, Kumamoto Kinoh Hospital, Kumamoto, Japan

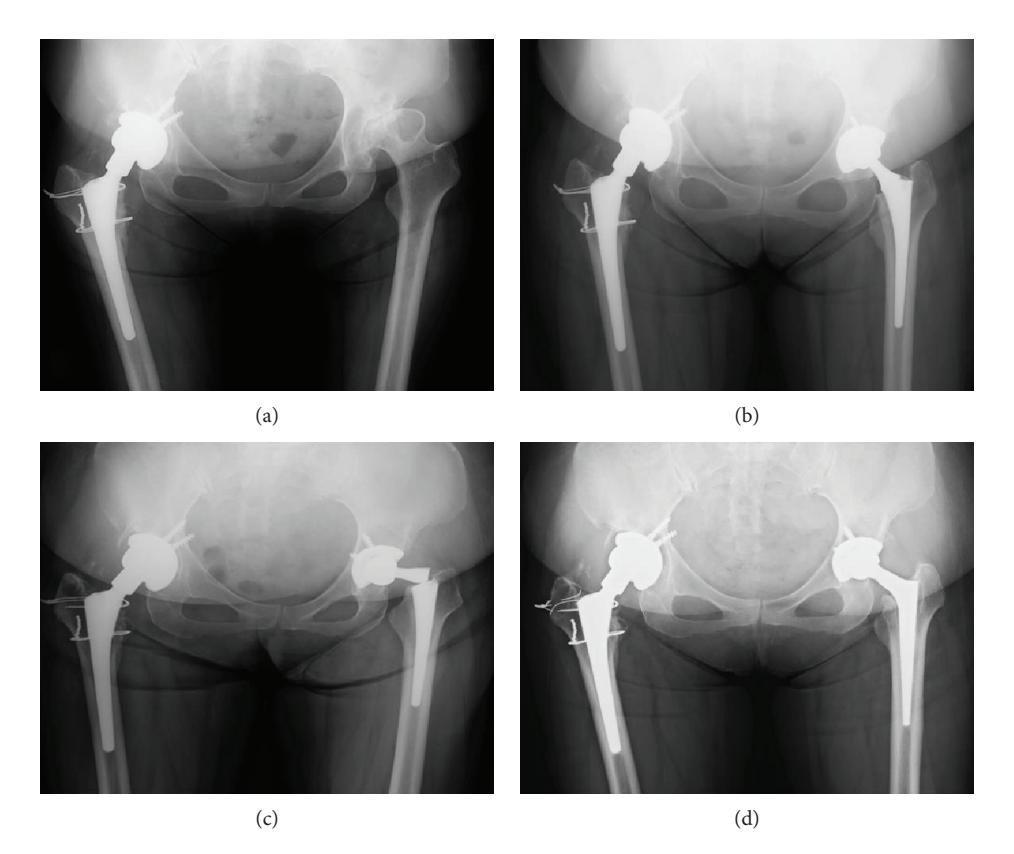
A 57-year-old woman (body weight: 70 kg, body mass index: 27.3 kg/m²) had severe bilateral coxalgia. She had undergone right THA at another hospital. Because of early aseptic loosening and recurrent dislocation of the hip, four revision hip arthroplasties had been performed within one year after the first right THA. After these interventions, she presented at our hospital because of left coxalgia. Radiography revealed end-stage severe left hip arthritis and malposition of the cup implant on the right side (Figure 1(a)).

FIGURE 1: Radiographs. (a) Preoperative radiograph showing severe osteoarthritis of the left hip. (b) Postoperative radiograph of primary THA of the left hip using AHFIX Q stem (NAR #1). (c) Radiograph showing breakage of the AHFIX Q stem at the base of the neck. (d) Postoperative radiograph after revision THA of the left hip. THA: total hip arthroplasty.

Left THA was therefore performed via a posterior approach using an uncemented hip stem (AHFIX Q, KYO-CERA, Japan) (Figure 1(b)). The size of the AHFIX Q stem was NAR #1, the smallest size available. The stem was implanted in a neutral position with 25° of stem anteversion. A cementless acetabular cup (AHFIX Q3 shell, KYOCERA, Japan) was fixed with two screws. The acetabular cup anteversion and inclination were 15° and 42°, respectively. A 26 mm Co-Cr-Mo head with a +3 mm neck was installed with high cross-linked polyethylene liner. The University of California at Los Angeles (UCLA) activity score improved from 3 to 6. She was discharged from our hospital after complete recovery from left coxalgia shortly thereafter. Four years and eight months after left THA, she developed severe left thigh pain without any trauma. Radiography revealed an uncemented femoral stem fracture at the base of the neck (Figure 1(c)). Revision THA was immediately performed using a Wagner cone stem (Zimmer Biomet, Warsaw, IN, USA, Figure 1(d)). At the final follow-up visit, although she felt instability on her right hip, she managed to walk without coxalgia. We proposed revision THA on the right side several times; however, the operation has been delayed because of the patient's health condition. There has been no early loosening of the left prosthesis until now.

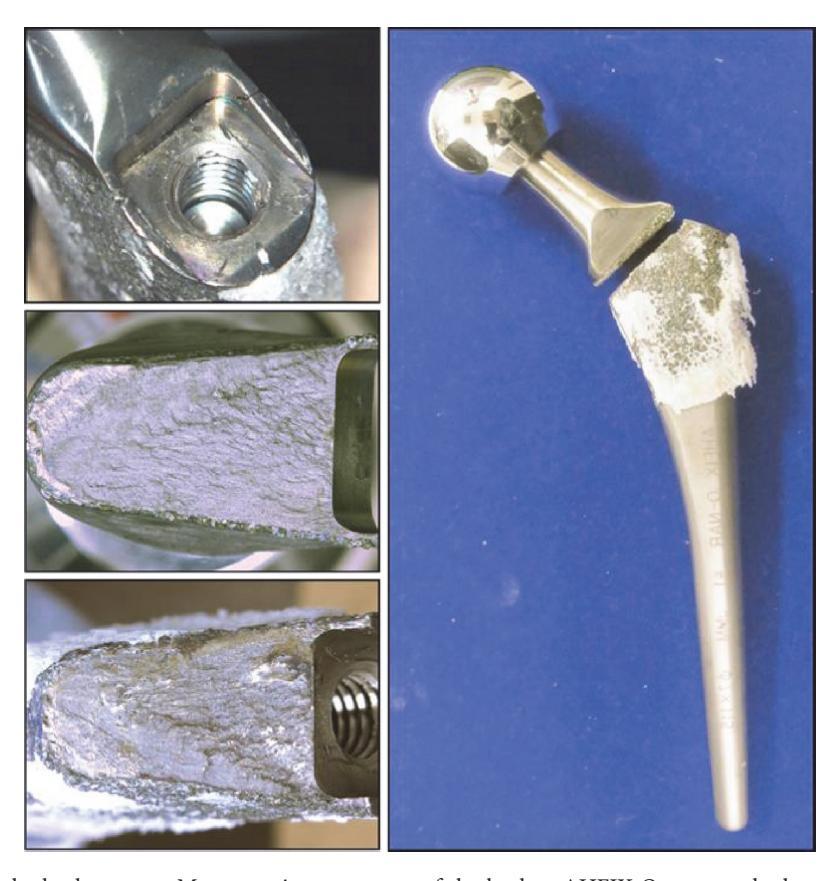
and scanning electron microscope (SEM; ~×2000, S-3400N, HITACHI, Japan). The proximal coating area of the stem showed good bone ingrowth macroscopically (Figure 2). Observation under a digital microscope and SEM showed some cracks from the anterolateral edge of the fracture surface at the shoulder corner of the stem's neck, which had a hollow junction for apparatus attachment. The cracks extended from the anterolateral surface to the posteromedial surface (Figure 3). The fracture surface was divided into three areas according to the form. There were multiple micro streaks from the anterolateral edge to the medial side, accompanied by a wavy undulation in area 1. Based on these findings, the anterolateral edge was assumed to be the origin of the fracture. The surface in area 2 was flatter than that in area 1. This difference showed that the fracture reached the posterior wall and that the fracture progress had changed. There were multiple striations in areas 1 and 2 (Figures 3 and 4). Striations showed a typical striped pattern with parallel streaks formed by repeated enlargement and destruction of the material caused by repetitive loading and usually appear in fatigue fractures. Furthermore, there were multiple dimples in area 3 (Figures 3 and 4). Dimples are dentconnecting microcavities caused by local tissue rupture, which typically appear in static fractures. Our findings suggested that the anterolateral corner of the stem's neck was the starting point of the fracture and that the fracture had spread from the anterolateral to the posteromedial aspect.

FIGURE 2: Appearance of the broken stem. Macroscopic appearance of the broken AHFIX Q stem at the base of the neck. The proximal coating area shows good bone ingrowth. The base of the neck has a sharp slot for handle attachment and the corner is not rounded but is angular.

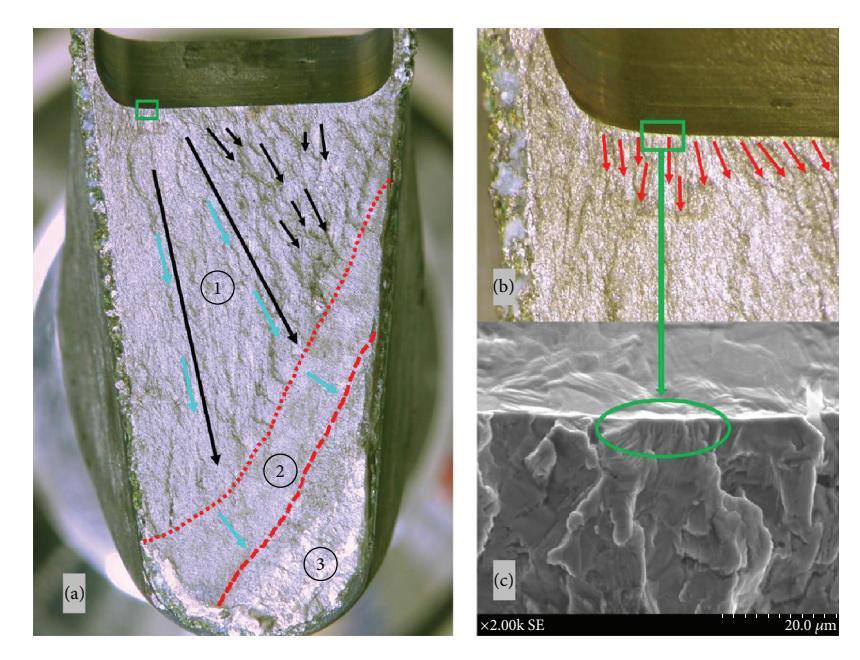
FIGURE 3: Fractured surface observed by macroscopy, digital microscopy, and SEM. (a) Fracture surface observed macroscopically. Arrows indicate the advancing direction of the progressive destruction. (b) Fracture surface observed by digital microscopy. There were multiple micro streaks from the edge of the attachment slot in the stem corner (red arrows). (c) Picture of the fractured surface observed by scanning electron microscopy ($\sim \times 2000$). The basis of the streaks was assumed to be the origin of the fracture. SEM: scanning electron microscope.

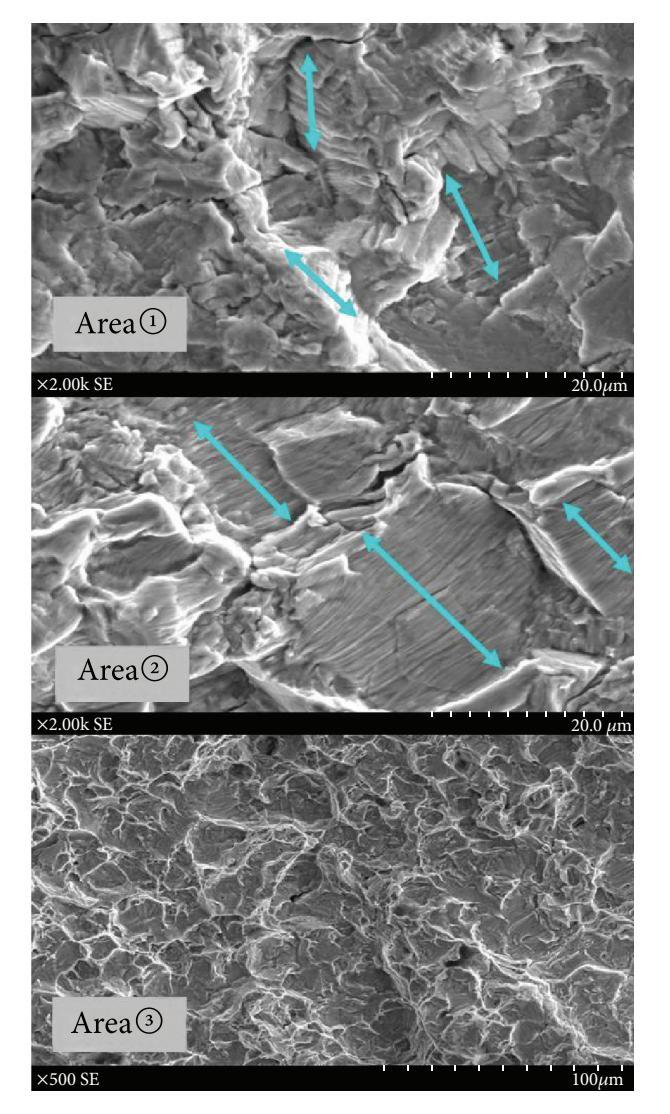
FIGURE 4: Analysis by SEM. The SEM images show many parallel striations in area 1 and area 2. Furthermore, there are many dimples in the area 3. SEM: scanning electron microscope.

Repeated loading led to progressive metal fatigue, which ultimately led to a static fracture.

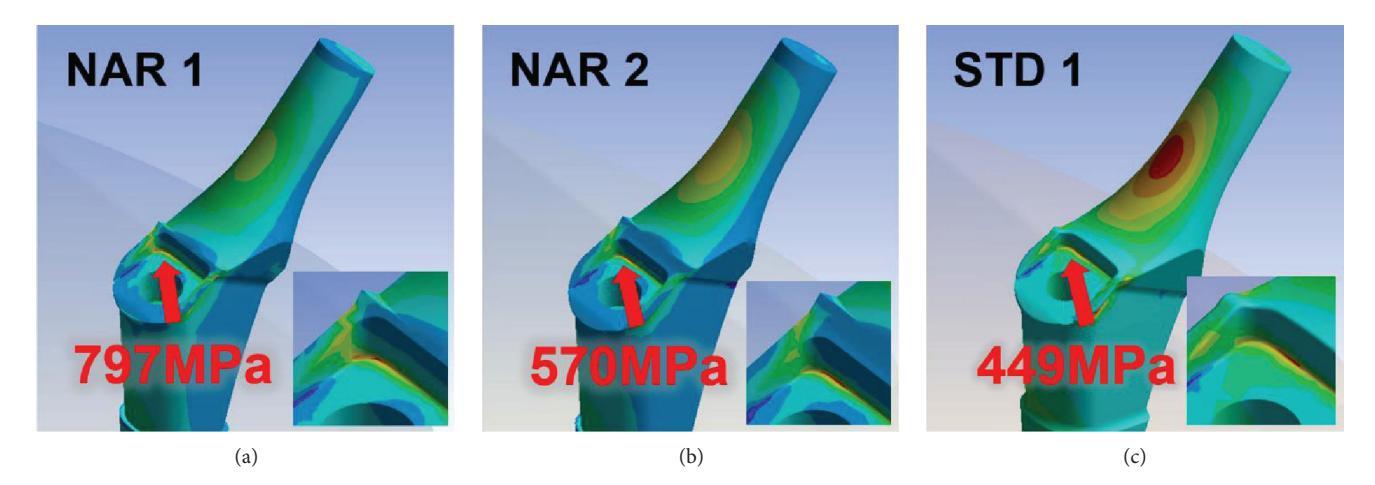
The stress condition of the stem was evaluated by the finite element method (FEM; ANSYS Workbench Ver.13, ANSYS, Canonsburg, PA, USA). The subjects of FEM analysis were the top three narrowest and smallest sizes: NAR #1, NAR #2, and STD #1, considering the effect of size. In this series, FEM analysis was carried out under the assumption that five times the load of 80 kg body weight was applied to the center of the femoral head statically. A weight of 80 kg was set as the body weight applied on the stem. FEM analysis showed that the stress concentration was maximum in the anterolateral corner of the hollow junction for all sizes. The maximum stress was highest for NAR #1 (797 MPa). For NAR #2, the maximum stress was 570 MPa (a decrease of approximately 28%, Figure 5). For STD #1, the maximum stress was 449 MPa. NAR #1 had the highest stress concentration compared with all other sizes. Thus, the stress concentration at the anterolateral corner of the stem neck seems to be a factor associated with fracture of the AHFIX Q stem NAR #1.

FIGURE 5: Result of the analysis by FEM. FEM images showing that the stress was maximum in the corner of the hollow junction for all sizes. FEM: finite element method.

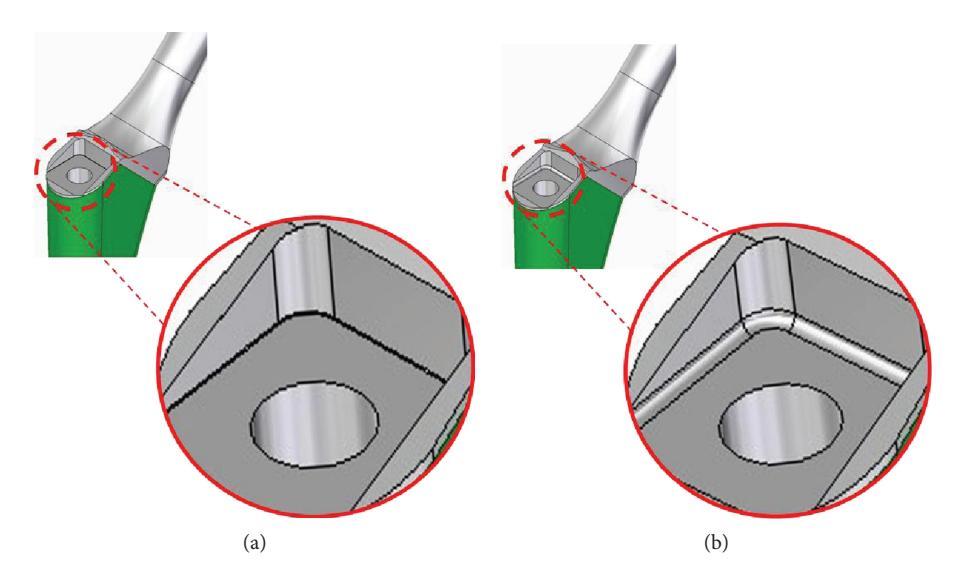
FIGURE 6: Improvement of the AHFIX Q stem design. (a) Conventional AHFIX Q stem design. (b) In the new design, the shoulder corner of the hollow had a curve (radius = 0.5 mm). This improvement of the design decreases the stress concentration.

Upon analysis, it was found that the breaking strength of the smallest size (NAR#1) is much weaker than that of the other sizes. Subsequent to this case, the shape of the hollow for stem removal has been improved. The new design of the shoulder corner of the hollow has a curve (radius = 0.5 mm, Figure 6). This improvement in the design decreases the stress concentration and increases the breaking strength. The fatigue strength of NAR #1 improved 33% from 2.0 kN to 3.0 kN, while the fatigue strength of NAR #2 improved from 2.8 kN to 5.0 kN. After the improvement of the stem, manufacturers restricted the use of the NAR #1 to patients with a body weight under 60 kg. Fractures of the AHFIX Q femoral stem have not been reported after this improvement.
