Cureus

# Pacemaker Failure to Capture Caused by Electrocautery: A Rare Pacemaker Pulse Generator Change Complication

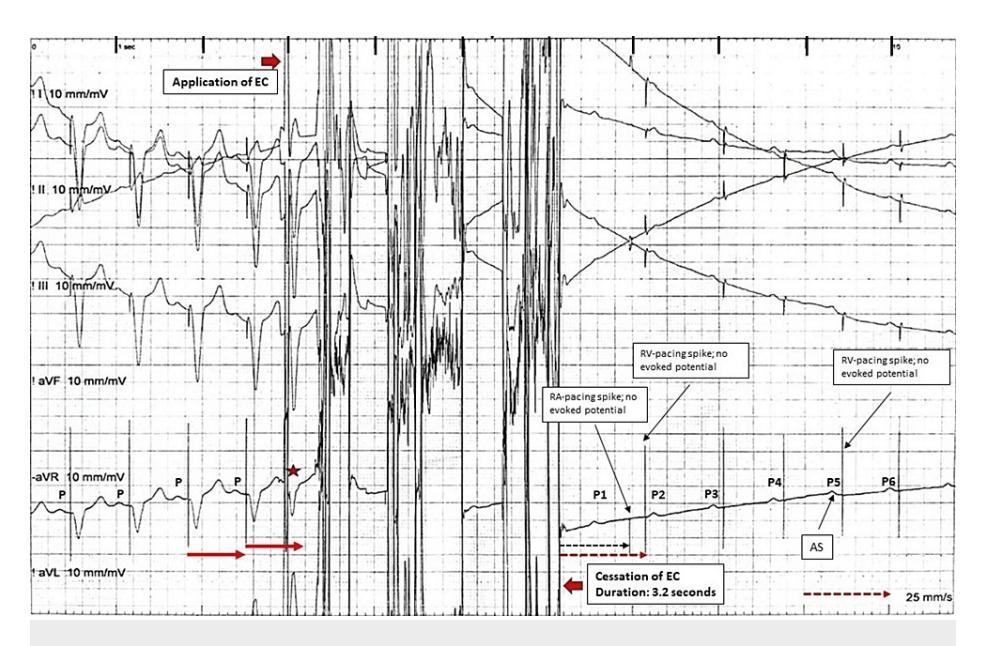
#### FIGURE 1: Electrocardiogram During Electrocautery

On the day of the procedure, the patient was hemodynamically stable with preliminary laboratory workup all within the normal range. Manually operated transcutaneous pacemaker (TCP) pads were applied that are used for both cardioversion/defibrillation and pacing. The return patch for the EC was placed on the right leg. Although the patient was pacemaker-dependent, we did not put a temporary pacemaker as it increases the risk of infection. After preparing the left infraclavicular area, midazolam 1 mg aliquots to a total of 3 mg were administered to establish conscious sedation. The old scar was removed using an ellipsoid wedge incision. To stop bleeding in the scar, unipolar EC was used in a short burst. The EC was set at 45 watts, and only coagulation was used. This resulted in a sudden and unexpected loss of ventricular capture (Figure *1* and Figure *2*).

Six-lead rhythm strip that shows atrial sensing, followed by a unipolar pacing spike and appropriate ventricular pacing. There is an application of electrocautery (EC) for a period of 3.2 seconds and then an abrupt failure to pace. The first beat after the application of EC (star) is possibly a tracked-paced beat. After EC cessation, the first two P waves (P1 and P2) are not sensed. There are atrial and ventricular pacing spikes without evoked potentials (failure to pace). Onward from P4, there is appropriate atrial sensing then the programmed AV delay and unipolar ventricular pacing spikes, but no ventricular evoked potential (failure to pace), which remains for the duration of the trace.

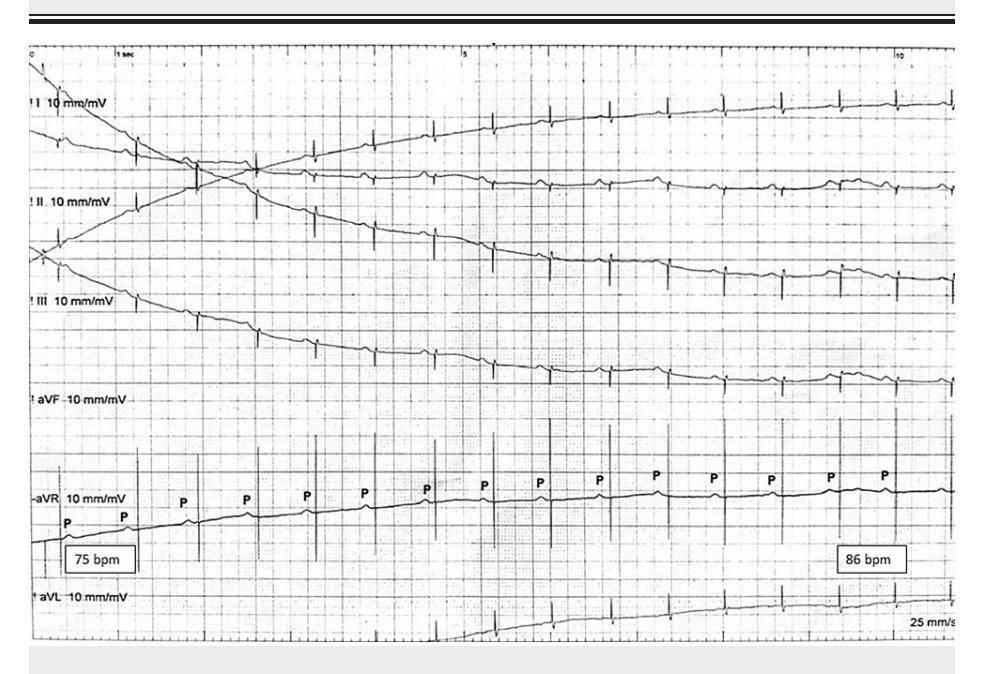
#### FIGURE 2: Six-Lead Electrocardiogram

The figure shows the continuation of the six leads from Figure 1, showing atrial sensing and ventricular pacing spike with failure to capture. The device outputs after the programmed AV delay but does not capture the myocardium. The sinus rate goes from 75 to 86 bpm in 10 seconds.

The loss of capture (LOC) remained for 30 seconds, and before the TCP could kick in, the ventricular capture through the permanent pacemaker spontaneously resumed. The further procedure was done using blunt dissection. When the device was removed from the pocket, a few beats were missed because of unipolar pacing, necessitating the generator to be repositioned in the pocket. The device was replaced into the pocket, and pacing resumed. The device ventricular lead was then carefully shifted to the analyzer cable, and subsequent pacing was done through it. The leads were rechecked for thresholds and impedance and were
