A simple yet novel solution to prevent stent stripping in Guidezilla use

Kerim Esenboğa,
Kaan Akın,
Nil Özyüncü,
Türkan Seda Tan,
Durmuş Eralp Tutar
Department of Cardiology, Faculty of Medicine, Ankara University;
Ankara-*Turkey*

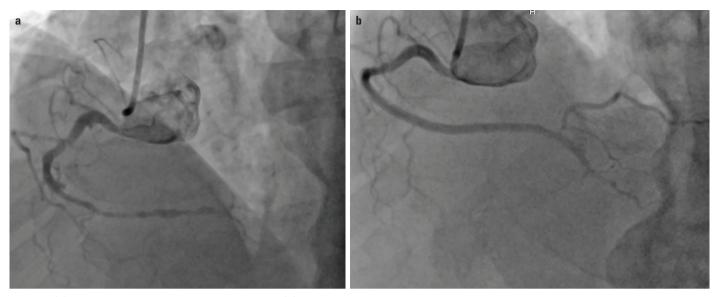
Figure 1. (a) Pre-revascularization right coronary artery. (b) Right coronary artery post revascularization

We performed transradial coronary angiography and identified severe occlusion in the proximal left anterior descending (LAD). Right coronary angiography revealed diffuse 70% occlusion after branching of acute marginal artery followed by 90% and 99% occlusion in the distal right coronary artery (RCA). The ostium of the posterior lateral artery (PLA) was totally occluded (Fig. 1a). We performed revascularization of the LAD first.

Following deployment of the first stent, we deployed a 2.25*26 mm DES in 90% occlusion just before the crux and a 2.5*30 mm DES in the most proximal occlusion. After stent deployment, we post-dilated stents with noncompliant balloons (Fig. 1b).

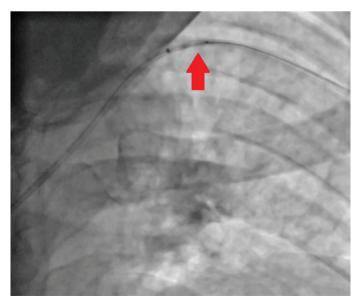
The ostium of RCA had an atypical take-off, and good cannulation was achieved via a 6F hockey stick guiding catheter. However, adequate back-up support could not be achieved to deliver PCI equipment to the distal vessel. We could not advance the floppy guidewire through the occlusions; therefore, a microcatheter assist device was used for wiring the distal RCA. We could not advance the percutaneous transluminal coronary angioplasty (PTCA) balloon through the most critical part of the occlusion. Therefore, we decided to use a guide extension catheter (Guidezilla 6F Boston Scientific) for effective cannulation and adequate back-up support. We advanced the PTCA balloons with the help of Guidezilla and predilated the lesions. After predilation, we could not advance the 2.0*28 mm DES; therefore, we retracted the stent and dilated the lesions with a 2.5 mm noncompliant balloon. When we tried to advance the 2.0*28 mm stent again, we could not advance it through the proximal junction of Guidezilla. We overcame this obstacle by dilating the proximal junction of the

Figure 2. Dilation of the proximal junction of Guidezilla

perform the operation successfully; however, we encountered a previously documented complication of Guidezilla - stent stripping due to difficulty in advancing the stent through the proximal junction of Guidezilla (6) - and developed a novel technique to prevent the occurrence of this adverse event.

We believe that this problem arises from an interaction between the less flexible metal collar of Guidezilla and the metal composition of the stent. Alterations and deformations that arise while pushing the stent into the proximal junction of Guidezilla may be the plausible culprit as this complication is rare with balloons and more likely when a stent that was retracted earlier is implanted.

The dilation of the proximal junction of Guidezilla does not increase the diameter of the junction significantly. Therefore, we do not think our maneuver functions by such a mechanism. We do think, however, that dilation of the junction causes structural alterations that allow a different alignment for the previously deformed stent. PTCA balloons of a diameter larger than the jammed stent could be easily advanced, supporting our belief that structural deformities caused by Guidezilla's metal collar are the primary mechanism of this particular problem, rather than the insufficient diameter of the proximal junction.

Another possible explanation could be the narrowing of the lumen due to a kinked guidewire. Depending on the structure of Guidezilla, a kinked wire might lead to an obstruction of the proximal junction in return. Balloon dilation of the proximal junction might have allowed stent advancement by flattening the guidewire, thus, relieving the obstruction.

Guidezilla extension catheter with a 2.5*15 mm PTCA balloon with 14 atmospheric pressure (Fig. 2). After dilation, we advanced the stent with ease and deployed it in the distal RCA.
