Received: 2014.09.30
Accepted: 2014.10.29
Published: 2015.02.23

Authors' Contribution:

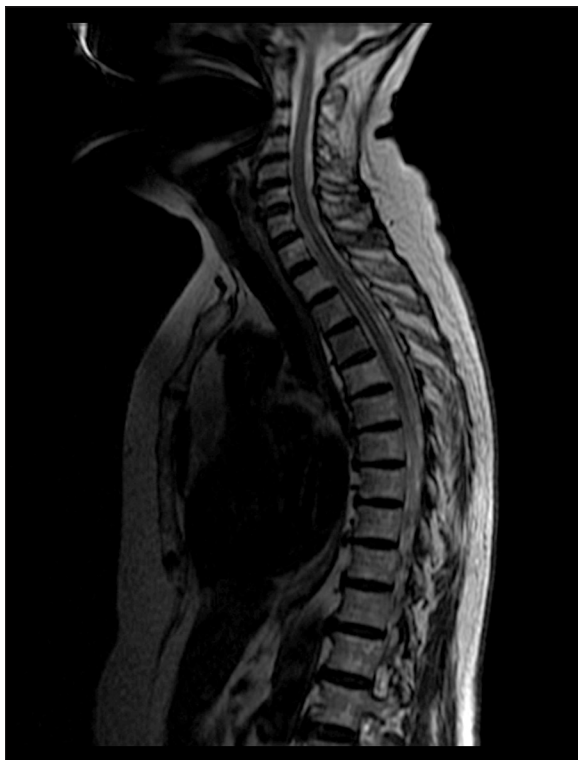
Figure 1. Typical syrinx-like manifestation of truncation artifact in the spinal cord.

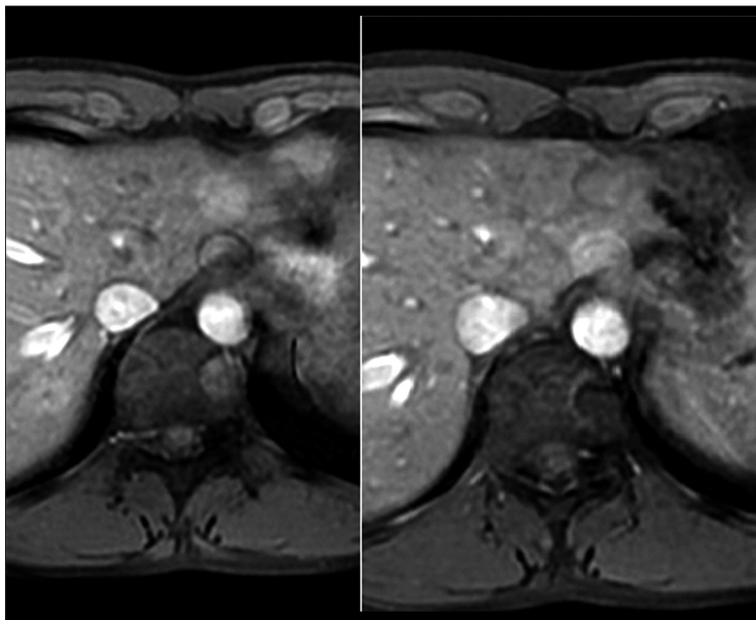
Figure 3. Multiple images of the aorta – ghosting artifact caused by aortal pulsation.

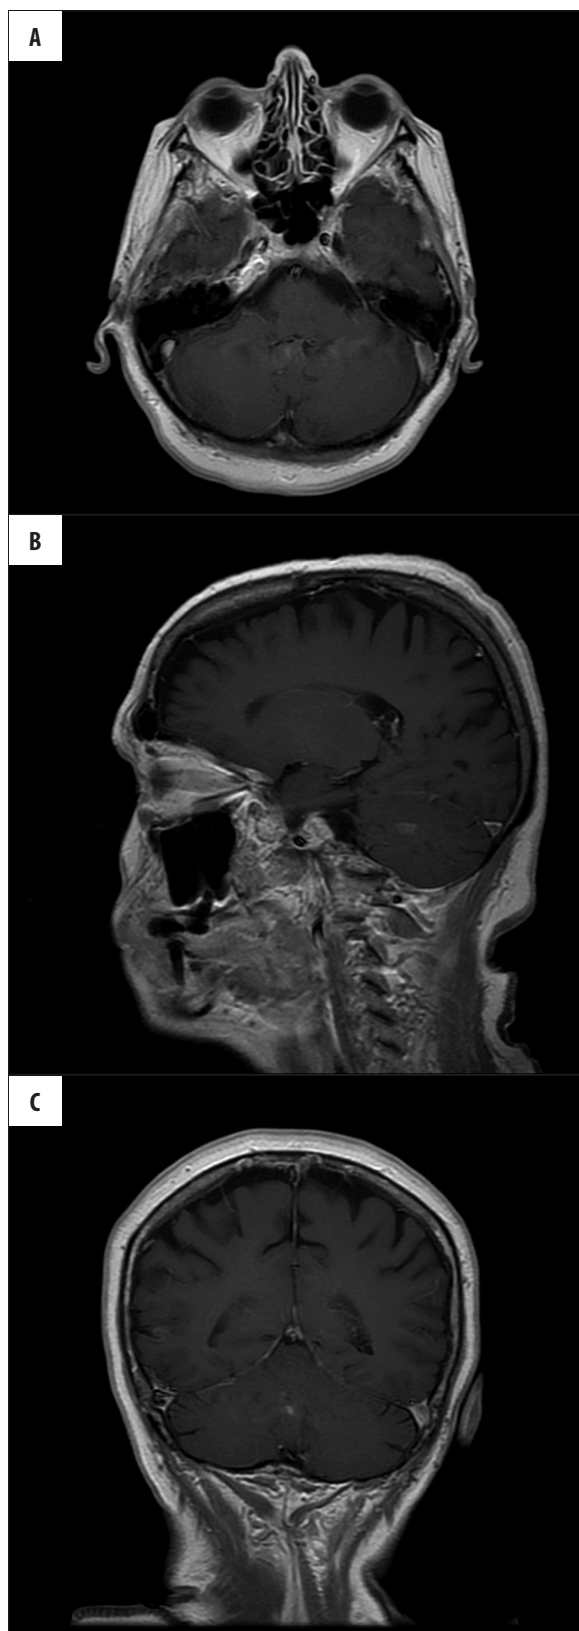
Figure 4. SE/T1-weighted images after intravenous administration of the contrast material – hyperintense signal caused by arterial pulsation imitates a cerebellar, contrast-enhanced lesion (A – axial plane, B – sagittal plane, C – coronal plane).

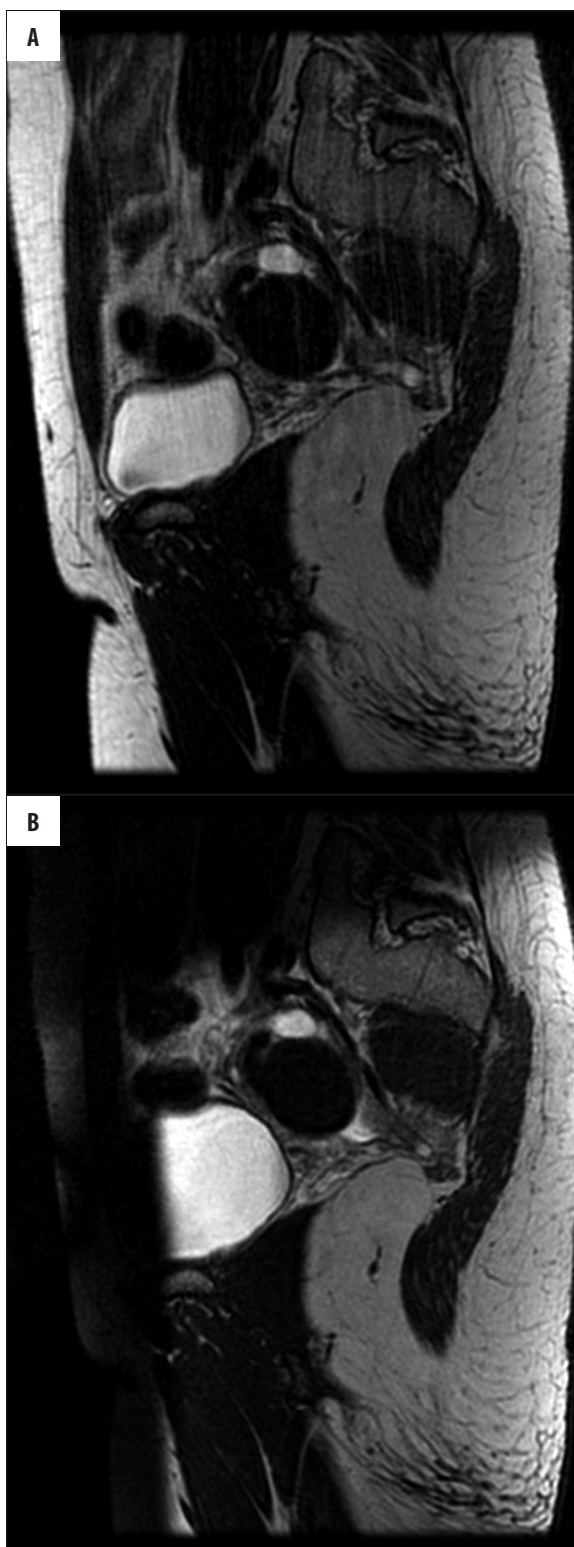
Figure 5. Motion artifacts caused by breathing (A). Saturation band (B) reduces the artifacts and improves image quality.

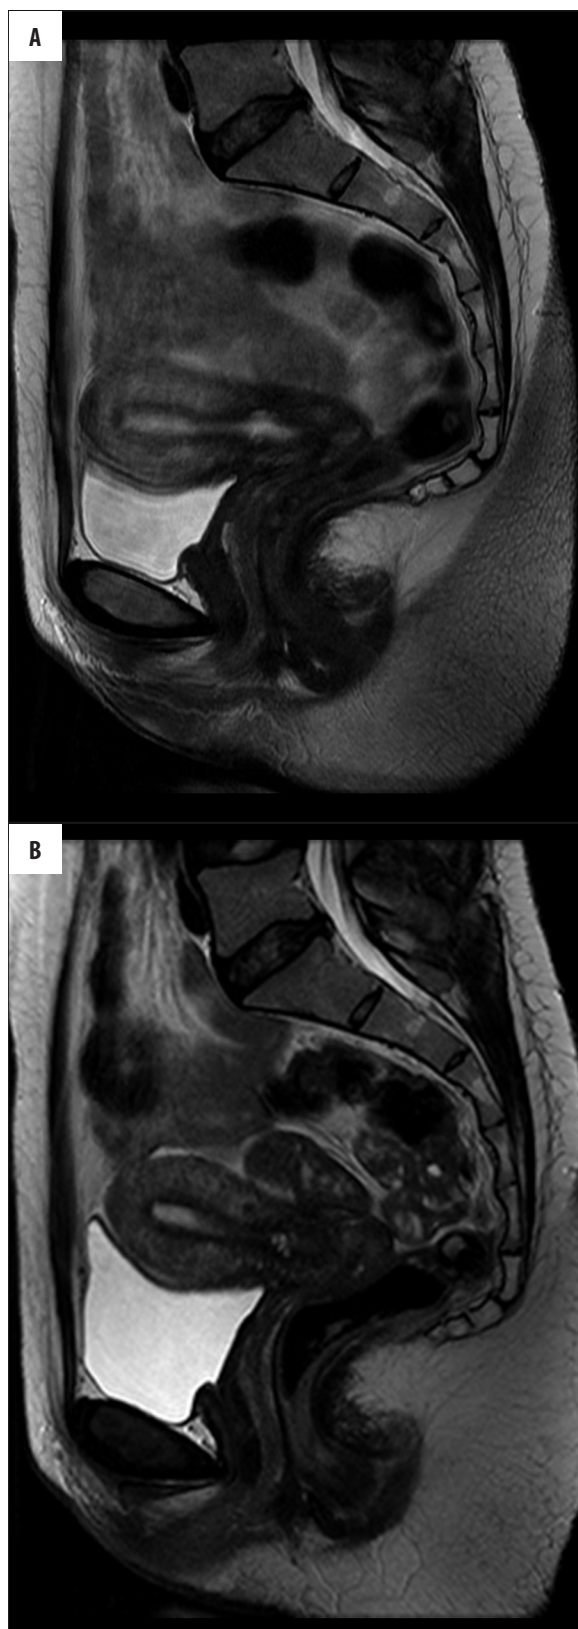
Figure 6. Motion artifacts caused by the peristalsis produce a blurry image of the uterus in pelvic MRI (A). Reduction of the artifacts after intramuscular or intravenous administration of buscolysin (B).

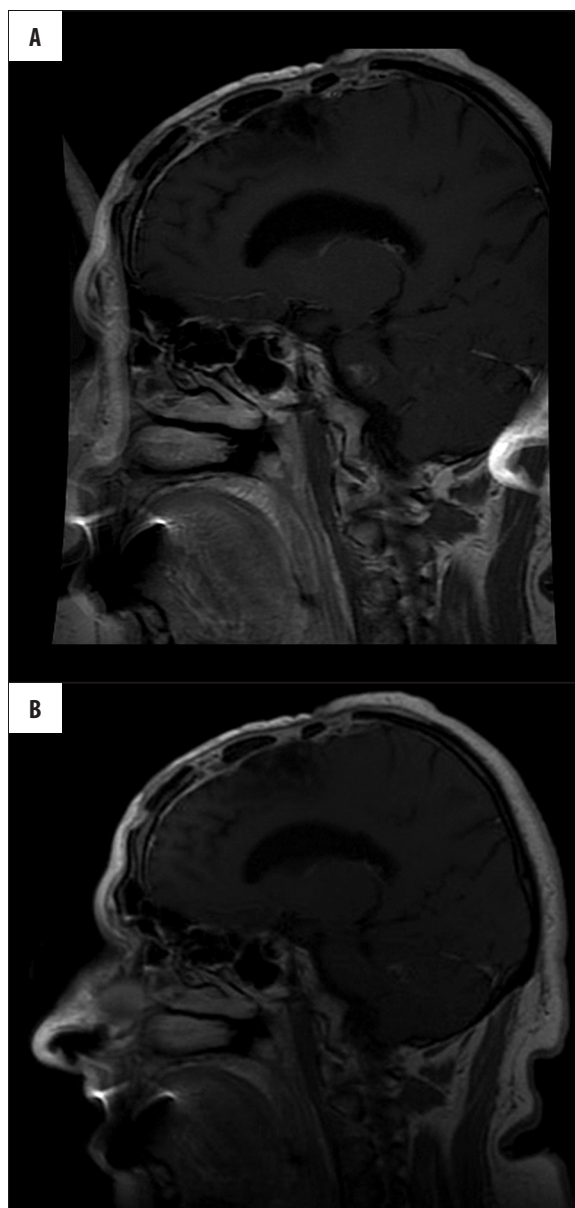
Figure 7. Aliasing artifact (“wrap around”) on brain MRI with FOV=24×18 cm (A). The same patient, examination with FOV=24×24 cm (B).

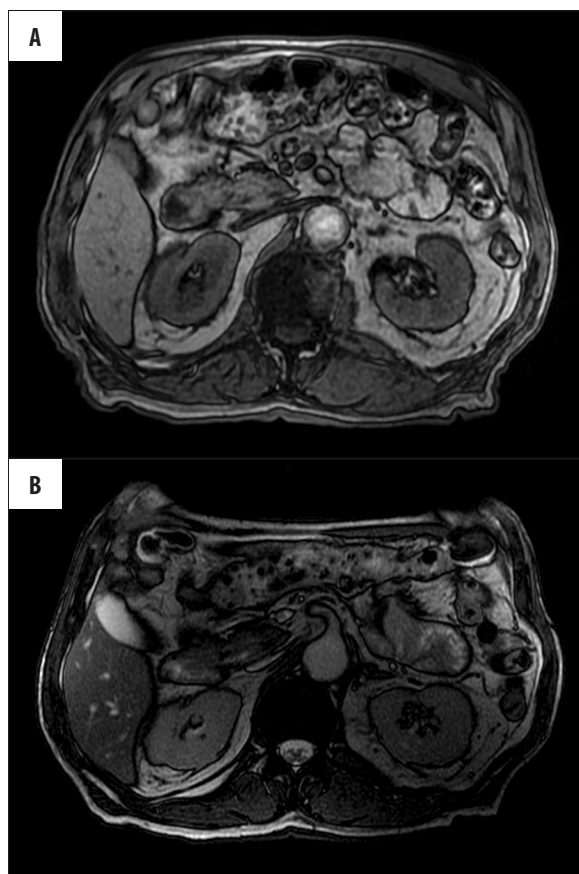
Figure 8. Examples of chemical shift artifacts in the out-of-phase image (A) and in FIESTA/2D sequence (B).

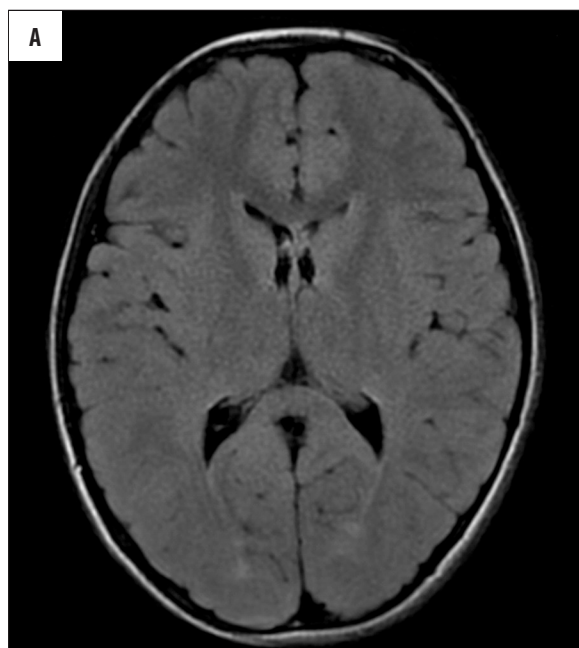
the patient's body in magnetic resonance imaging in order not to confuse them with pathological conditions. The authors presented a gallery of such images. All examinations were performed with use of GE Signa HDxt scanners with a magnetic field strength of 1.5 T.

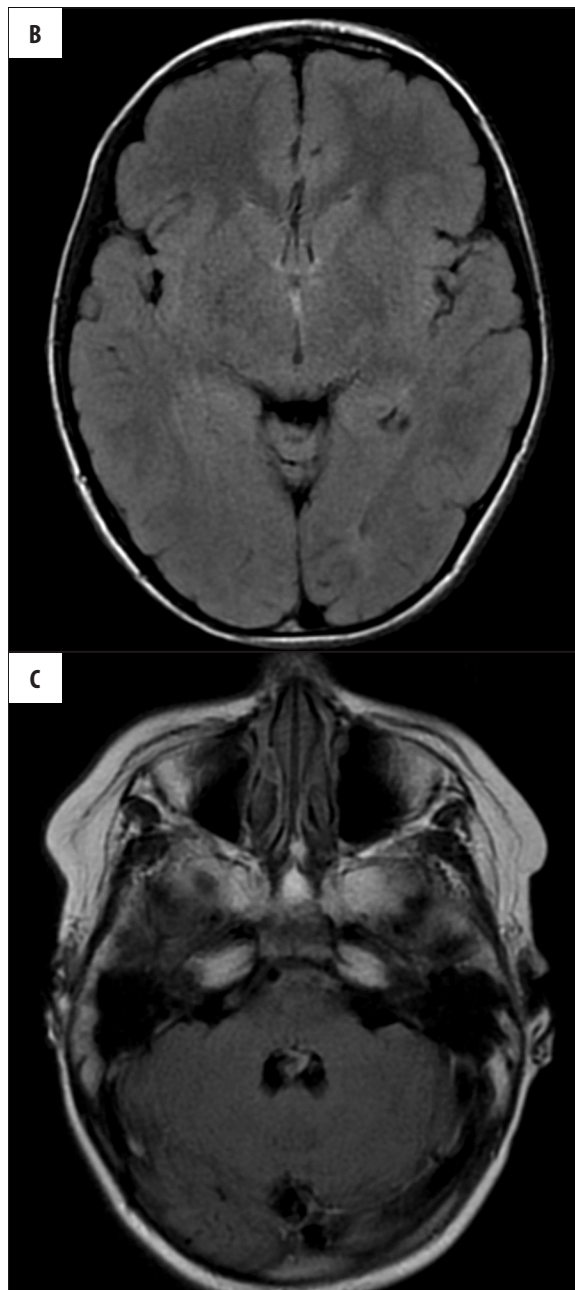
Figure 9. FLAIR-hyperintense signal in the frontal horns of the lateral ventricles (A), third ventricle (B) and in the fourth ventricle (C).

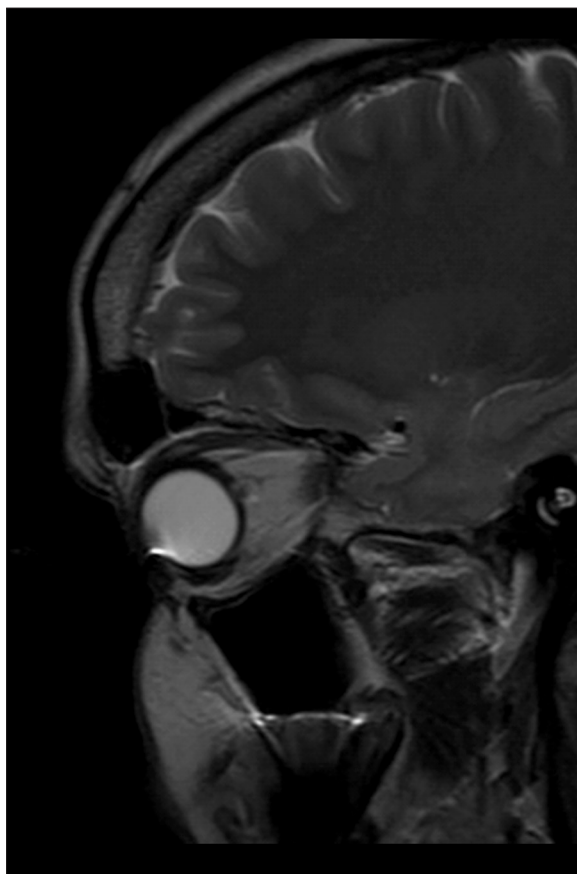
Figure 12. Artifacts in the eye ball region caused by the make-up. Artifacts caused by a dental implant in the maxillary sinus region are also seen.

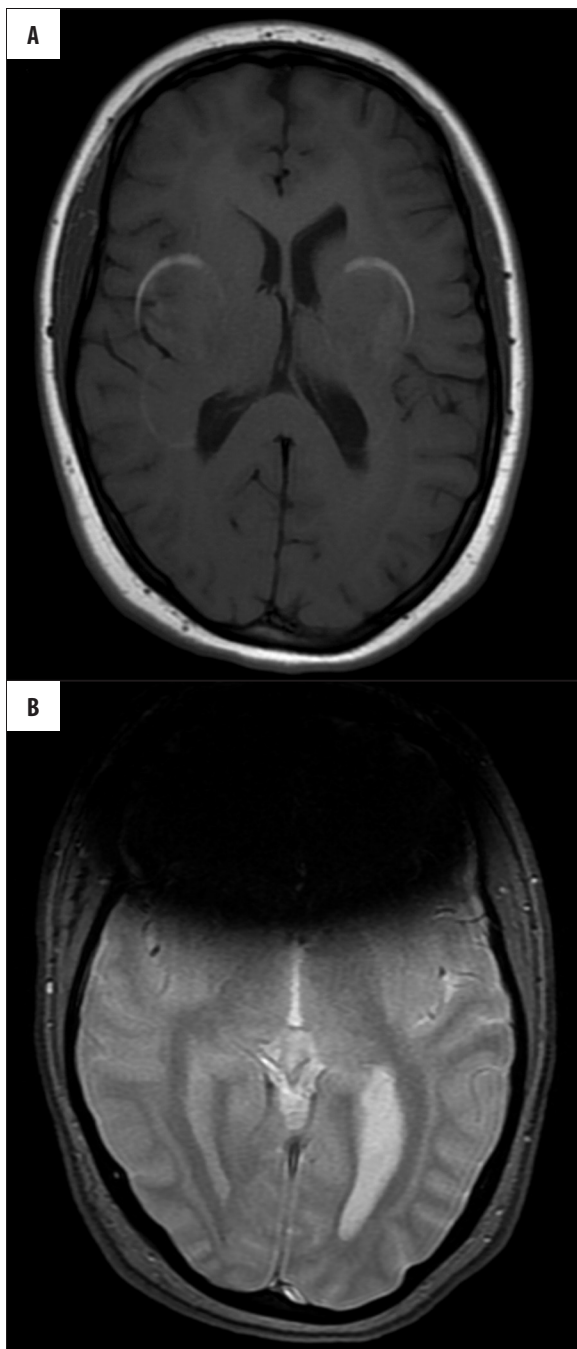
Figure 14A, B. Orthodontic braces. Typical T1-hyperintense artifacts (A). Loss of signal in GRE/T2*-weighted images (B) makes it impossible to see the anterior part of the brain in this patient with seizures but band heterotopia can be appreciated if the radiologist is familiar with this kind of neuronal migration defect.

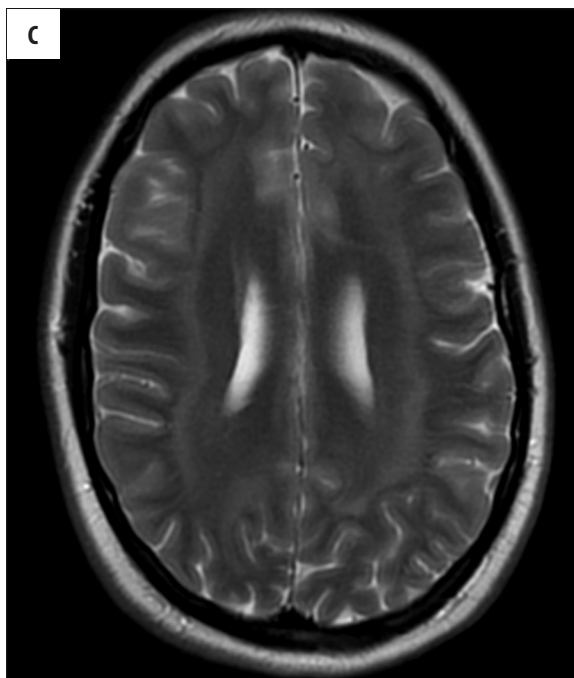
Figure 14C. Orthodontic braces. FSE/T2-sequence is less sensitive and band heterotopia can be diagnosed more easily.

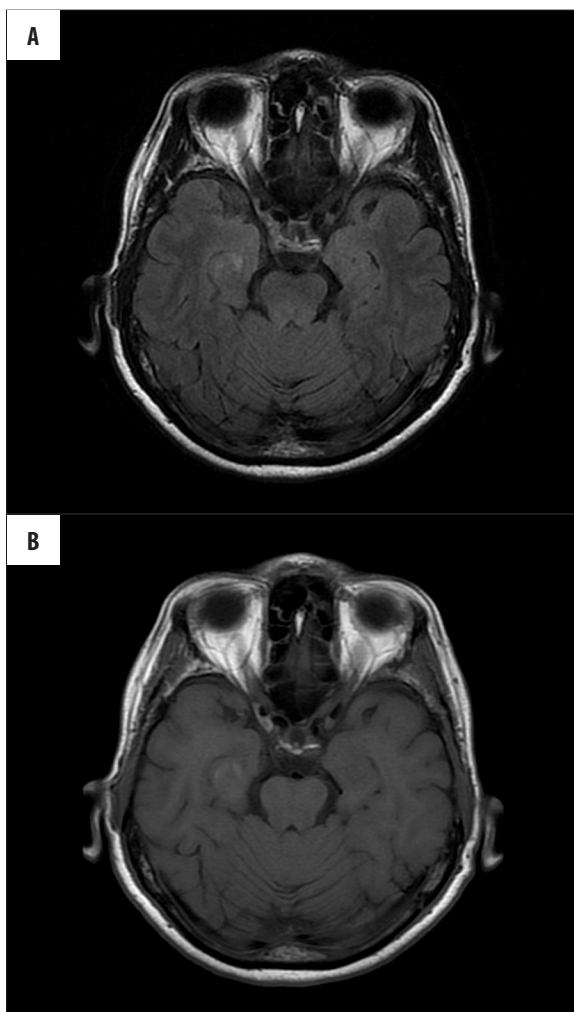
Figure 15. Artifact caused by a dental implant in the right temporal lobe can be easily misinterpreted as a focal lesion on FLAIR images (A) but its typical rounded hyperintense appearance on T1-weighted images (B) enables proper interpretation of this finding.

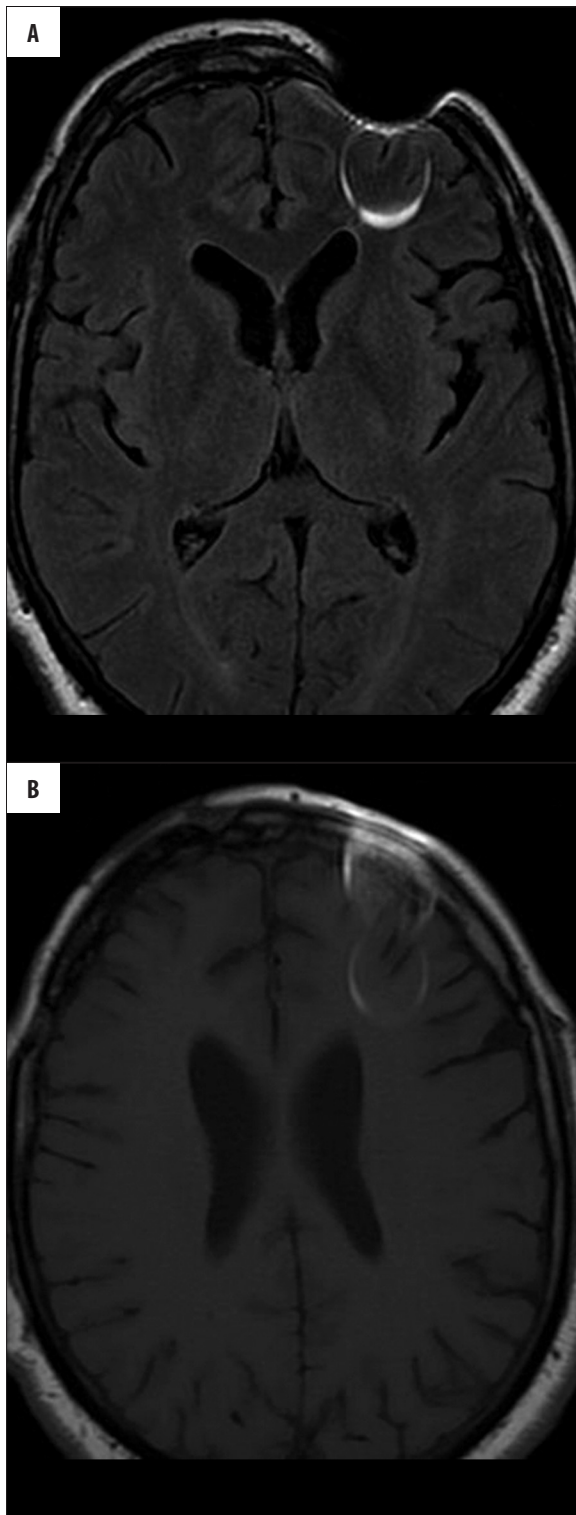
Figure 16. Artifacts produced by neurosurgical clips. FLAIR, ax (A), SE/T1, ax (B).

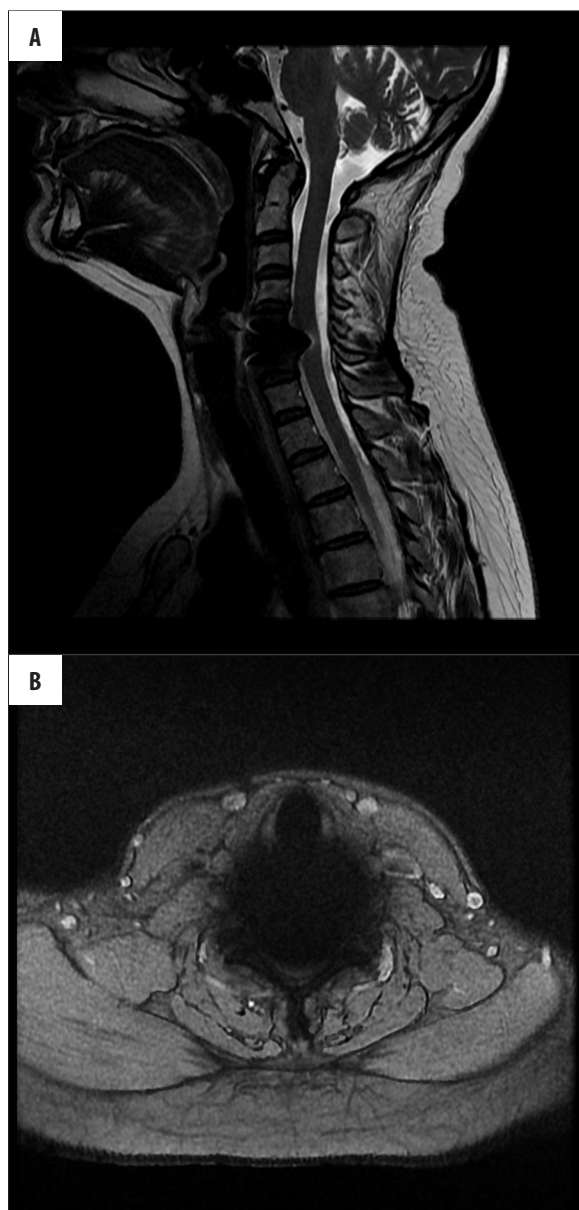
Figure 18. Artifacts caused by an intervertebral implant are less pronounced in FSE/T2-sequence (A) than in GRE sequence (MERGE/2D, T2, ax – B) at the operated level of C5/C6.

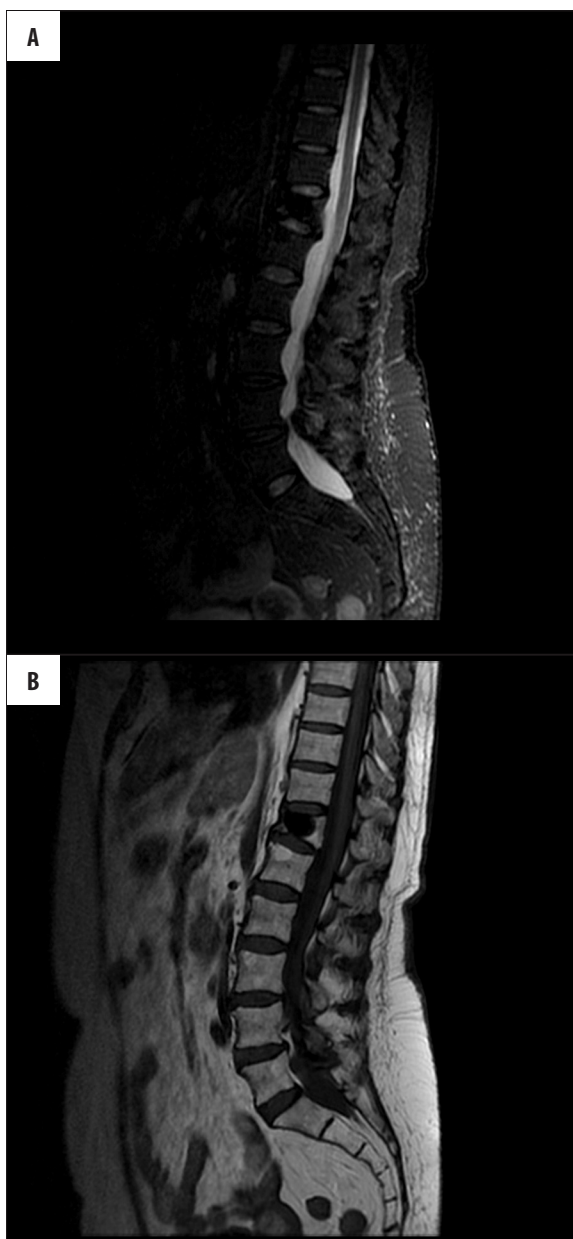
Figure 19. Vertebroplasty after Th12 fracture. STIR, sag (A), FSE/T1, sag (B).

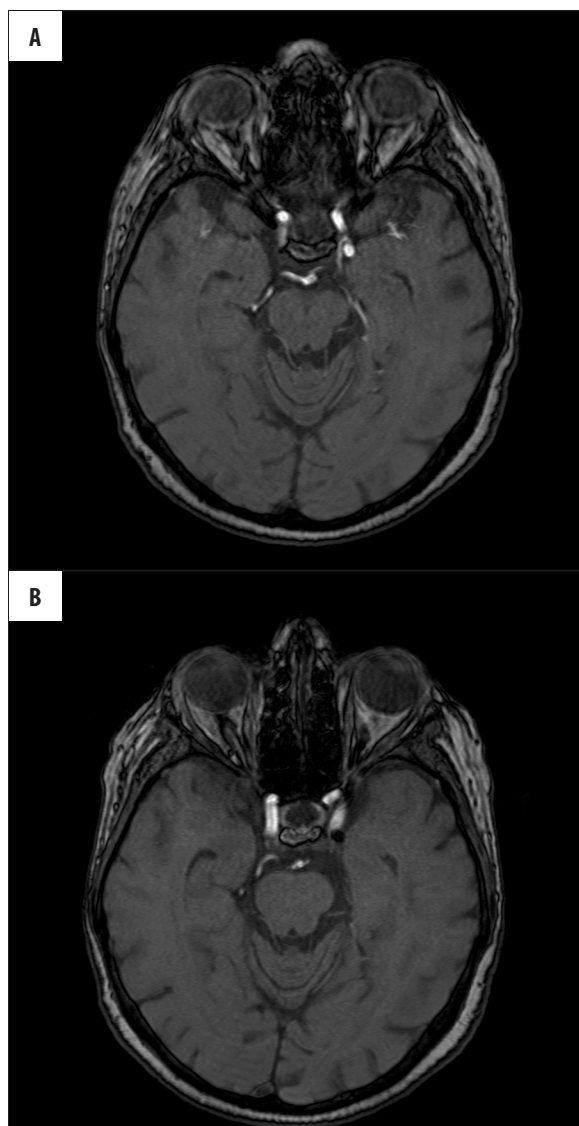
Figure 20. MR-angiography, raw data. Aneurysm at the bifurcation of the left ICA (A). "Black hole" in the treated aneurysm after embolization (B).

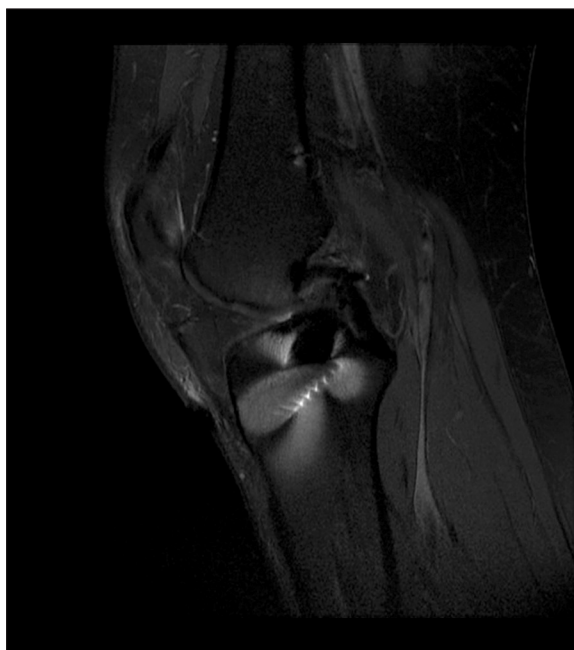
Figure 21. Excessive artifacts in the MRI (FSE, PD + fatsat) of the knee after the reconstruction of the anterior cruciate ligament with the use of stainless steel screws.

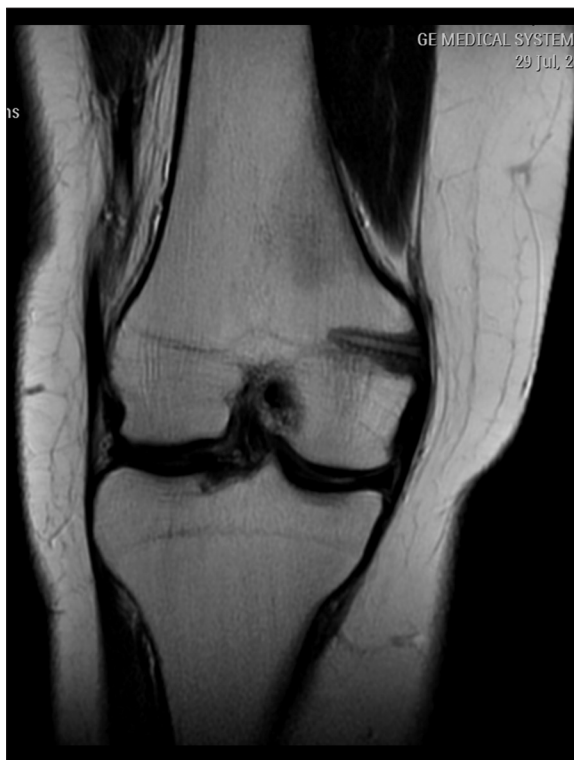
Figure 22. No artifacts in case of polymer biodegradable interference screws.

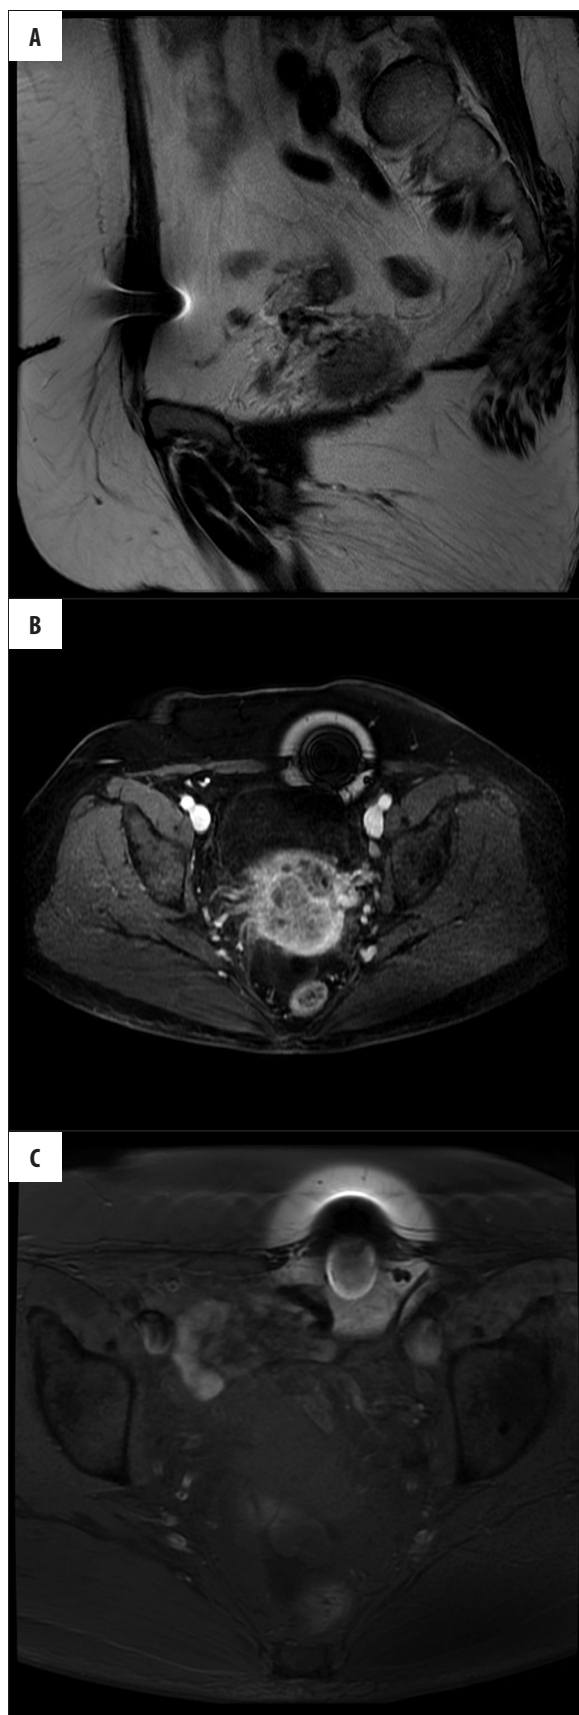
Figure 23. Metallic surgical clip in the abdominal wall, almost harmful in FSE/T2-weighted image in the sagittal plane (A) but disturbing the assessment of the uterus in that 44-year-old woman with cervical cancer (LAVA, post Gad, ax – B, FSE/T1+fatsat, ax – C).

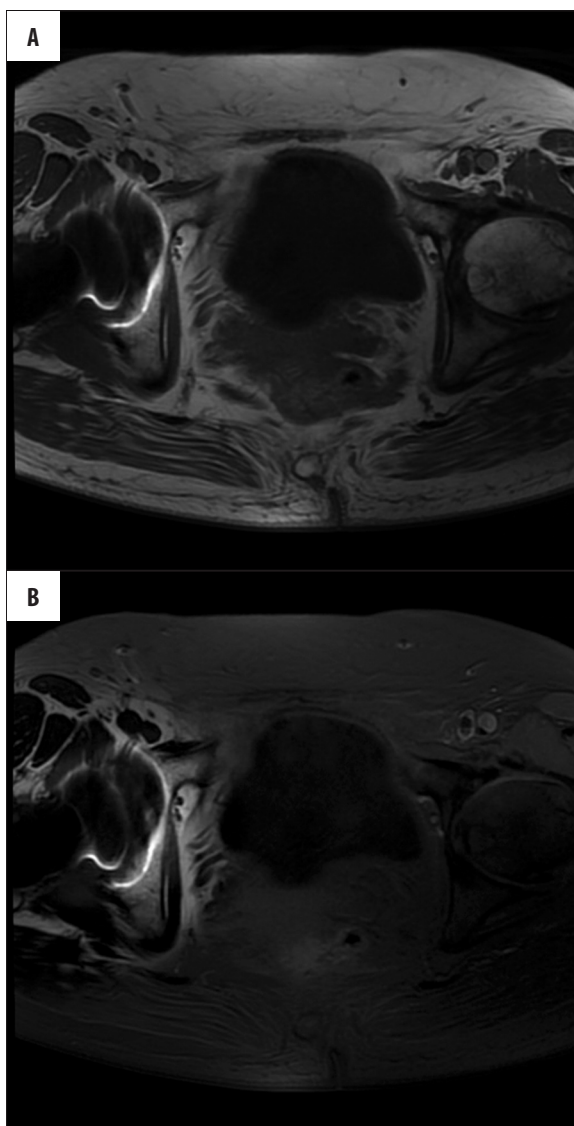
Figure 24. Right hip prosthesis. FSE/T1, ax (A), FSE/T1+fatsat, ax (B).

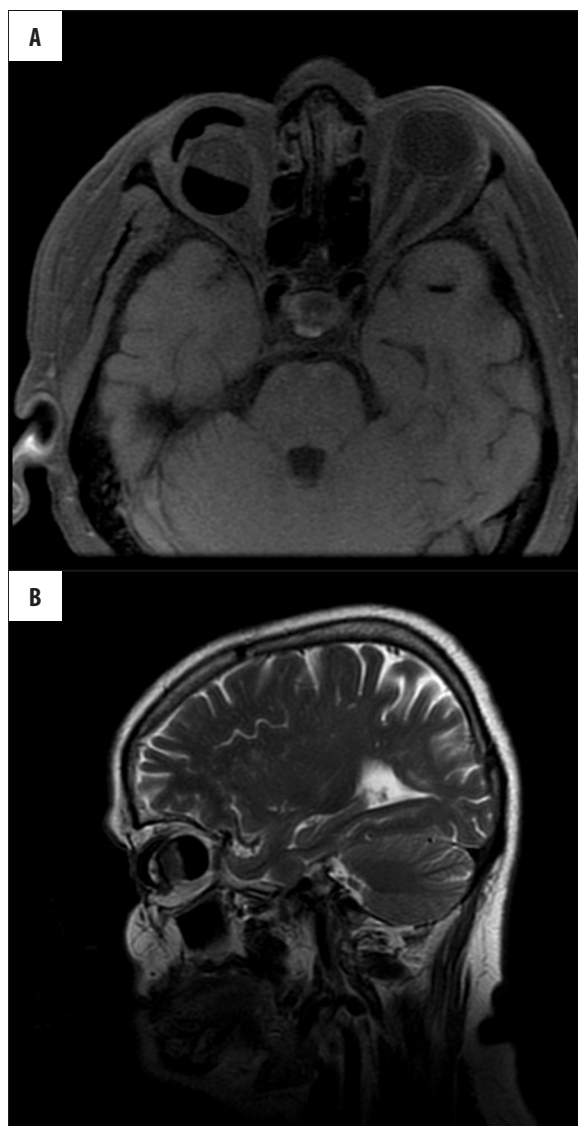
Figure 25. Patient with a history of enucleation due to melanoma. FSE/T1 + fatsat, ax (A), FSE/T2, sag (B).
