# Loss of right ventricular capture: When it is not the lead's fault

(Heart Rhythm Case Reports 2025;11:2–7)

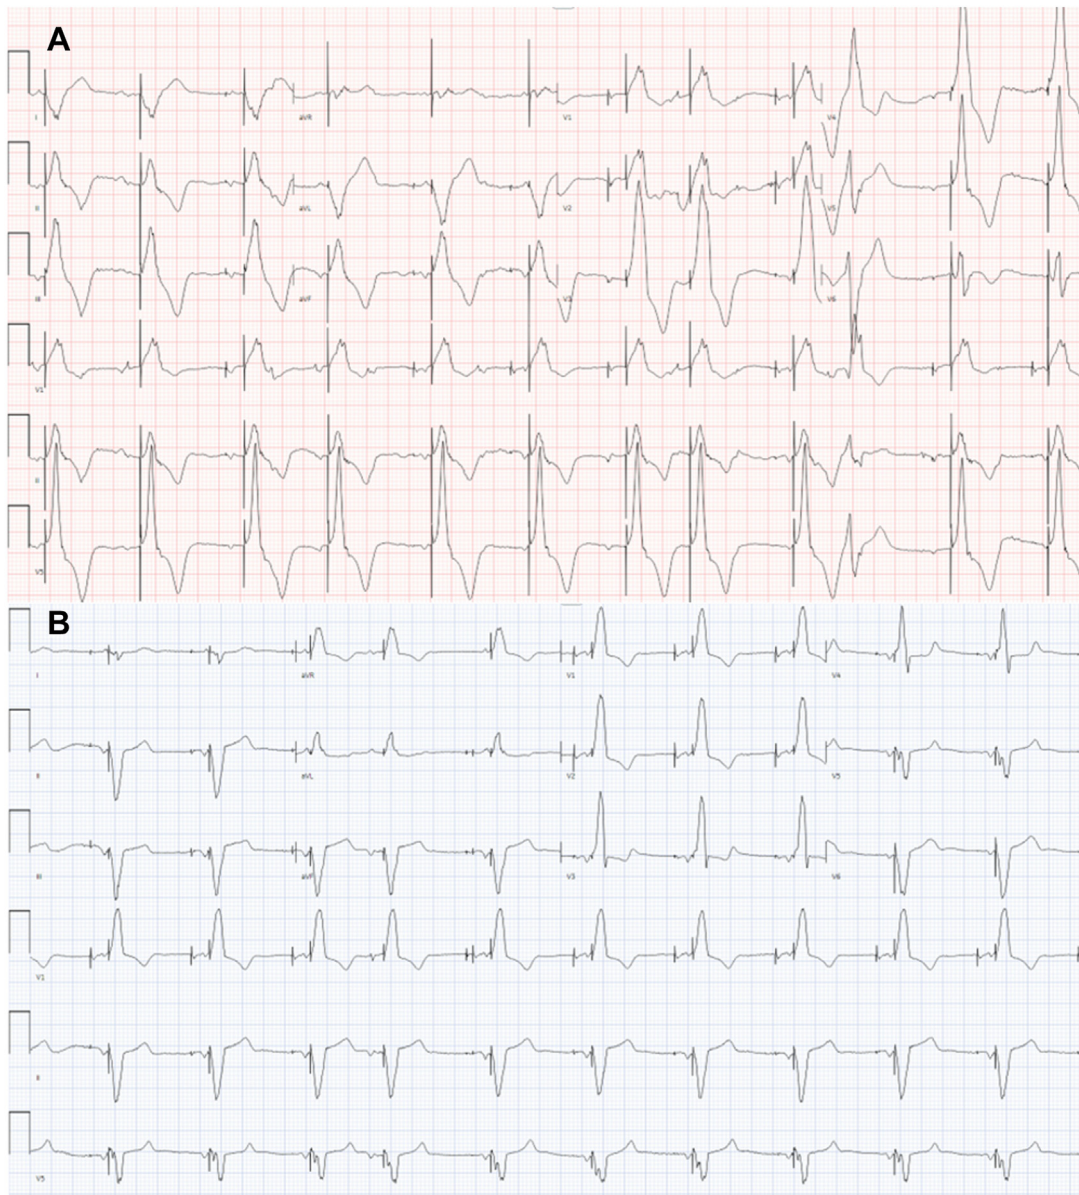
**Figure 1** A: Electrocardiogram (ECG) at presentation: an atrioventricular (AV) paced rhythm with premature atrial and ventricular complexes. QRS morphology is consistent with left ventricular (LV)-only pacing from the basal anterolateral LV. This is markedly different from (B), an ECG obtained after cardiac resynchronization therapy pacemaker implantation, which shows an AV paced rhythm with biventricular pacing.

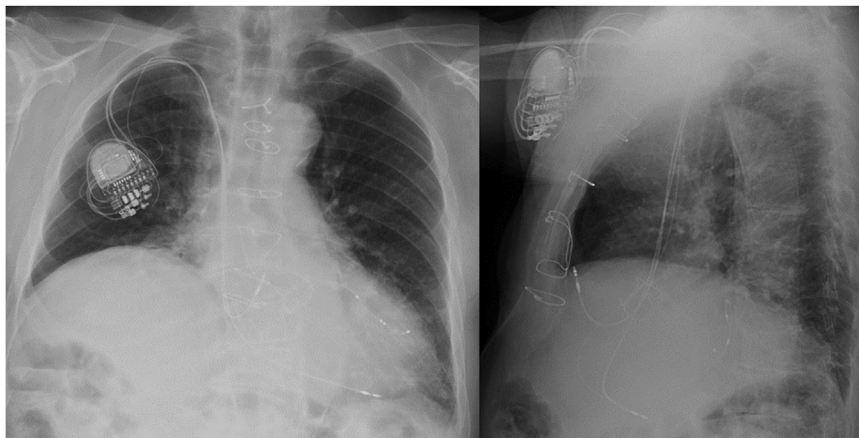
diagnosis of complete heart block, and she raised concerns about device malfunction. Vitals signs were normal and the patient appeared comfortable, without signs of venous congestion, lung crackles, or lower extremity edema. Laboratory evaluation was unremarkable, including an undetected troponin I level, normal thyroid levels, and normal electrolyte levels. His 12-lead electrocardiogram (ECG) showed an atrioventricular paced rhythm with premature atrial and ventricular complexes. The QRS morphology had changed significantly compared with a prior ECG, suggesting left ventricular (LV)-only pacing (Figure 1). A chest x-ray (CXR) showed a right-sided cardiac resynchronization therapy pacemaker with the coronary sinus lead in a basal anterolateral position, with no obvious lead fracture, lead dislodgement, or poor connection between the lead pin and the generator set screw (Figure 2).

**Figure 2** Posteroanterior and lateral chest x-ray showing right-sided cardiac resynchronization therapy pacemaker with leads terminating in the right atrial appendage, right ventricular apex, and anterolateral branch of the coronary sinus.

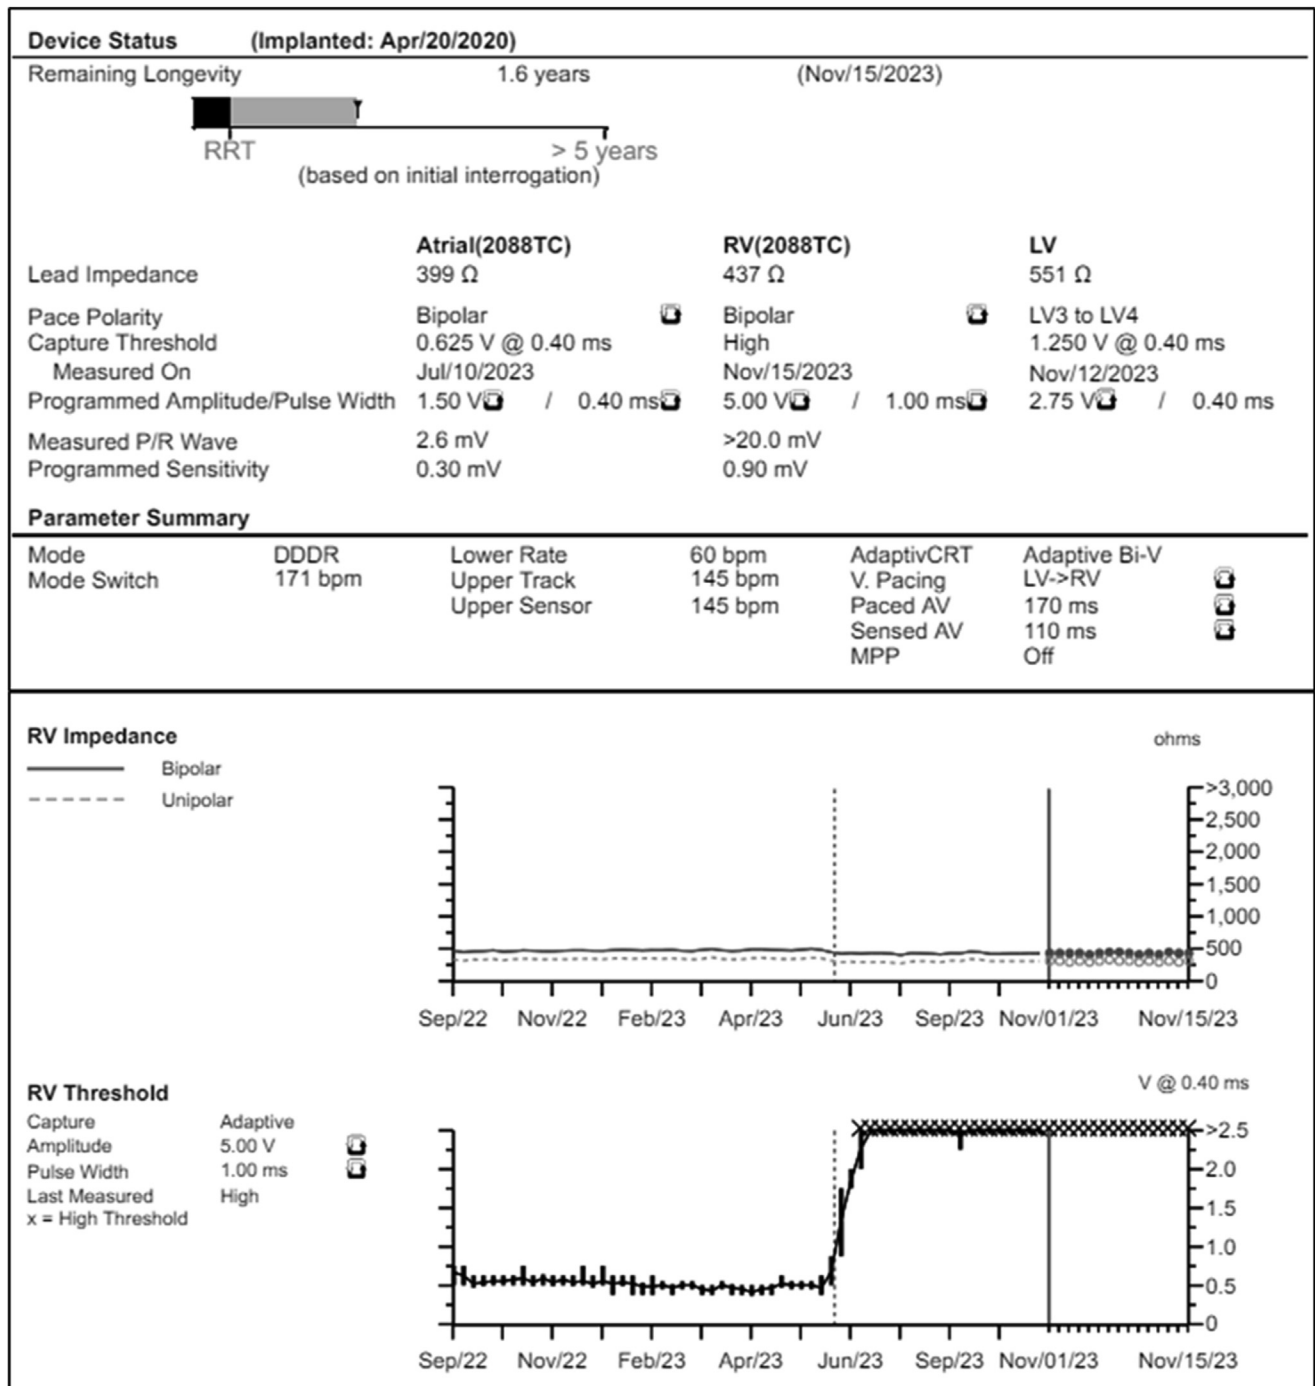
Bedside device interrogation revealed a subacute but rapid rise in device-measured RV pacing threshold, with stable lead impedance and no lead noise (Figure 3). Both unipolar and bipolar capture thresholds on the RV lead were confirmed to be elevated at 4.5 V at 1.5 milliseconds and 5 V at 1.5 milliseconds, respectively. LV lead diagnostics were stable, with a capture threshold of 1.25 V at 0.4 milliseconds with bipolar pacing from LV3 to LV4. AdaptiveCRT (Medtronic) was on with LV to RV and auto V-V Pace Delay. Ventricular capture management was disabled to prevent algorithm-related loss of LV capture and RV lead output was increased to 8 V at 1.2 milliseconds to restore biventricular pacing, with immediate improvement in the patient's symptoms. A computed tomography (CT) chest scan demonstrated a necrotic pericardial mass at the RV apex in close approximation to the lead tip (Figure 4). This mass was positron emission tomography (PET) avid on a subsequent PET CT scan, with additional concern for a potential tract of avidity between the lead and the mass. The patient underwent excisional biopsy of the mass, with a histopathologic

**Figure 3** Initial device interrogation showing rapid rise in the right ventricular (RV) lead threshold with stable lead impedances and sensing. Right atrial and left ventricular lead parameters remained stable from prior.

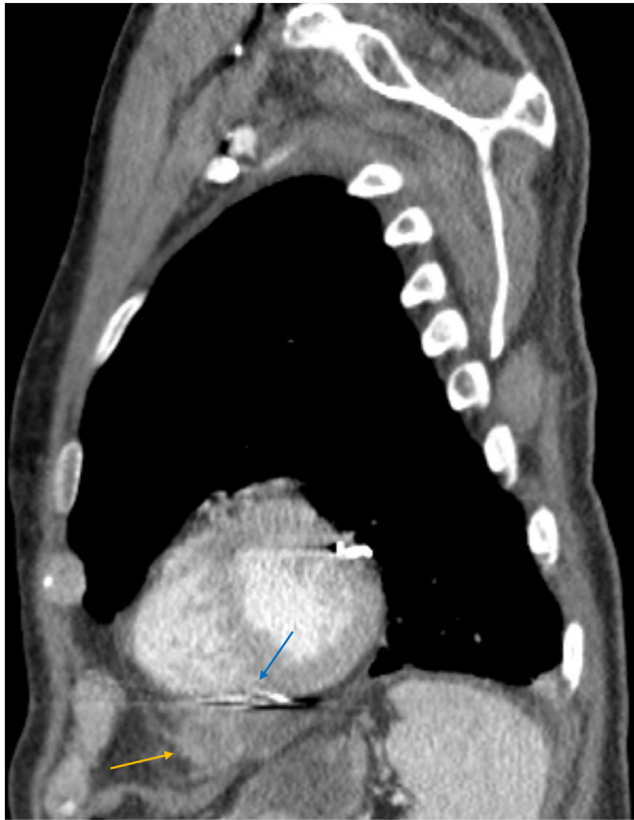
**Figure 4** Computed tomography chest scan shows a necrotic 4-cm pericardial mass (orange arrow) adjacent to the right ventricular lead tip (blue arrow).

diagnosis of fibrosis with a central region of inflammation and granulation tissue, consistent with an organizing abscess. Intraoperative cultures grew *Cutibacterium acnes* and *Staphylococcus epidermidis*. Device extraction was discussed with the patient due to concerns for lead-related infection, inadequate pacing safety margin, and substantial battery drain from high pacing outputs, but was deferred due to potential morbidity and patient preference. He received a course of

antibiotics, followed by ongoing suppressive antibiotics, but continued to have persistently elevated RV thresholds. A repeat PET CT scan 2 months after excisional biopsy demonstrated a residual fluid collection with enhancement at the operative site, thought to be most consistent with a postoperative seroma. A few months later, he was found to have complete dislodgment of the RV lead and underwent successful extraction and reimplantation of the RV lead.
