Case Report

Restoration: Implant with Devastated Platform through Metal Post

Central University of Ecuador Dental School, Quito, Ecuador

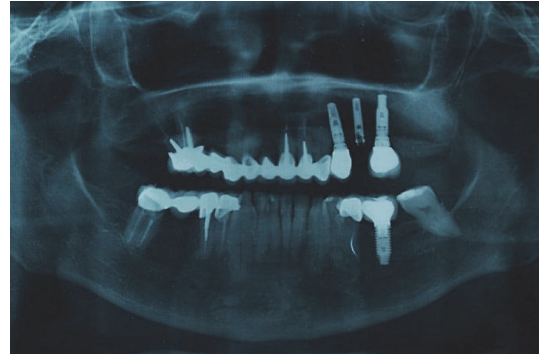
A 66-year-old female patient who takes bisphosphonates for osteopenia presented at the dental practice in the Postgraduate School of Oral Rehabilitation, Central University of Ecuador, with fracture of the implant prosthetic screw and damaged hex platform (Figure 1).

FIGURE 1: Panoramic radiograph. Implant (2.5) with fracture screw and hex devastated platform.

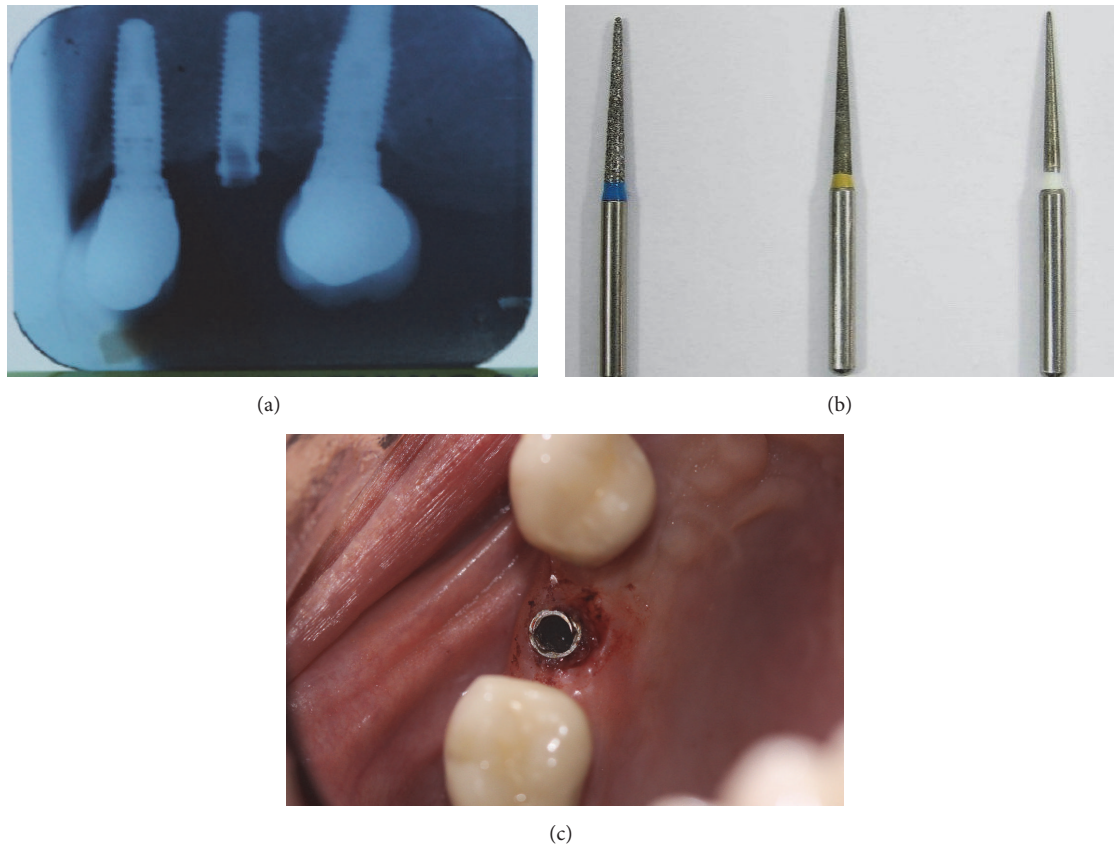
FIGURE 2: Removal of fracture fragment: (a) radiograph; (b) fissure bur was used to remove the fractured screw; (c) occlusal view.

The first step was to attempt extraction of the fragment, beginning with the most conservative and simple method, through dental explorer, without success. Therefore, the fragment was destroyed with a fissure bur, touching the internal threads of the implant, as seen radiographically (Figure 2).

It has been proposed to wear down or attempt to make a notch in the head fragment of the broken screw with a round bur at high speed, depending on the location of the prosthetic screw. In the case reported it was not possible to extract the fragment because it was below the implant head so it was ground down with a bur. The risk of puncturing the implant and bone was controlled radiographically. After achieving the objective, a metal and porcelain post and crown were made.

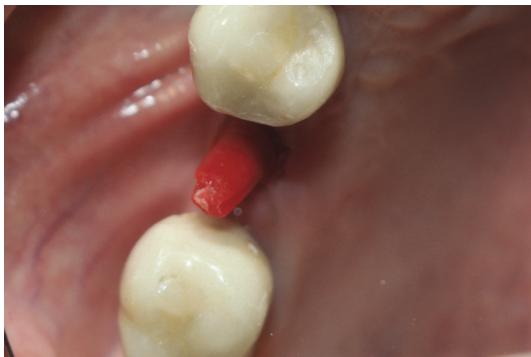
FIGURE 3: DuraLay post.

The gum around the implant platform was cut minimally and an acrylic resin impression made of the inside of the implant (DuraLay, Reliance Dental Mfg. Keliance) (Figure 3).

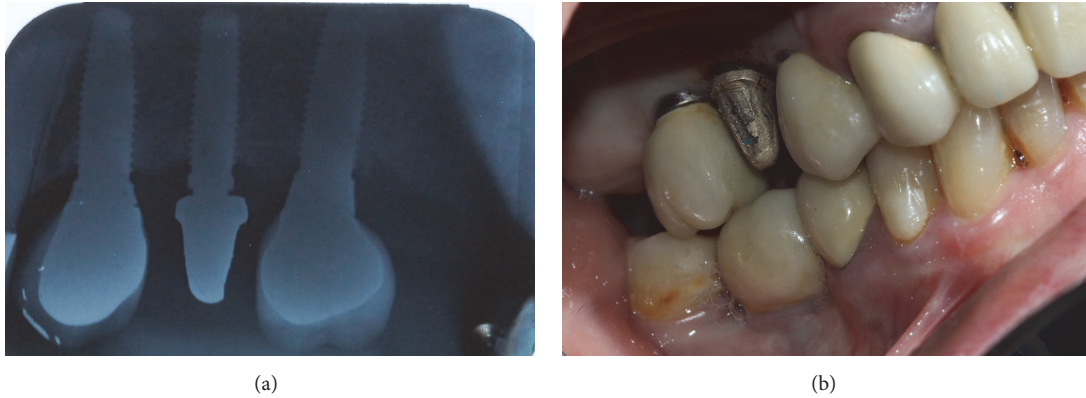
FIGURE 4: Sealing and adaptation were made: (a) radiographic control and (b) disclosing wax verifications.

Once the post cast bolt (gold-palladium) was made and its adaptation with wax (Wax Disclosing Kerr) checked radiographically (Figure 4), it was cemented with the following protocol (Figure 5):

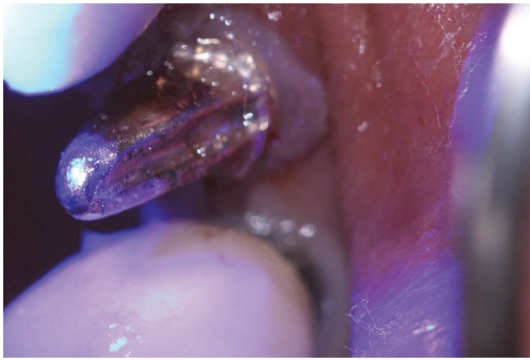
FIGURE 5: Post cement.

- (a) The inside of the implant was cleaned, washed, and dried
- (b) Hydrofluoric acid gel at 9.6% (EUFAR Laboratories S.A.) was applied to the post for 60 seconds, then washed, and dried
- (c) Luting cement (DTK-Klever Bredent, DE) was mixed and placed both on the post and inside the implant
- (d) The post was photopolymerized with ultraviolet light (350 to 500 Nm) for 3 minutes
- (e) Excess cement was removed

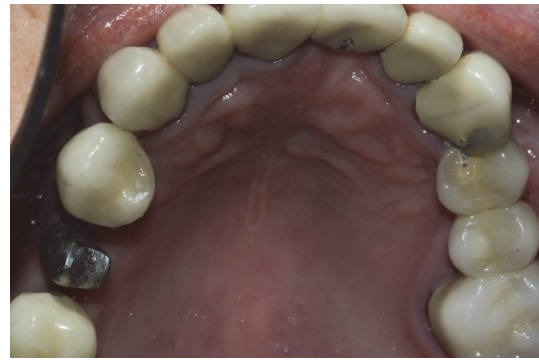
FIGURE 7: Framework sealing and adaptation of metal crown.

Once the post cemented, cord (Ultradent Ultrapak of two ESPA 00) is placed, printing was performed with heavy and light polyvinyl siloxane (Elite HD + from Zhermack IT) (Figure 6), and metal framework developed (silver-palladium) (Figure 7), by wax (wax Disclosing Kerr) adaptation, and sealing was made.

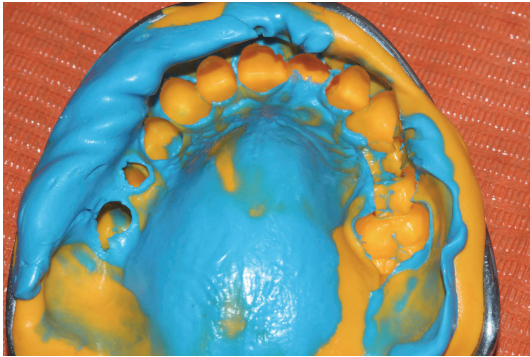
FIGURE 6: Dental impression.

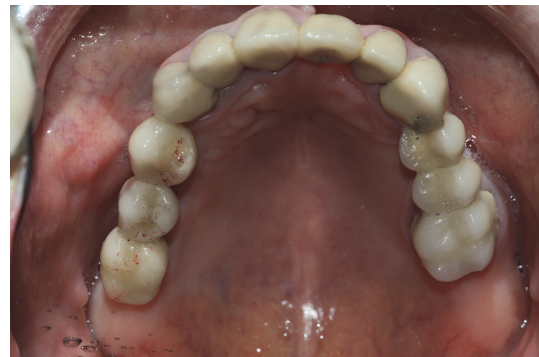
FIGURE 8: Crown cement and occlusal adjustment.

Finally the prosthetic crown is cemented, after occlusal control, which was allowed to be below 12 micrometers' occlusion (Figure 8) and the patient received information about oral hygiene. After one year of treatment, clinical and radiographic monitoring is performed (Figure 9).

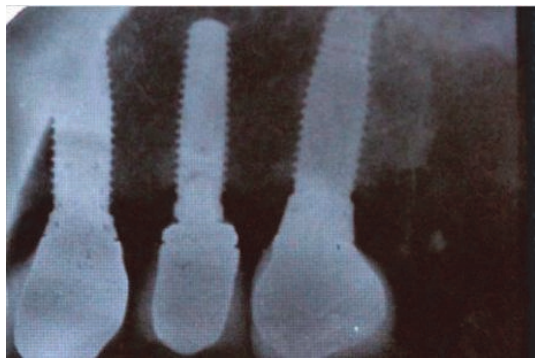
FIGURE 9: Intraoral radiograph at the 1-year follow-up.

Finally, in a monitoring appointment after one year of treatment the patient reported no discomfort. Normality was clinically and radiographically checked.
