IMAGES IN STRUCTURAL HEART DISEASE

Percutaneous Management of Acquired Right Ventricular Outflow Tract Obstruction due to Giant Coronary Vein Graft Aneurysm

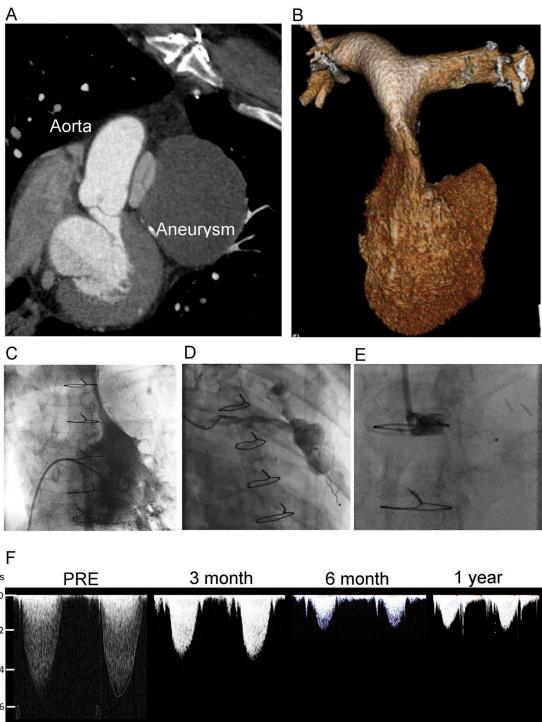
Figure 1. Acquired right ventricular outflow tract (RVOT) obstruction due to coronary graft aneurysm treated by percutaneous graft occlusion. (A) 2D multidetector computed tomography (MDCT) showing compression of the pulmonary valve between the graft aneurysm and the native aorta. (B) 3D MDCT reconstruction of the RV and pulmonary arteries showing the slit-like appearance of the main pulmonary artery. (C) Right ventriculography shows a minimum dimension of 2.2 mm, with an invasive pressure of 83 mmHg. (D) Graft angiography demonstrates the large aneurysm and feeding vessel. (E) An 8-mm AVPII device was used to occlude the graft with the expectation that thrombus would form and ultimately resorb. (F) Serial non-invasive Doppler assessments of the RVOT velocity show progressive and then stable reduction from 5.1 m/s at presentation to 1.7 m/s in follow up. RV dimensions, and hypertrophy normalize over this period. The patient was well and able to return to work at 6 months.

A 56-year-old fireman previously revascularized by coronary artery bypass presented unable to work 9 years following index surgery. Investigations revealed extrinsic compression of the right ventricular outflow tract between a coronary vein graft aneurysm and the ascending aorta (Figure 1A,B). Invasive systolic right ventricular pressure was elevated (83 mmHg peak pressure), with dynamic outflow tract obstruction (Figure 1C, Supplemental Video 1). Following heart team discussion in the absence of distal run off from the graft aneurysm the patient was offered transcatheter closure of the feeding vessel. The vein graft was cannulated with a JR4 catheter, sized (Figure 1D), and an 0.035" Terumo wire used to advance distally to position an Amplatzer superstiff wire in the aneurysm. A 5F Amplatzer Torquevue 2 delivery system was used to deploy an 8 mm AVPII device within the proximal part of the vein graft. Non-invasive follow-up over the next 12 months showed resolution of acquired RVOT obstruction. The patient returned to work at 6 months
