Breast phantom with silicone implant for evaluation in conventional mammography

Key words: breast phantom, silicone prostheses, mammography, quality assurance

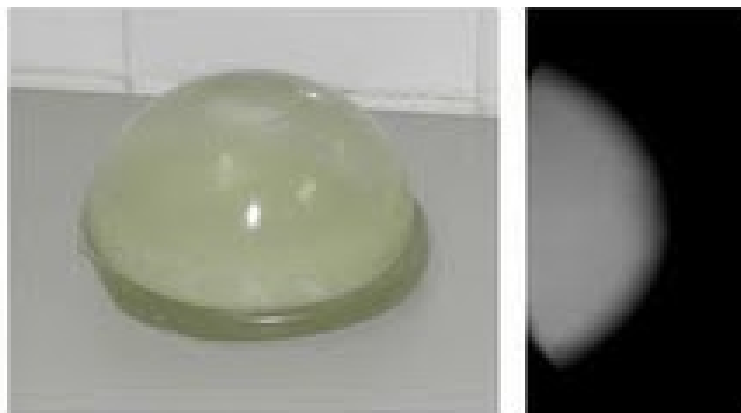
Figure 1, on the left, shows an image of the phantom which only contained the base material, and on the right, a mammogram obtained from this phantom. The mammographic image presents an optical background density of 1.46 OD.

Fig. 1. The sample with base material and its mammographic image.

For determination of the appropriate optical density, the sample which only contained the base material was exposed to a fixed value of 25 kVp and a range of 40 mAs to 200 mAs, which was the range determined by the thickness and density of the sample and clinically feasibility. Table 1 shows the optical density values obtained from the images of the phantoms with and without silicone implants by each technique selected.

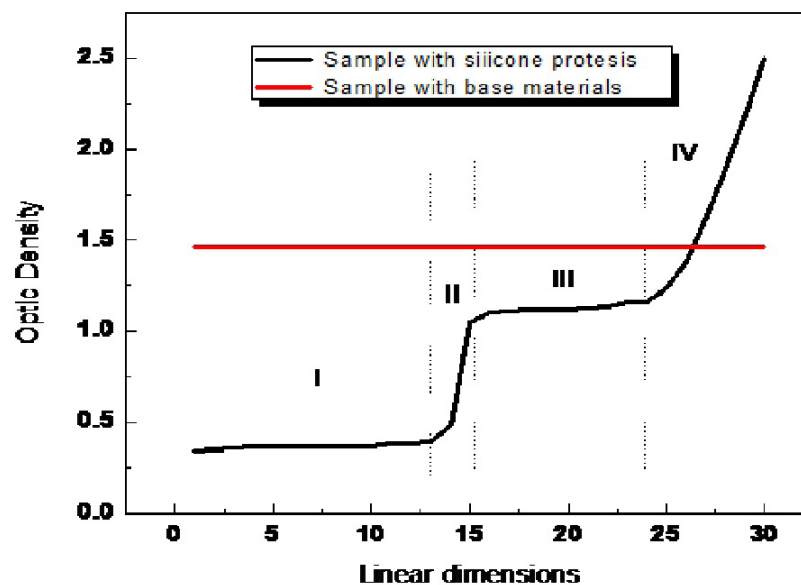
Figure 2 shows the behavior of optical density as a linear fit from the image corresponding to the sample that only contained the base material and which simulated breast tissue, and from the image corresponding to the sample in which the prosthesis was inserted into the base material. Differences in optical densities caused by X-ray beam interactions in the sample containing the prosthesis can be explained by describing the four regions observed in this mammogram. The first region (region I) is the region which corresponds to a sharp reduction in optical density due to the material of the implant. A transition region can be observed between the prosthesis and the material that simulated the breast tissue (region II). In the third region (region III), a gradient of optical density was found between the prosthesis and the outer limits of the base material. In this band the optical density was reduced from 1.45 to 1.12 on average, a reduction of 23% in the power of breast tissue visualization. In the last region (region IV), the darkest part of the film is observed on the direct exposition. In Fig. 3 we can see the intense brightness caused by the interaction of radiation on the silicone breast implant.

FIG. 2. Behavior in terms of optical density measured in sample with silicone prosthesis and sample with base material alone.

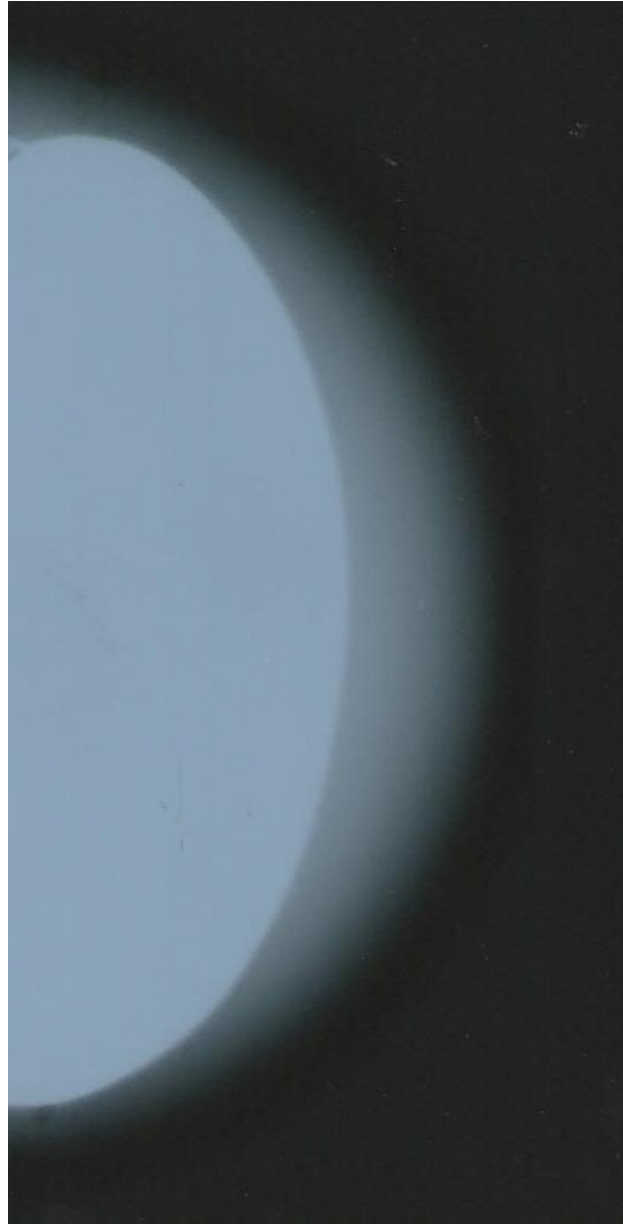
FIG. 3. Image of the phantom containing only the base material and the silicone breast implant.

Figure 5 shows the fourth phantom image containing both the prosthesis and the artifacts which simulated the main mammographic findings. The display of the test structures suffered a loss in sharpness because of the scattering of radiation within the prosthesis. Compared to Fig. 3, the number of artifacts that could be seen were reduced; only two sets of microcalcifications (detail 1), four tumor-like masses (detail 2), and two fibers (detail 3).

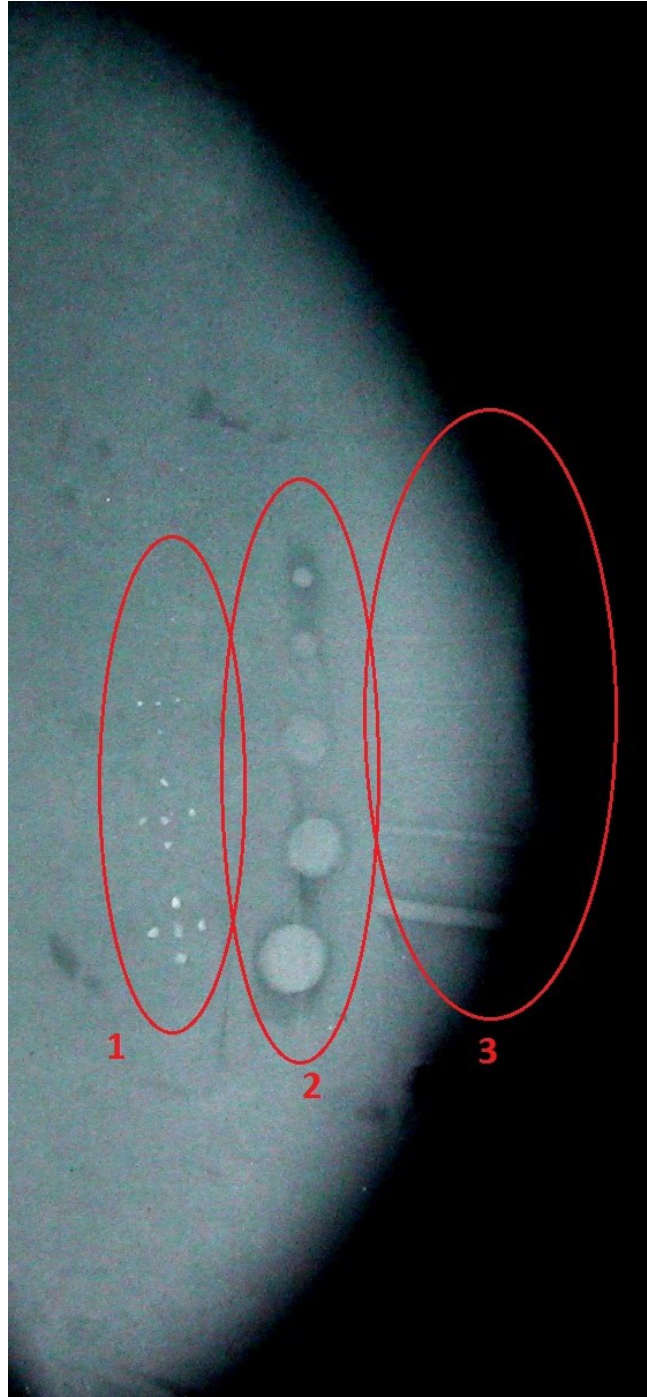
An image of the phantom sample containing the artifacts can be seen in Fig. 4. These artifacts were used to simulate the main mammographic findings and include: four sets of microcalcifications, five tumor-like masses and five fibers. However, it was only possible to visualize three sets of microcalcifications (detail 1), five tumor masses (detail 2), and four fibers (detail 3) in the image of this phantom sample.

FIG. 4. Image of the base material containing inserted artifacts: microcalcifications (detail 1), tumor masses (detail 2) and fibers (detail 3).

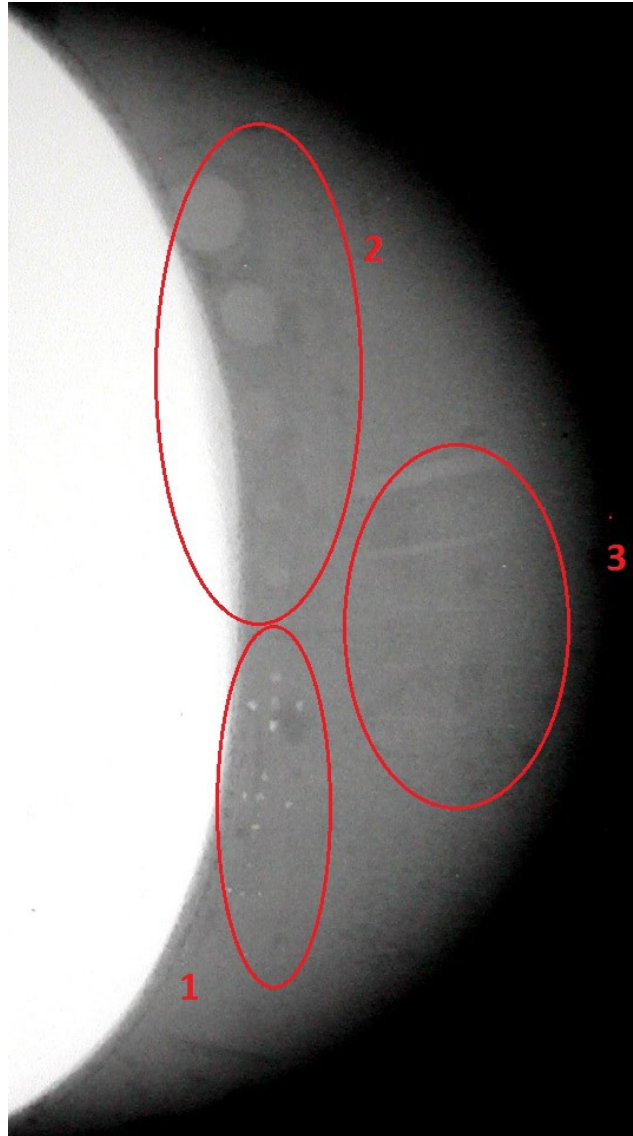
FIG. 5. Image of the proposed phantom containing the silicone implant and the inserted artifacts: microcalcifications (detail 1), tumor masses (detail 2) and fibers (detail 3).

It can be seen by analyzing the images just how much the prosthetic material reduced the view of the base material which simulated the breast tissue. A reduction of almost 30% was observed due to scatter, which created a gradient of brightness from the area adjacent to the prosthesis to the outer limits of the base material. However, even with the loss of sharpness due to the prosthesis, it was possible to observe most of the artifacts, thus illustrating how effective this simulator was for this particular application.
