Rolling resistance of casters increases significantly after two years of simulated use

Journal of Rehabilitation and Assistive Technologies Engineering
Volume 8: 1–9
© The Author(s) 2021
Article reuse guidelines:
sagepub.com/journals-permissions
DOI: 10.1177/20556683211025149
journals.sagepub.com/home/jrt

Abstract

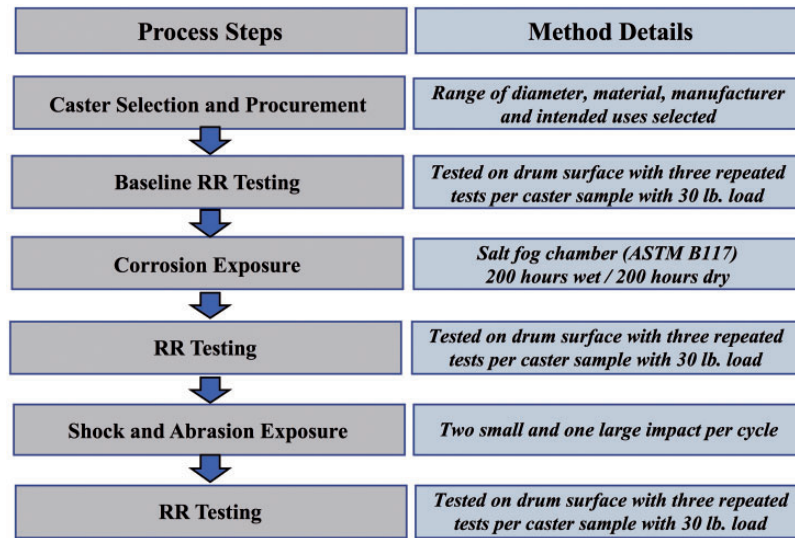
Figure 1. Flowchart of environmental exposure and testing.

The process for conducting the study is outlined in Figure 1.

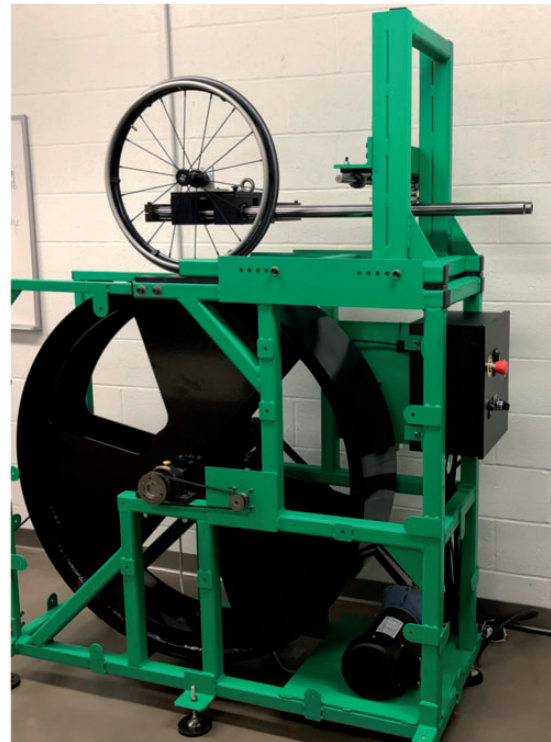
Figure 2. Drum based RR test equipment.⁹

Casters were tested with a 30lb. force load, representing the midpoint of typical caster loading of 20 to 40 lbs.^{8,22} The drum surface, simulating a solid propulsion surface, was used throughout all testing at a speed of 1 m/s. Previous testing at multiple speeds showed no change in RR forces, and 1 m/s is representative of

manual propel speed.⁹ Each test condition was repeated three times for each caster, and results were averaged. Due to limited caster availability and the extended time required for shock and abrasion testing, only 1 sample of each model was tested. Previous studies on multiple samples have shown similar failure outcomes.²² RR testing equipment shown in Figures 2 and 3 illustrates the equipment set up for casters.

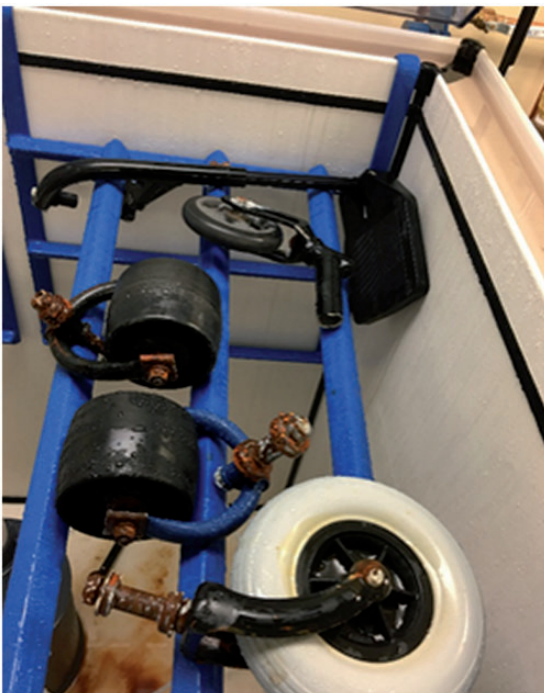
Figure 4. Salt fog test equipment for corrosion exposure.²¹

The standard protocol subjects casters to corrosion and durability testing. Accelerated corrosion testing was conducted in a salt fog chamber with exposure time of 200 hours of wet salt spray and 200 hours of dry cycle, shown in Figure 4. An evidence-based approach was employed to design the caster durability testing method. Community data on road shocks, corrosion, abrasion and caster failures informed the development of the laboratory-based testing method. Accelerations due to road shocks were translated to durability test equipment with appropriate slat height.²¹ Number of road shocks observed during the testing were extrapolated to two years of shock exposure since majority of casters fail within 2 years. Testing caster models with a combination of shocks, abrasion and corrosion reproduced real world caster failures.²¹ For example, corrosion affected the rolling of bearings. With abrasion, worn-out tire tread and tire cracking failures were observed.

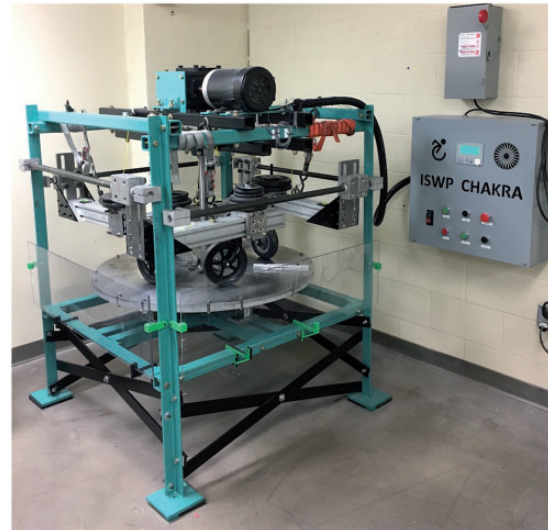
Figure 5. Shock and abrasion testing equipment.²¹

Durability test cycles are outlined in Table 1, with 90% forward and 10% reverse turntable rotations utilized for all caster testing. Durability testing as per the standard includes exposure to shocks and abrasion and is simulated on testing equipment shown in Figure 5.

A 36-grit sandpaper was fastened to the turntable. The speed of the caster on the turntable was 1 m/s. Up to four castors of similar size were tested at one time, and the castors were loaded with 30 pounds of weight. Caster wear was observed in a less-resourced setting and used as a standard to determine the grit of sandpaper best replicating wear to represent one year of use.²¹ The standard simulates around two years of

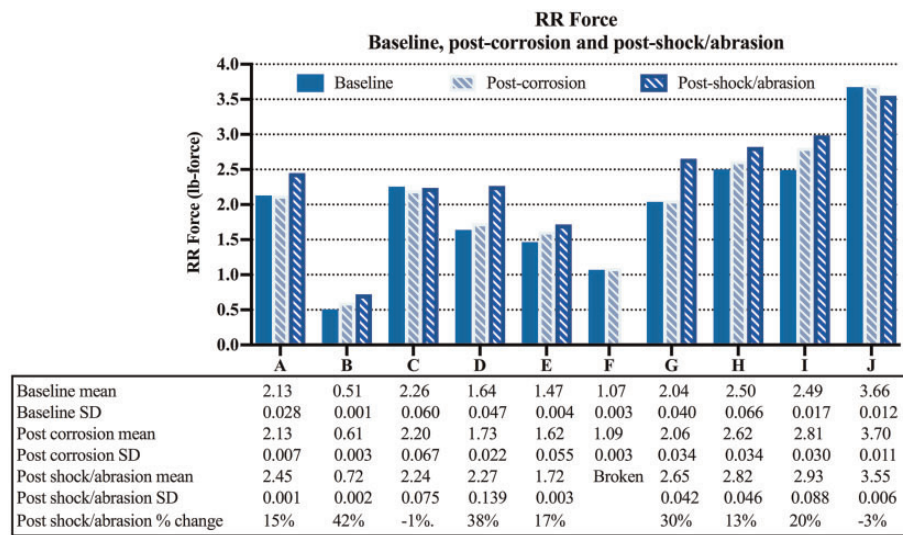
Figure 7. RR forces at baseline, post corrosion exposure, and post shock/abrasion exposure (mean of three trials) including mean and standard deviation (SD). The percentage change is between baseline and post shock and abrasion exposure.

to a stem bolt fracture. This left nine casters available for caster standard testing. Metal on several of the casters was visibly corroded after corrosion exposure, and caster tread surfaces were visibly abraded and dusty after the shock and abrasion testing, which is consistent with the observed outcomes from previous tests.^{19,22} RR forces ranged from 0.51 to 3.66 lb.-force initially, 0.61 to 3.7 after corrosion exposure, and 0.72 to 3.55 lb.-force after environmental exposure. RR forces and percent change between baseline and post shock and abrasion exposure for all casters is shown in Figure 7.

performance. In our study, the lowest initial RR was from caster B, and although this caster had the highest percentage increase in RR (42%) it remained by far the lowest for RR forces (0.7 lbs.). For caster J, designed for use on rough terrain and having a width of 3 inches, it had the highest RR overall, but RR decreased 3% after simulated environmental exposure. This highlights the importance of considering the total RR forces, as well as percentage changes in RR when assessing caster performance. Significant percentage increases in RR forces were seen for many of the casters.

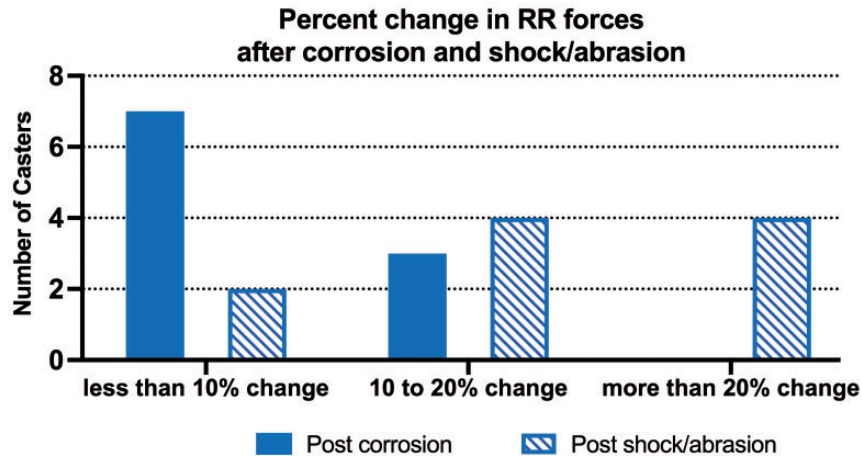
Figure 8. The number of casters with a specific percentage change to RR force post-corrosion and post-shock/abrasion exposure.

The number of casters with specific percentage changes in RR are shown in Figure 8. In this case, they are grouped by less than 10%, 10 to 20%, or over 20% change in RR due to environmental exposure.
