Case Report

Mechanical prosthetic mitral valve obstruction: Pannus or thrombus? A case report ☆☆☆

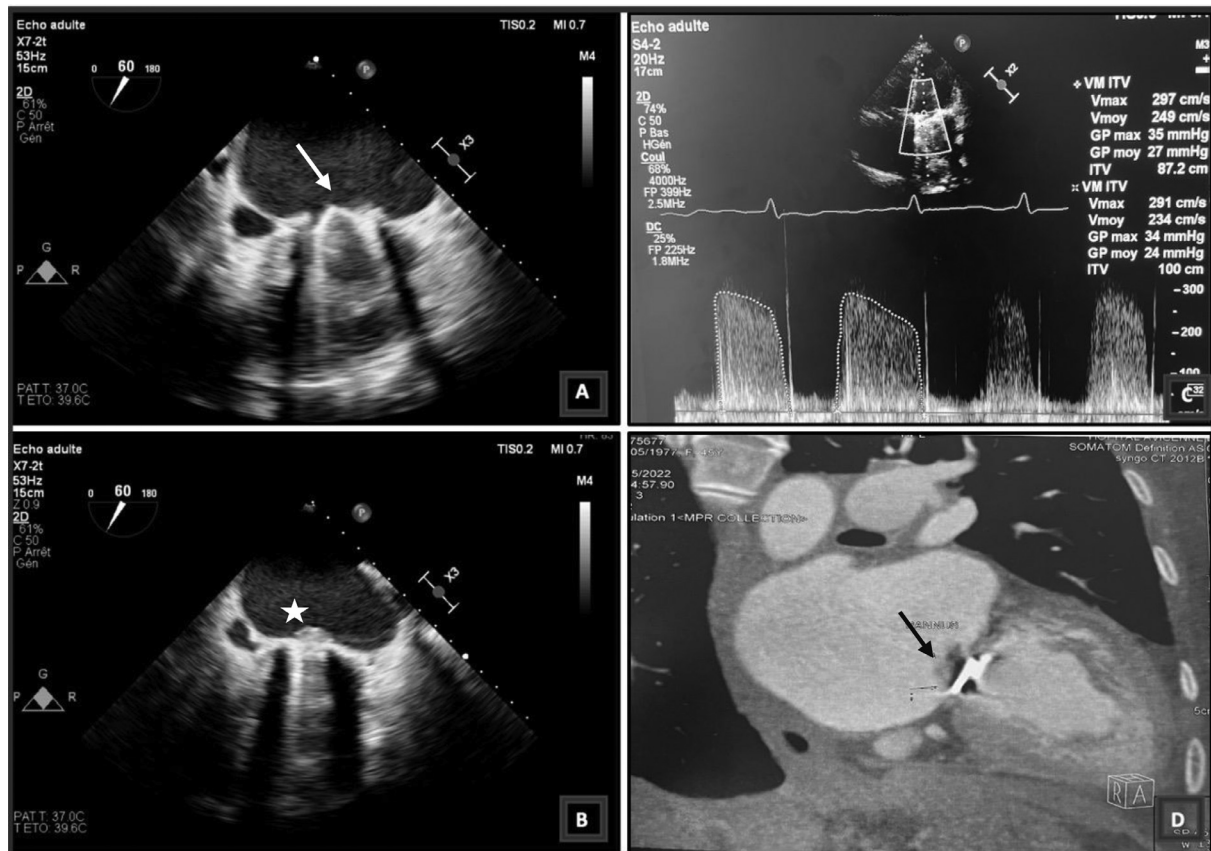
Fig. 1 – (A, B) Transesophageal echocardiogram findings: blocked leaflets (white arrow) with a small, dense, hyperechogenic, immobile mass, tightly attached to the auricular surface of the prosthesis (white asterisk). (C) Increased gradient across the mitral valve prosthesis (27 mmHg). (D) CT scan confirming the diagnosis of pannus (black arrow).

The chronology of 3 years before the appearance of signs suggestive of obstruction, the weak relationship with the value of international normalized ratio, the mitral position of the mass, as well as the other morphologic criteria (small and immobile mass, involving mostly the ring with growth beneath disc) were suggestive of pannus diagnosis. Because of the possible combination of both, cardiac CT scan was performed; it revealed a 5 mm hypodense valve outgrowth on the atrial side with an attenuation value > 200 Hounsfield unit, suggestive of isolated pannus (Fig. 1D).

Finally, the patient was directed urgently to the cardiovascular surgery department for mechanical mitral prosthesis replacement with a good follow-up.
