Case report

Histologic evaluation of the bone-ceramic interface of an alumina ceramic cup arthroplasty retrieved after 25 years in vivo

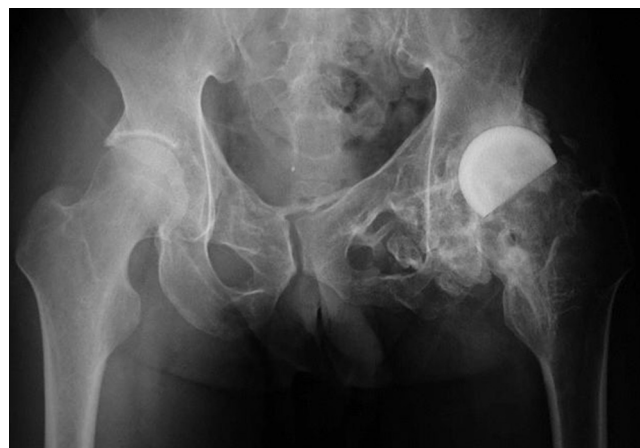
Figure 1. Anteroposterior radiograph of the left hip before revision surgery. Twenty-five years after cup arthroplasty, an alumina ceramic cup (Kyocera Corp.) survived with appropriate cup inclination angle and no varus slipping or shortening of the neck. Severe periarticular heterotopic ossification associated with traumatic brain injury and comminuted pelvic fractures were noted.

Anterior-posterior radiograph (Fig. 1) and computed tomography (Fig. 2) revealed appropriate cup alignment and stable fixation of the ceramic cup. Additionally, severe heterotopic ossification associated with previous comminuted pelvic fracture and traumatic brain injury was revealed around the left hip joint. However, negative radiographic findings, such as varus slipping, sinking and shortening of the femoral neck, were not noted with cup arthroplasty although it had been 25 years since surgery.

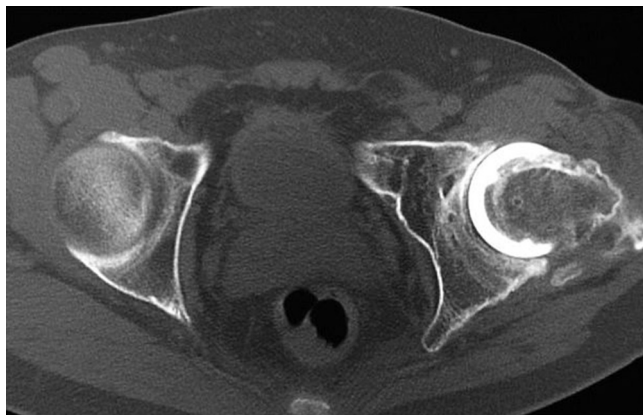
Figure 2. Computed tomography image of the hip joint. The axial image demonstrates that the femoral head and ceramic cup are void of significant gaps.
