Cite this: *RSC Adv.*, 2019, 9, 4035

Characteristics of water quality and bacterial communities in three water supply pipelines†

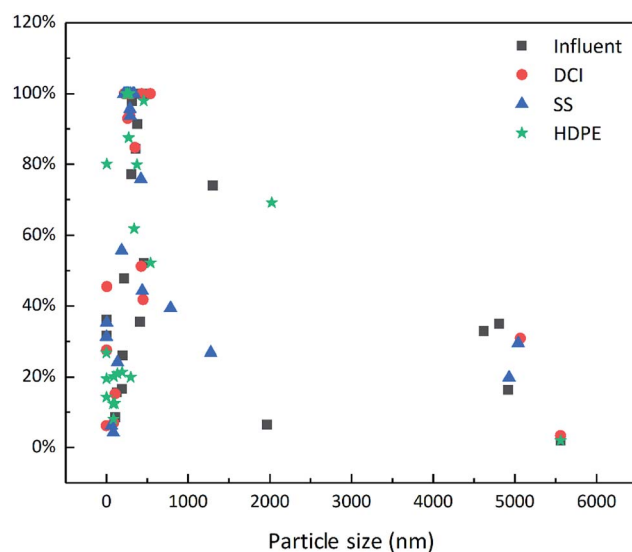
Fig. 2 shows the particle size distribution of the influent and effluents within 25 days. The particle size range (abscissa) of the particulates can be obtained from the particle size frequency distribution map, while the frequency (ordinate) of the particle size of each particulate within the particle size range can be quantified by the content of each particle size fraction present in the water. From Fig. 2, it was found that the solid content of the influent was lower, and the content of small particle sizes was more significant, with particles mainly concentrated in the 0 to 200 nm fraction, while the content of particles in the 400 to 600 nm fraction was relatively small. The large particle sizes in the effluent in the DCI and the SS pipes increased, mainly being concentrated in the 200 to 600 nm fraction, and their distribution at 400 nm was more concentrated. This is consistent with the particle-size distribution of the actual water sample (ESI 2†). The particle size of solids in the HDPE pipe samples showed no obvious change compared to the influent. Simoes *et al.* reported that biofilm growth in DWDS contributes to the accumulation of inorganic particles.³¹ Slaats *et al.* reported that when the pH increases, calcium carbonate can precipitate on

Fig. 2 Frequency distribution of particle size in the influent and effluents.

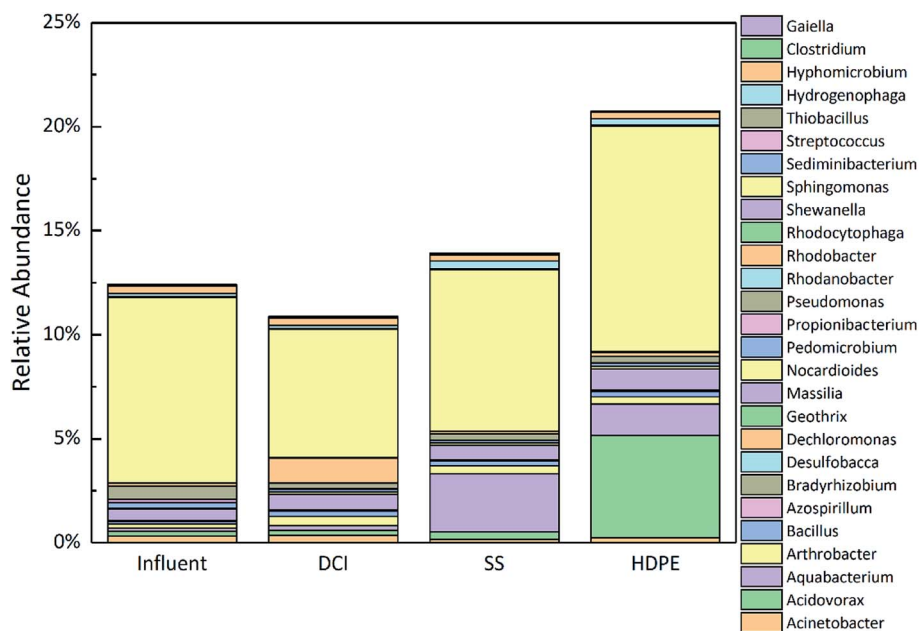
The relative abundance of the various corrosive-related bacteria in the influent and different pipeline effluents are shown in Fig. 4. *Sphingomonas* was dominant in both the influent and effluent of the three tubing material samples (8.9209%, 6.1609%, 7.7781%, and 10.8632%, respectively), followed by *Pseudomonas* (0.6265%) and *Massilia* (0.5473%) in the influent, *Rhodobacter* (1.2033%) and *Massilia* (0.7555%) in the DCI tube effluent, *Aquabacterium* (2.8047%) and *Massilia* (0.6892%) in the SS tube effluent and *Acidovorax* (4.9221%) and *Aquabacterium* (1.5092%) in the HDPE tube effluent. It could thus be seen that the different tubing materials affected the different corrosive bacterial communities.^{28,45,82,84,87,95,96}

Fig. 4 Relative community abundance of corrosion microorganisms at the genus level.
