Case report

Phlegmasia cerulea dolens and external iliac vein disruption after revision total hip arthroplasty

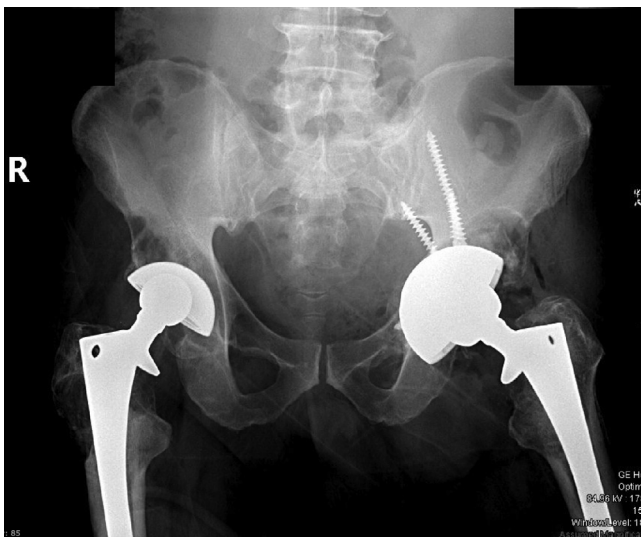
Fig. 3. Postoperative anteroposterior pelvis radiograph demonstrating ilium screw placement into pelvis.

there have been no recent reports of phlegmasia cerulea dolens following revision hip replacement [9]. We hypothesize that the intrapelvic screw placement or extrusion of bone graft through the medial acetabular wall caused the venous injury, which led to venous congestion of the entire limb and phlegmasia cerulea dolens. We also believe that tranexamic acid played a role in preventing profuse bleeding from the venous injury, which eventually became acutely hemorrhagic subsequent to intravenous heparin administration.

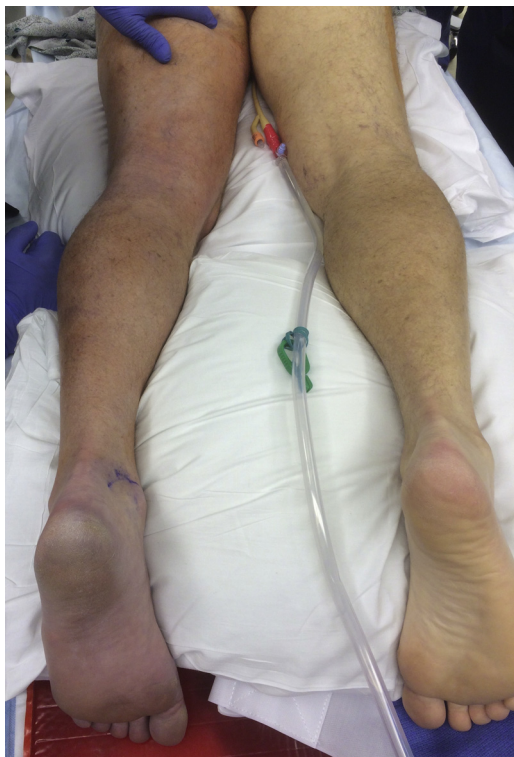
Fig. 5. Intraoperative clinical picture demonstrating increasing cyanosis of left lower extremity during the venogram.
