Short and Long Term Measurements in Assessment of FRP Composite Footbridge Behavior

Mikołaj Miśkiewicz

Faculty of Civil and Environmental Engineering, Department of Mechanics of Materials and Structures, Gdańsk University of Technology, G. Narutowicza 11/12, 80-233 Gdańsk, Poland; mikolaj.miskiewicz@pg.edu.pl (M.M.); bartosz.sobczyk@pg.edu.pl (B.S.)

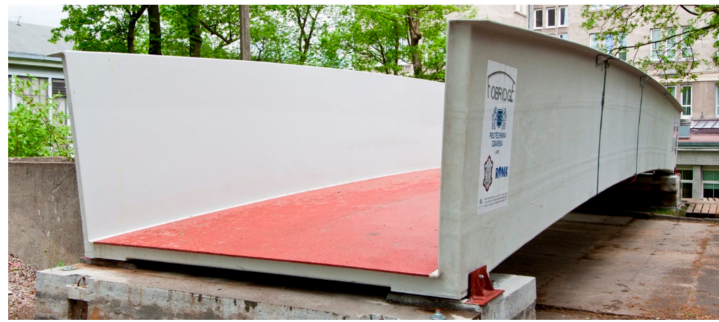
Figure 1. Composite footbridge designed within the FOBRIDGE project.

In 2015, the consortium associating Gdańsk University of Technology (GUT), Military University of Technology in Warsaw and ROMA Co. Ltd. (Grabowiec, Poland) constructed a single element, sandwich composite footbridge with a span of 14 m long using vacuum infusion technology (Figure 1). This is the final product of the FOBRIDGE project, which aims to design pedestrian and cyclist bridges made of composite materials for use over dual carriageways and motorways. The footbridges were designed from scratch. The whole process resulting in bridge production included development of a preliminary concept, material selections, identification of material properties, numerical simulations, strength calculations, and serviceability analyses. The structure is innovative aforementioned for these reasons. According to the author knowledge, it has been the first structure in the world to be classified as a consistent, single element structural girder, without any connectors or fasteners, made of sandwich shells, entirely produced in a single cycle vacuum infusion process. The application of non-classical materials caused problems, as no guidelines nor recommendations were available in existing design codes during project realization. This is why the project was expanded to include additional material parameters identification, validation analyses at different complexity levels, and experimental tests.

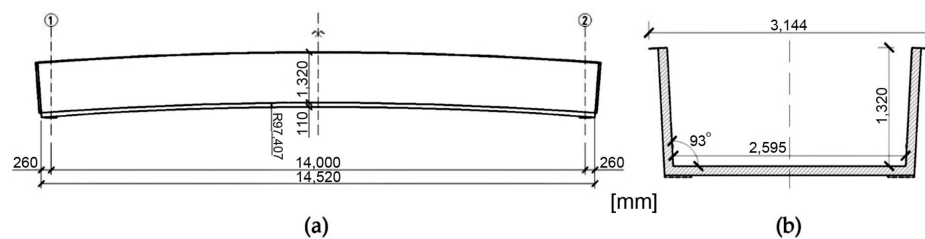
Figure 2. Footbridge views: (a) Side view; (b) Cross section.

The considered footbridge is a composite, U-shape, simply supported, shell-type sandwich structure, the dimensions of which are shown in Figure 2. The total weight of the footbridge superstructure is 3200 kg. It is completely made of hi-tech composites, without any conventional elements. The footbridge was designed to carry a uniformly distributed 5 kN/m² service load.

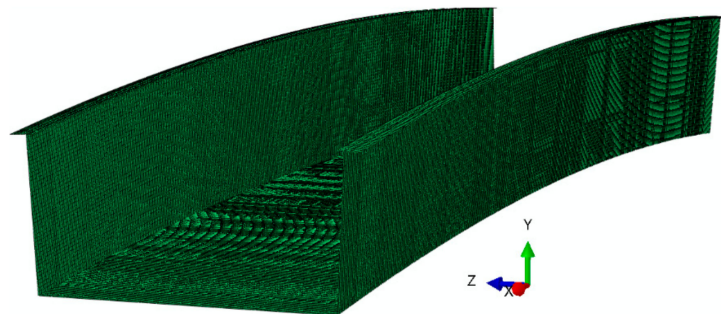
Figure 3. Visualization of the footbridge numerical model.

Many finite element method (FEM) computational models with different levels of complexity were created in order to estimate the bridge response under different conditions. They were used to carry on various studies intending to design the footbridge and establish a load tests program, including using a ballast selection or location of network of sensors. All the aforementioned studies were however preceded by complex validation analyses of laminate coupons, sandwich beams and 3 m long full-scale footbridge segment (see references [29,30]). In this paper some FEM estimations of strains and displacements under loads applied during short-term static load test are compared with the in-situ values in order to evaluate accuracy of measurements and modeling. A pure shell equivalent single layer (ESL) (refer to reference [31]) FEM model was used for this purpose (refer to Figure 3), which was motivated by the fact that in this case, only a global response of the bridge needed to be determined and consideration of local effects and influences could be avoided. The precision of numerical results was sufficient and relatively low computational effort was required. It is worth mentioning that the ESL was also found to be used in more sophisticated approaches of shell structures analysis [32].

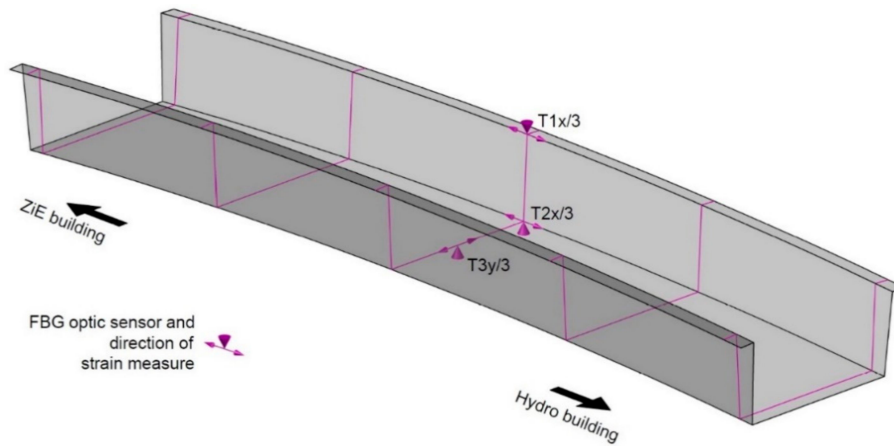
Figure 5. Location of FBG optic fiber sensors.

The fiber optic measurement system is based on two kinds of sensors. It includes three Bragg gratings to measure strain and one for temperature compensation. They form a one wire chain, ending in the SC/APC connector, see Figure 4. The following parameters characterize the Sylex (Bratislava, Slovakia) strain gauges used in measurements: 8 mm measuring length, $0.85 \mu\epsilon$ resolution, $1.7 \mu\epsilon$ accuracy, range of measure up to $5000 \mu\epsilon$. The temperature gauge parameters are: $0.1 \text{ }^\circ\text{C}$ resolution, $0.2 \text{ }^\circ\text{C}$ accuracy, in a measuring range from $-20 \text{ }^\circ\text{C}$ to $+150 \text{ }^\circ\text{C}$. The single strain gauge length is 30 mm, it was fixed to the structure by the cyano-acrylate dedicated glue. The measurements were carried out using the Sylex SCN-80 S-line Scan 800 interrogator and a computer with dedicated ILLumiSense Strain software. The locations of the sensors are shown in Figure 5, they are all placed in one cross-section at the mid-span.

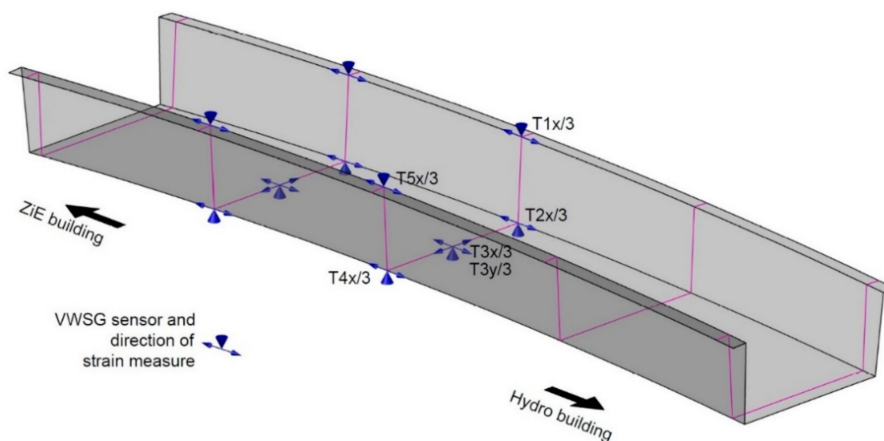
Figure 6. Location of VWSG sensors.

The VWSG measurement system is based on twelve GEOKON strain and temperature model 4000 gauges. The strain is measured on the basis of changes in the natural frequency of a string attached to anchor blocks inside a device. The system is characterized by a very good stability during long-term monitoring. The sensors are connected to the 16-channel recorder, which initiates the measurement within a given time interval. The parameters of the sensors are: measuring length of 150 mm, measuring range up to 3000 $\mu\epsilon$, resolution of 1 $\mu\epsilon$, accuracy <0.5% FS, temperature range $-20\text{ }^{\circ}\text{C}$ to $+80\text{ }^{\circ}\text{C}$, simultaneous measurement of temperature and strain. The locations of the VWSG are shown in Figure 6. The sensors are placed in two cross-sections, at quarter and mid-span. One of the sensors, being fixed to the bridge deck is presented in Figure 7.

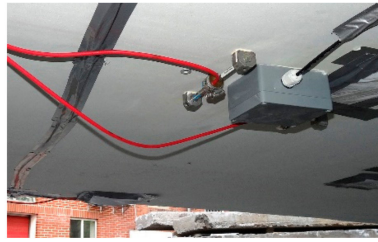
Figure 7. VWSG sensor fixed to the bridge.

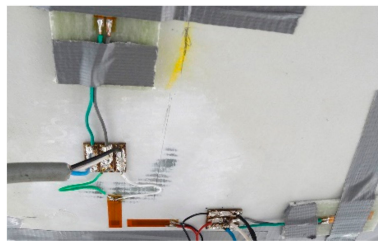
Figure 8. SG sensors mounted to the structure.

The measurement system is based on the electrical resistance strain gauges. The Hottinger Baldwin Messtechnik (HBM) (Darmstadt, Germany) foil gauges are used. They have the following properties: active grid length of 20 mm, 120 Ω nominal resistance and 50,000 microstrain range. Temperature is compensated in each measurement point using individual sensors, as is shown in Figure 8. The measurements were carried out using the HBM QuantumX MX1615B strain gauge bridge amplifier and a computer with dedicated the CatmanEasy/AP software. The locations of the sensors are shown in Figure 9, they are placed at the quarter spans and at the mid-span and over the supporting area (a rosette).

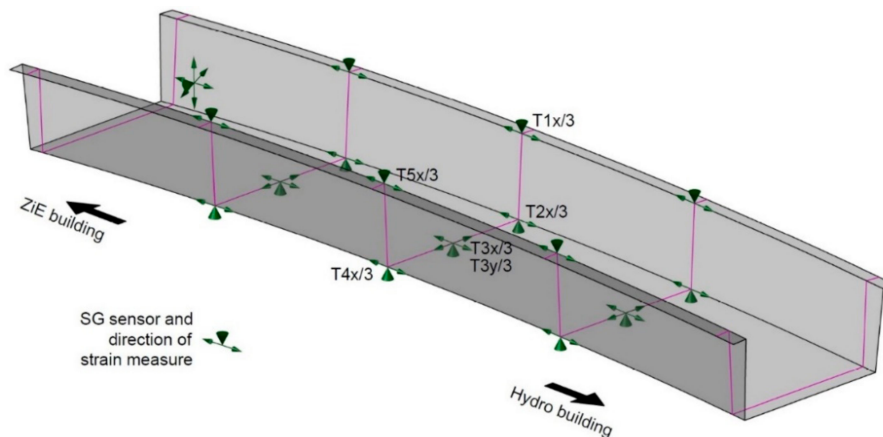
Figure 9. Location of SG sensors.

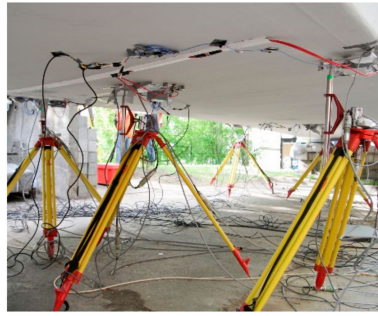
Figure 10. Inductive transducers used during measurements.

The displacement measurement subsystem includes inductive transducers (see Figure 10) and precision leveling. The nine 100 mm range HBM inductive transducers connected to the HBM MX840B universal amplifiers are located as shown in Figure 11. The precision leveling measurement by Leica Geosystems (Heerbrugg, Switzerland) Nova TM50 Robotic Total Station was achieved with an accuracy of 0.1 mm in the locations presented in Figure 11 as well.

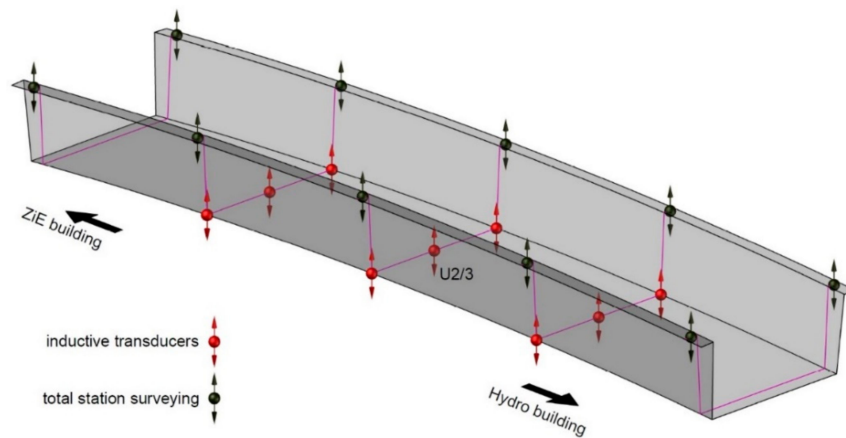
Figure 11. Location of displacement measurement points: inductive transducers and total station surveying.

Also, displacements were measured during the short-term test. The example results from inductive sensors are shown in Figures 17 and 18 correspondingly for U1 and U3 tests in U2/3 points, for which extreme values were reported (refer to Figure 11).

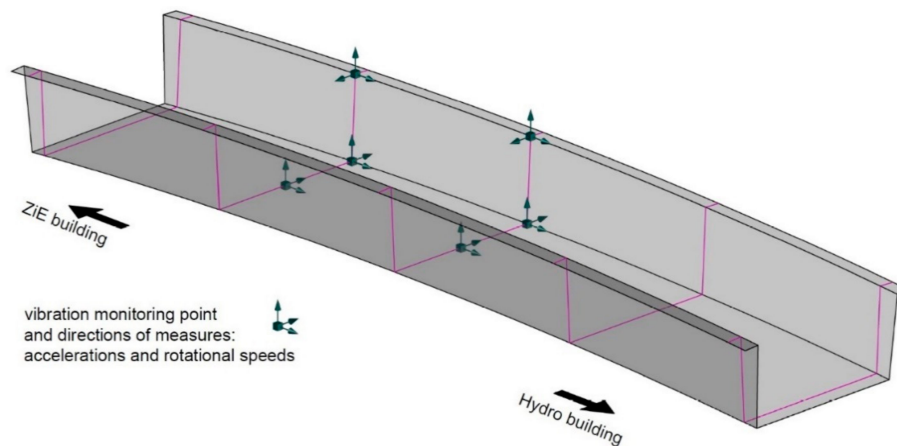
Figure 12. Location of vibration monitoring sensors.

The vibration measurement subsystem was based on a six-channels prototype sensors. They comprise of three integrated orthogonal channels to measure accelerations and three orthogonal channels to measure rotational speed. The accelerometers output range is ± 2 g, the default frequency measure capabilities range from 0 Hz to 40 Hz (possible to 200 Hz), and the error of non-linearity is 0.5%. The gyroscopes range is ± 250 °/s, the default and possible frequency range is the same as above and the error of non-linearity is 0.2%. The data is sent to a workstation the via internet. This allows for previewing results in real time and data archiving. It also provides a possibility of measurement signal post processing at any time. The sensors are designed to work in temperatures from -30 °C to $+85$ °C and have a degree of protection of IP67. The system, in total, contains six sensors, six-channels each, giving eighteen measurement points. Their locations are shown in Figure 12.

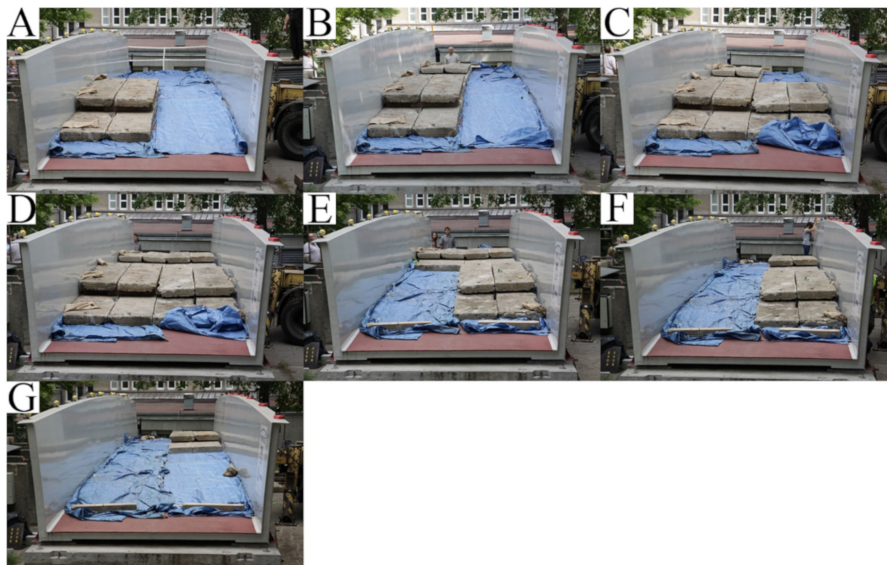
Figure 13. Loading sequence during the U1 test (from A to G).

In all static cases, the ballast was applied using concrete slabs. The total weights of the slabs during the tests were—U1: 141.2 kN, U2: 150.0 kN, and U3: 201.7 kN. The load was always put on the deck in subsequent steps. During the U1 test, the concrete slabs were placed in seven steps from A to G (each quarter of the deck) were loaded separately, see Figure 13. During U2 and U3 tests in three steps from A to C, each half of the deck loaded separately, see Figure 14. The ballast was laid on the structure in stages, asymmetrically, with respect to the longitudinal and transverse axes of the footbridge. The approach, in which so many different types of measuring points are used, was designed to identify possible irregularities in the behavior of the footbridge parts.

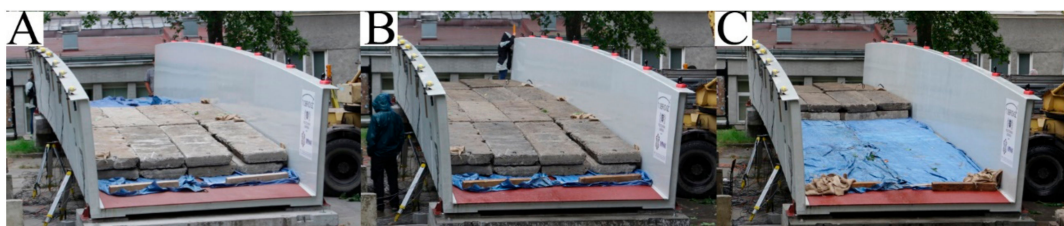
Figure 14. Loading sequence during the U3 test (from A to C).

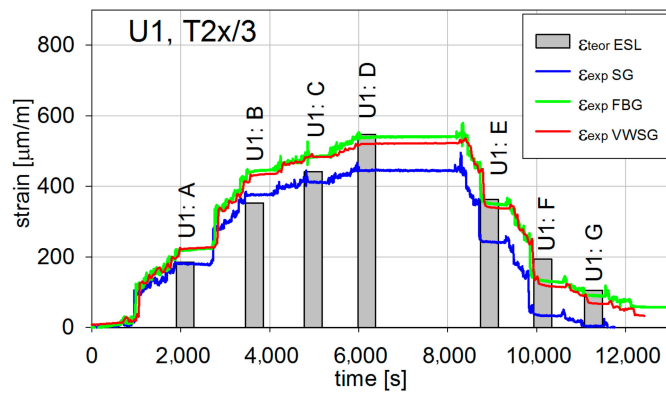
Figure 15. Longitudinal strains in T2x/3 for the U1 test.

During the short-term load tests, all three systems of strain measurement sensors were used. The exemplary results, being the extreme values, shown in Figures 15 and 16, present registered strains (temperature compensation had been made during the measure) correspondingly during U1 and U3 tests in T2x/3 measurement point (refer to Figures 5, 6, and 9). The experimental results ε_{exp} are compared with the numerical ones $\varepsilon_{\text{teor}}$ ESL. The results in the remaining measurement points reveal similar character and result precision, and hence are not depicted.

All strains measured with three different techniques are quite comparable. Therefore, it can be concluded that the in situ strain values are correct. The differences observed between them are caused mainly by slightly different locations of sensors. It is not possible to locate all of them precisely at the same point of the bridge. Additionally, the measurements can be also influenced by the sensor characteristics and their measuring precision. The numerical values are higher or close to the in situ ones. This shows that the structure is in general stiffer than it was designed to be and therefore enables safe exploitation.

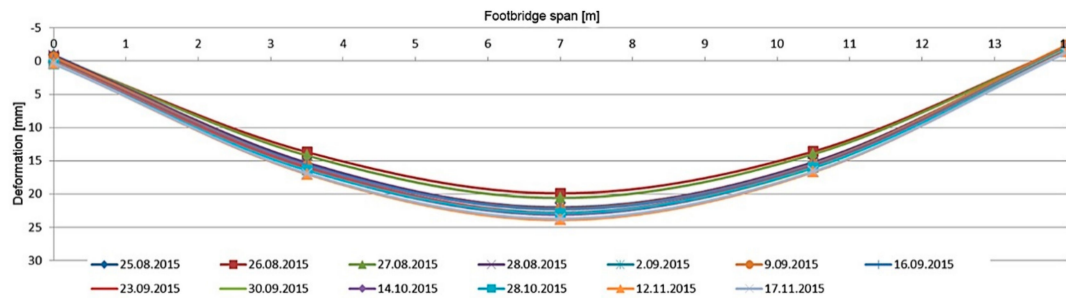
Figure 21. Displacements in U4 measurement points, footbridge with ballast.

During the long-term load tests (U2 ballast had been left on the deck) the measurement system included VWSG sensors and vibration monitoring, as well as periodic precision leveling. The changes of the mid-span strains in time are shown in Figure 19, while the change of temperature in the same domain of time as presented for strains is shown in Figure 20. The established time intervals measurements in characteristic points of the structure by precision leveling is presented in Figure 21. For more detailed verification, regardless of whether the weight of the ballast caused rheological changes in displacements, the obtained results were normalized with respect to the deflection at start of the test. The result is shown in Figure 22.

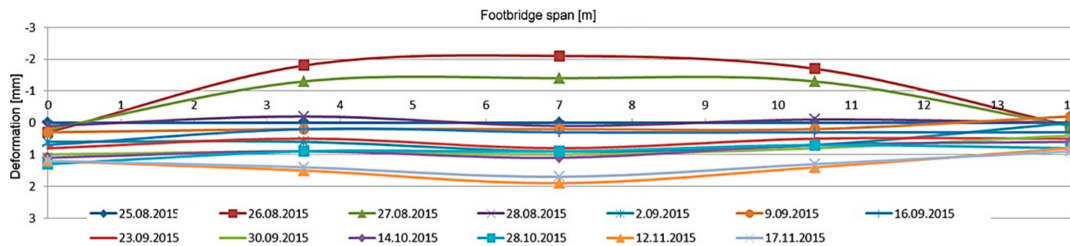
Figure 22. Normalized displacements in U4 points, footbridge with ballast.

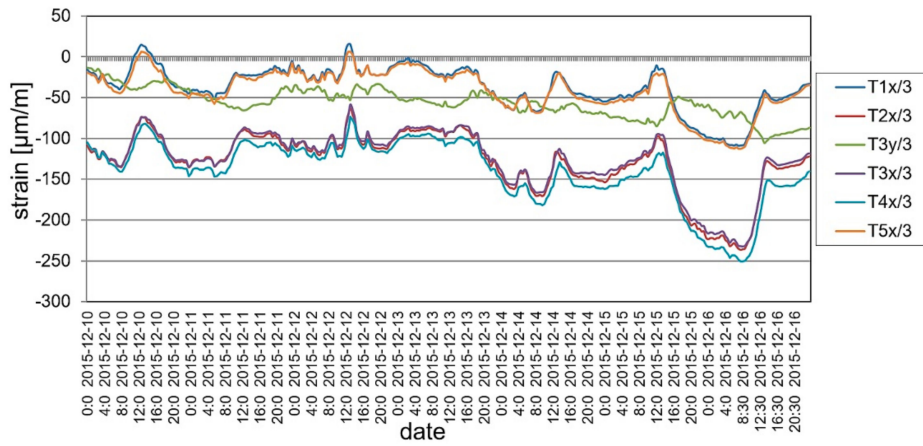
Figure 23. Strain monitoring using VWSG sensors during a one week period.

The structure was still continuously monitored by the SHM system when there were no static loads on the footbridge, between May 2015 and May 2016. In order to maintain readability of the recorded data, the presentation of results was limited to the periods of November 2015 and May 2016. The changes of the mid-span strains in time for ambient testing during a sample week period is shown in Figure 23. The temperature change in the same domain of time as presented for strains is shown in Figure 24. According to the surveillance observations and the gathered data the temperature changes and wind were the main influences affecting the footbridge. It can be observed in Figures 25 and 26, which are strains and temperature time histories throughout the six month monitoring period, that because of these effects, strains range from about -400 to 400 microstrains. Nevertheless, higher values were calculated at the stage of bridge designing. Therefore, the SHM strain measurement confirms the safe design and behavior of the bridge for environmental influences. The graphs clearly show the impact of both daily temperature changes and the ones associated with the change of seasons. The research confirmed previous observations that composite sandwich material is sensitive to thermal influences, which should definitely be taken into account when designing this type of structure.

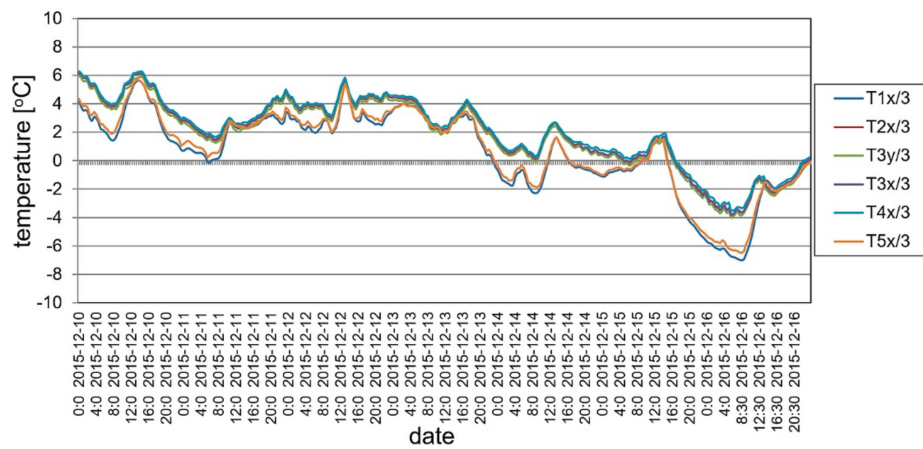
Figure 24. Temperature changes during a one week period.

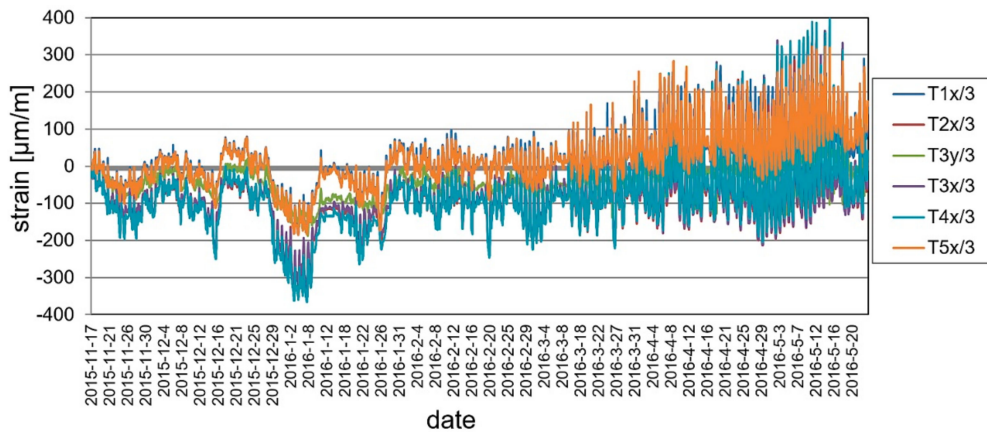
Figure 25. Strain monitoring using VWSG sensors during a six month monitoring period.
