Multi-Level Sensing Technologies in Landslide Research—Hrvatska Kostajnica Case Study, Croatia

Abstract: In March 2018, a landslide in Hrvatska Kostajnica completely destroyed multiple households. The damage was extensive, and lives were endangered. The question remains: Can it happen again? To enhance the knowledge and understanding of the soil and rock behaviour before, during, and after this geo-hazard event, multi-level sensing technologies in landslide research were applied. Day after the event field mapping and unmanned aerial vehicle (UAV) data were collected with the inspection of available orthophoto and "geo" data. For the landslide, a new geological column was developed with mineralogical and geochemical analyses. The application of differential interferometric synthetic aperture radar (DInSAR) for detecting ground surface displacement was undertaken in order to determine pre-failure behaviour and to give indications about post-failure deformations. In 2020, electrical resistivity tomography (ERT) in the landslide body was undertaken to determine the depth of the landslide surface, and in 2021 ERT measurements in the vicinity of the landslide area were performed to obta

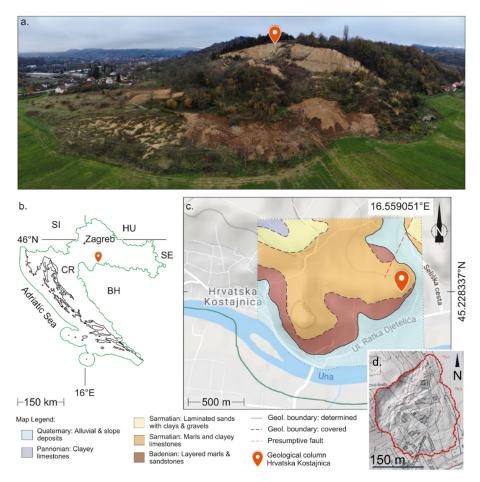
Figure 2. Study area: (a) landslide panorama in Hrvatska Kostajnica—on the south-eastern slope of Kubarnovo brdo, photo taken by unmanned aerial vehicle (UAV), by Croatian Geological Survey (CGS); (b) landslide location is in Croatia, near the border with Bosnia and Herzegovina; (c) basic geological data [23,24]; and (d) detail from topographic map (before landslide) overlaid with landslide area and detailed hillshade DEM (after landslide) and houses within landslide area: destroyed and damaged. Landslide area was defined by Croatian Geological Survey (CGS).

Geographically, the study area is located on the south-eastern slope of Kubarnovo brdo, a hilly area (Figure 2a). The landslide toe part is on the flat area near Kostjničica stream situated only 100 m east from the landslide, and ~400 m south is Una River. Geologically [23], within Quaternary alluvial and silty flood sediments slope deposits are also present. The landslide occurred in Sarmatian marls and clayey limestones and Badenian layered marls and sandstones (Figure 2c) [24]. In terms of engineering geology [25,26] there is soil on the surface in the area. The thickness of soil varies but it is generally thinner than 0.5 m. At the main scarp area, the soil layer thickness is between 0.3 and 0.7 m. Below the soil layer, there is a layer of diluvial sediments which are represented by clays and clayish marls up to 3 m thickness (estimated). These sediments are weathered, and the weathered zone can reach up to 5 m of depth (estimated). This zone of weathered bedrock is generally below the stretch of the diluvial sediments. These weathered materials are (mainly) composed of sandy-silty-clays. Below the weathered zone bedrock follows, which is represented by clayish marls, silty marls, as well as layers of sandstones and weathered clayish limestones. The landslide has affected the soil layer, weathered zone, and bedrock, so the material characteristics vary in a wide range from soils to rocks. The actual study area covers $\sim 500 \times 500$ m and it is somewhat wider than the landslide area.

On the Landslide Susceptibility Map of Croatia, the wider area is generally depicted as prone to landslides [27], as on the 1:100,000 scale Landslide Susceptibility Map of Sisačko-Moslavina County (Figure 4a) [4] and on the 1:500,000 scale Engineering Geological Map of Yugoslavia, on which active landslide locations are marked with red semi circles (Figure 4c) [28]. The detail from the 1:500,000 scale Engineering Geological Map indicates that two units are present in the study area: (i) sandstones, marly clays, marls, and sands; Upper Neogene lacustrine bedded sedimentary complex with very variable porosity and permeability, prone to erosion and sliding (brown on map); and (ii) sandy gravels, sporadically clayey; Pleistocene–Holocene fluvial sediments, mostly covered with loam, poorly settled and bedded, rather porous (white on map). The topographic maps (1:5000 from NGA and the one developed from LIDAR data) in combination with developed landslide inventory for study area provides a good idea about the spatial distribution of landslides in this area (shown in detail in Figure 2d).

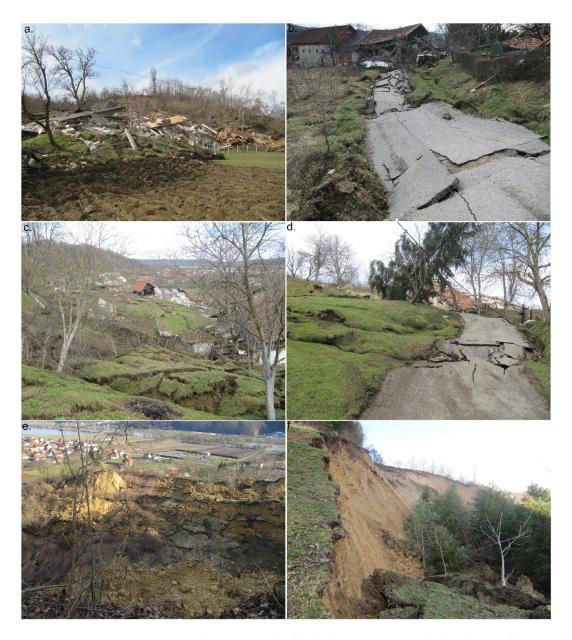
Figure 3. Hrvatska Kostajnica landslide damages: (a) completely destroyed houses; (b) completely destroyed road and damaged objects; (c) cracks and heavy terrain deformations; (d) flow like deformations on terrain surface; (e) view from main scarp toward flooding Una River; (f) landslide main scarp—almost 30 m at the highest point (photos by Croatian Geological Survey (CGS), day after the event, 14 March 2018).

The study area is in Croatia in the Sisačko-Moslavina County in the city of Hrvatska Kostajnica (Figure 2a), near Una River, which is the border with Bosnia and Herzegovina (Figure 2b). The city area is 53 km^2 and the population is ~ 3000 . Una River is situated $\sim 400 \text{ m}$ south from the Kubarnovo brdo where on 13 March 2018 the landslide occurred (Figure 2a–d). Una River is $\sim 100 \text{ m}$ above sea level, while Kubarnovo brdo peak is 188 m above sea level. Landslide is mainly rotational (only in some smaller parts can be considered as composite, a combination of types: rotational and translational slide and flow) [10,22], with area of $\sim 300 \times 300 \text{ m}$ and maximum of $\sim 61 \text{ m}$ height difference: the highest part of the landslide (crown) is at 175 m above sea level while the lowest part of the landslide (toe) is 114 m above sea level. In combination with geological setting (Figure 2c), rapid temperature change (from below 0° to above zero which caused $\sim 80 \text{ cm}$ of snow cover to melt), period of rain, and Una River flooding, slope failure occurred (Figure 2d) and completely destroyed multiple households. The damage was extensive, and lives were endangered (Figure 3a–f).

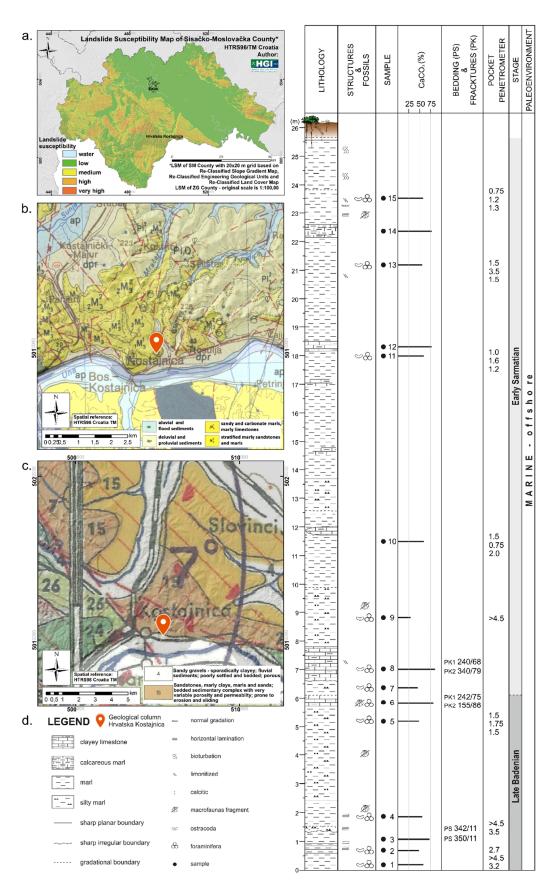
Figure 4. Study area "zoom in": (a) landslide susceptibility Map of Sisačko-Moslavina County [4]; (b) detail from the Basic geological map [23]; (c) detail from the Engineering Geological Map [28]; and (d) the developed detailed geological column for Hrvatska Kostajnica landslide, modified after [24].

Available geological and landslide data were reviewed, mostly in the forms of existing guides and maps (Table 1, Figure 4a–d). Hrvatska Kostajnica is in the continental part of Croatia, where soils are commonly developed on the surface of the different types of sediments and slides in soils frequently occur (Figure 4a) [4].

This is also reflected in the Re-Classified Lithological Map of Croatia, where clayey materials and alluvial/diluvial deposits are depicted in the study area [6]. The 1:100,000 scale Basic geological map (Figure 4b) [23] and the 1:100,000 scale Geological Map of Sisačko-Moslavina County [29] indicate that Badenian (conglomerates, sandstones, marls, limestones) and Sarmatian (sandstones, gravels, sands, marls) deposits are present in the area with diluvial and proluvial Holocene sediments (sands, silts). Near the Una River, alluvial Holocene sediments (sands, gravels, silts, clays) are common [24]. In the 1:100,000 scale basic geological map, the presumptive fault locations are also marked (red dashed lines, Figure 4b) [23].

From the available geological and landslide data, it can be concluded that the area is generally prone to landslides (see Section 2.3. and Figure 4) [27,28]. The developed 26 m high detailed geological column at main scarp of Hrvatska Kostajnica landslide reveals that the landslide occurred mainly in the "marly" sediments, but clayey (weathered) limestone is also present at location [24]. The landslide affected the soil layer, weathered zone, and "bedrock", but no clear sliding zone(s) was mapped on the field during geological column development and during engineering geological mapping in 2018 [25]. The assumption is that there were multiple weakened "zones" due to rhythmic changes within material, i.e., geological heterogeneity. Multiple field measurements and samples from the landslide head scarp were taken for the determination of on-site material characteristics and laboratory analysis. Field pocket penetrometer values and CaCO₃ ratio variations also indicate differences in material properties (Figure 4d). Within weathered clayey limestones on bedding plains and fracture planes, "preferred" seepage and water "leakage" could

have occurred, and at the same time in these discontinuities thin clay layer(s) are sometimes present. Moreover, seven interchanges of marls–clayey limestone can be tracked at geological column/landslide main scarp (Figure 4). On this geological column, the main geo-specific characteristics of the location can be observed: the material is mainly marl with silts and it is interlayered with clayey limestone. This "interlayering" is common, and the materials are generally weathered. Moreover, the bulk analysis of marls shows that the main mineral components are calcite and clay minerals (i.e., smectite, ilite, kaolinite, vermiculite), with some of them with high shrink-swell capacity [24]. All the "geo" data indicate multiple sliding surfaces as result of "rhythmic" changes within the material.

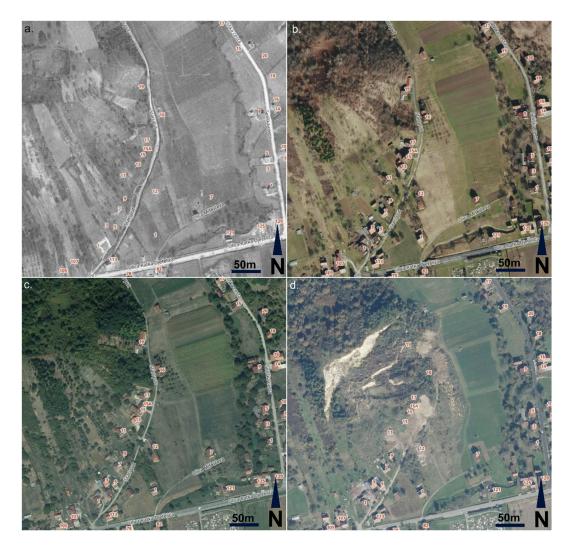
Figure 5. Hrvatska Kostajnica landslide area orthophotos from National Geodetic Administration of Croatia (NGA): (a) from 1968—historical data; (b) from 2016—pre-failure data; (c) from 2018—(recent) pre-failure data; and (d) from 2020—post-failure data.

Available orthophotos were reviewed as a source of land use change records (Figure 6a–d) [12,32]. In the historical photo from 1968, the landslide area is cropland without houses/objects (Figure 5a). On the "recent" photos from 2016 (Figure 5b) and 2018 (Figure 5c), the pre-failure situation can be observed: houses (1–19 house numbers), croplands, and woods. On the post-failure photo from 2020 (Figure 5d), it is visible that

houses 11–19 are removed (as they were destroyed or heavily damaged by landslide) and the croplands are destroyed. Houses 7 and 9 are damaged while houses 1, 3, and 5 are still endangered. In all figures (Figure 5a–d), the house numbers at Stari put Street are marked as reference. Stari put Street was completely destroyed by the landslide (Figure 5d).

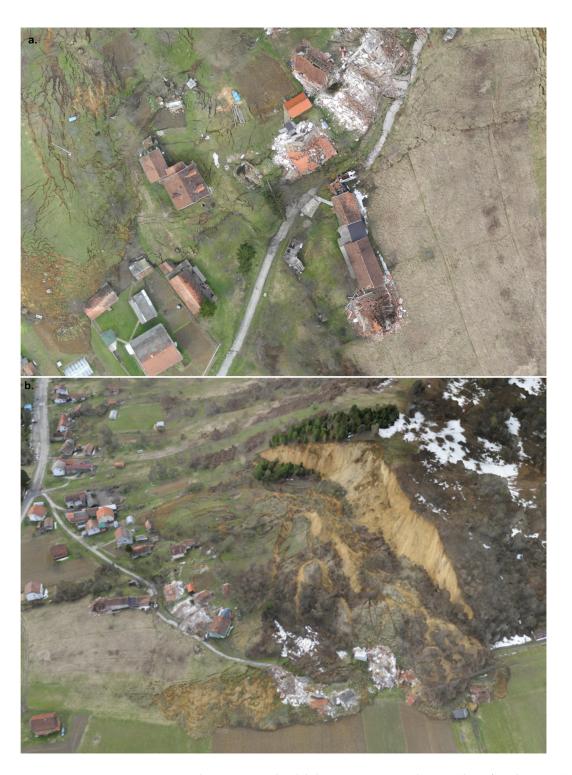
Figure 6. Hrvatska Kostajnica landslide area on 14 March 2018 (day after the event)—UAV data collected, analysed and developed by CGS: (a) detailed orthophoto data; and (b) 3D landslide area spatial model.

As the field mapping was carried out in an emergency (in only 1 day, 14 March 2018 by Croatian geological Survey), the detailed orthophotos taken by UAV on the same day proved to be a valuable source for follow-up landslide mapping [12,41,42]. The landslide area, features, and damages can be clearly distinguished in these photos, i.e., cm size features could be mapped (Figure 6a). For the more complete landslide area interpretation, a 3D landslide area spatial model was also developed (Figure 6b).

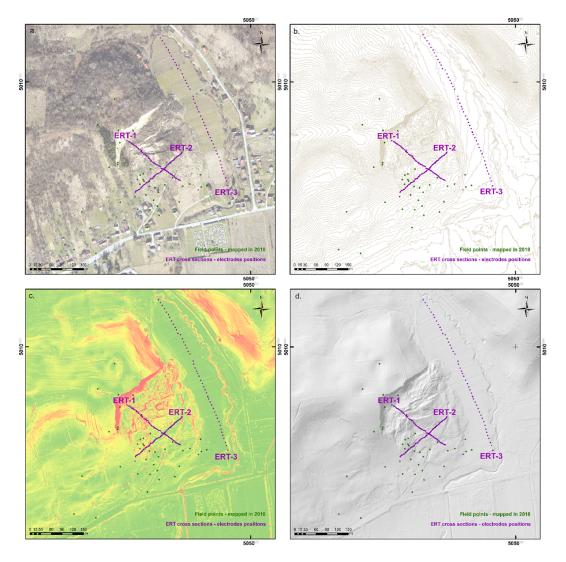
Figure 7. High resolution data from the Hrvatska Kostajnica area and landslide study area with mapped field points from 2018 and locations of ERT cross sections from 2020 and 2021: (a) detailed orthohpto from 2021; (b) 1 m contour lines based topography map; (c) detailed slope model; and (d) detailed terrain hillshade model.

Based on aerial LIDAR scanning, high resolution remote sensing data sets (Figure 7a–d) were used in landslide model development [6,43–45]. With the combination of a detailed orthophoto (Figure 7a), 1 m contour lines developed from LIDAR data (Figure 7b), a detailed slope model (Figure 7c), and terrain hillshade model (Figure 7d), quality terrain landslide surface model development (2D) was possible (Figure 8) [12,46]. These high

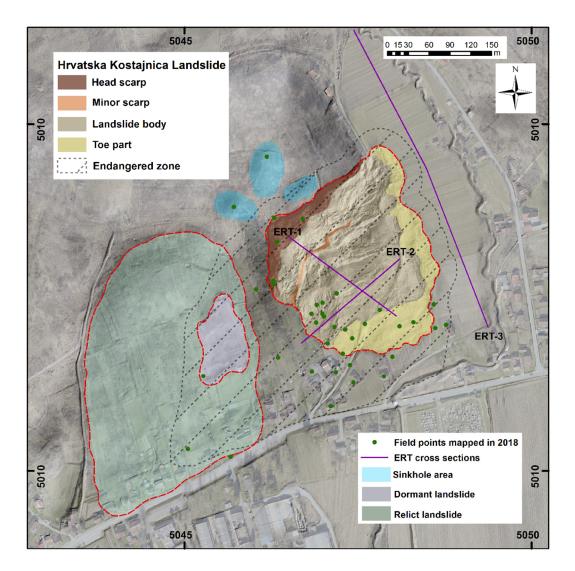
Figure 8. New Hrvatska Kostajnica Landslide Map with marked areas of active, dormant and relict landslide. Landslide areas are depicted with red dashed lines. On the map re-defined area of landslide(s) endangered zone is also marked (grey dashed polygon area).

Using detailed LIDAR based data, precise terrain landslide surface model development was possible, which served as baseline for new landslide map development [47]. A precise terrain landslide surface model was also used for landslide features re-evaluation and mapping and the re-evaluation of possible endangered zones. As a result, the New Hrvatska Kostajnica Landslide Map was developed (Figure 8). The map was also field verified in September 2021 (within GeoTwinn project, with experts from the Geological Survey of Denmark and Greenland, GEUS).

On the New Hrvatska Kostajnica Landslide Map, all the areas which are/or could be influenced by landslide(s) are reviewed and as a result the area of Endangered zone is redefined [43,45,46]. Within the Hrvatska Kostajnica landslide body, there is still activity: the erosion of the head scarp area due to atmospheric influences is an ongoing process i.e., the landslide is developing retrogressively [6,44,47]. Moreover, the settlement of the colluvium at the toe part area is ongoing at some (minor) rate. In the landslide body, there are still many wide-open cracks which are not stabilized. In the case of extreme rain, new movements within landslide body are possible. That is the reason for the endangered zone encircling the area of the active landslide body (same as on field map and report from 2018), but after revision of the available data the endangered zone was enlarged and an area with no traces of deformations was included with the area of the dormant landslide. The reason

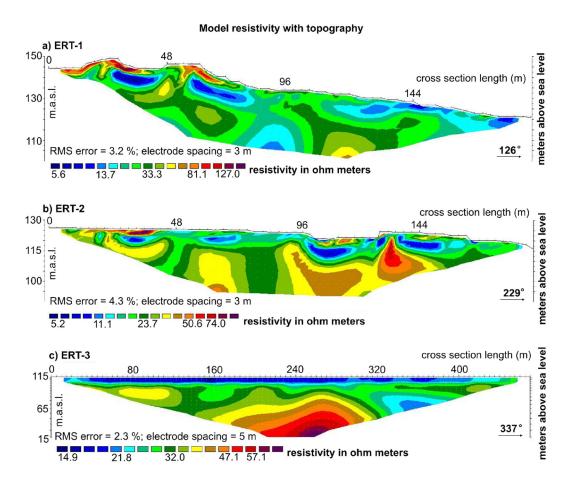
Figure 9. Electrical resistivity tomography results: (a) ERT-1 in the landslide body, cross section is oriented along the movement direction; (b) ERT-2 in the landslide body, cross section is oriented vertically on the movement direction; and (c) ERT-3 in the vicinity of the landslide, cross section is located in the "undisturbed soils". On the ERT-1 and ERT-2 highly deformed/disturbed near surface areas can be depicted while on ERT-3 paleo-relief can be interpreted.

ERT-1 and ERT-2 were measured in the landslide body in October 2020, while ERT-3 was measured in the immediate vicinity of the landslide, in the Quaternary sediments in May 2021. Surveys were conducted using the Wenner–Schlumberger array for ERT-1, ERT-2, and ERT-3 at a frequency of 7.15 Hz and a maximum phase of 200 between the voltage signal and the current signal. The ERT-1 and ERT-2 were measured with 64 steel electrodes and the length of the cross sections was 189 m with an exploration depth of about 40 m. ERT-3 was measured with 48 electrodes and the length of the cross sections was 470 m with an exploration depth of about 95 m.

The apparent electrical resistivity data were inverted using the RES2DINV software [50] to obtain the 2D electrical resistivity images of the subsurface model [55–58]. The ERT-1 and ERT-2 were measured in a landslide body, and therefore the topography effect was taken into account during the execution of the data set inversion in RES2DINV software. The optimization method adjusts the 2D electrical resistivity model trying to iteratively reduce the difference between the calculated and measured apparent resistivity values [59]. The root-mean-squared (RMS) error provides a measurement of this difference. All three cross sections have acceptable RMS values: for ERT-1 RMS, 3.2%; for ERT-2 RMS, 4.3%; and for ERT-3 RMS, 2.3%. The 2D model sections obtained from data inversion are presented as resistivity tomograms (Figure 9a–c).

If we compare the resistance measurements of the "bedrock" on the ERT-3 with the ERT-1 and ERT-2 measured in the landslide body, we can conclude that "bedrock" is the same, but there are probably variations in the depth of the weathered zone and in the heterogeneity of the structure, i.e., in the number and thickness of "interlayers" (Figure 9a–c).

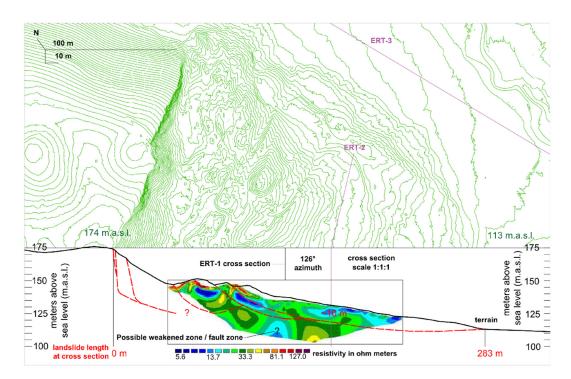
Figure 10. Hrvatska Kostajnica landslide cross section (parallel to movement) and interpreted ERT-1 data. At cross section area the length of the landslide is 283 m with multiple slide surfaces. The depth of the interpreted sliding surfaces varies from \sim 20–30 m at head scarp area, to \sim 10–20 m at landslide body area and \sim 1–10 m at landslide toe part area. In the middle part of the cross section possible fault zone is present (marked with question mark). The contour line interval on the topographical map is 1 m.

ERT-1 is located in the central part of the landslide body, parallel to the mass movement (Figures 8 and 10) and consists of layers with different resistance values varying from 5–130 Ohm meters [59]. The upper part of the cross section refers to unsaturated residual and saturated colluvial soil with different resistivity values (in the range of 5–20 Ohm meters) [40,55]. Very low resistance values in this layer are saturated colluvial soils/materials [48,59]. The thickness of these deposits (colluvial material) varies, but it is generally in the range of 10–20 m, i.e., it is thicker near the head scarp whereas it is thinner near the toe part of the landslide. Below colluvial materials, the resistivity values are higher but still relatively low, in the range of 20–50 Ohm meters. This can be explained by material properties, i.e., the sediment is represented by weathered deposits which are built of marls with interlayers of clayey limestones, calcareous marls, and silty marls (see geological column, Figure 4). Even some weakened zones/fault areas can be assumed on this cross section (middle part, Figure 10). Higher resistivity values (>50 Ohm meters) are found on the deepest part of the cross section, indicating that the materials are generally still the same but the weathering effect is probably not so expressed (bedrock; upper Badenian and lower Sarmatian).

ERT was applied on the Hrvatska Kostajnica landslide to determine the physical properties of soil and rock, subsurface lithology, groundwater condition and geometry of the slide surface [11,40,48,55,60]. According to the measured resistances, it can be concluded that the landslide has multiple sliding surfaces and that the highly deformed materials are present mainly in the main body of the landslide (Figures 10 and 11). The cross

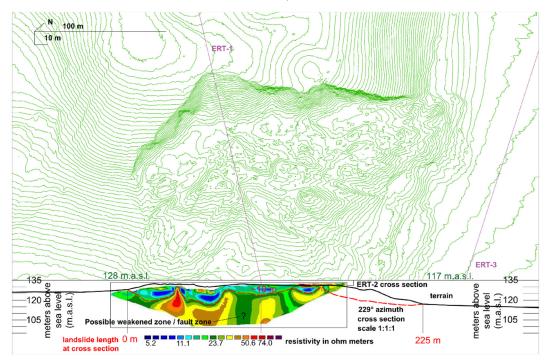
Figure 11. Hrvatska Kostajnica landslide cross section (perpendicular to movement) and interpreted ERT-2 data. At cross section area the length of the landslide is 225 m with slide surface at the depth of ~10 m. In the middle part of the cross section possible fault zone is present (marked with question mark). The contour line interval on the topographical map is 1 m.
