Article

Experimental Investigation on the Structural Performance of Single Span Hollow Core Slab under Successive Impact Loading

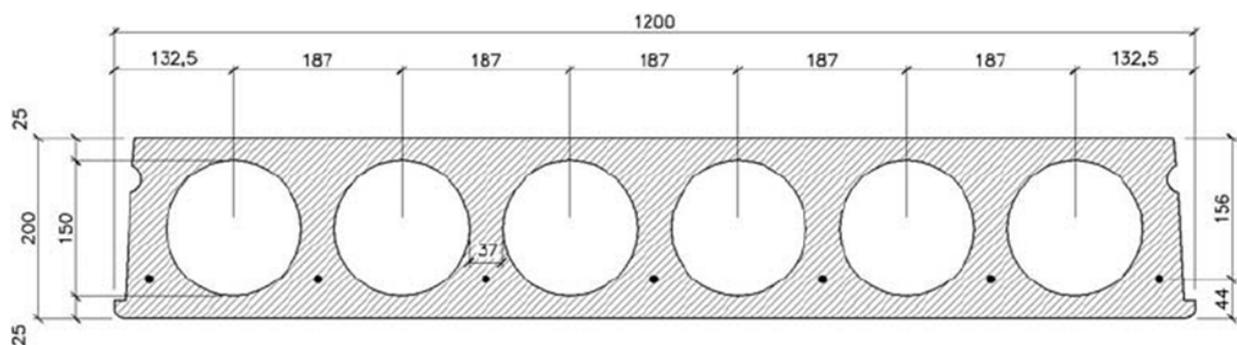
The analyzed slab is a structure 6000 mm in length by 2400 mm (width) and 200 mm thickness as illustrated in Figure 1.

Figure 1. Layout and cross-section details of a typical pre-stressed concrete hollow core slab unit.

The hollow core slab unit was selected based on the thickness to span and characteristic service loads where a 200 mm hollow core slab with a 6 m long span can support 10.5 KPa according to the manufacturer.

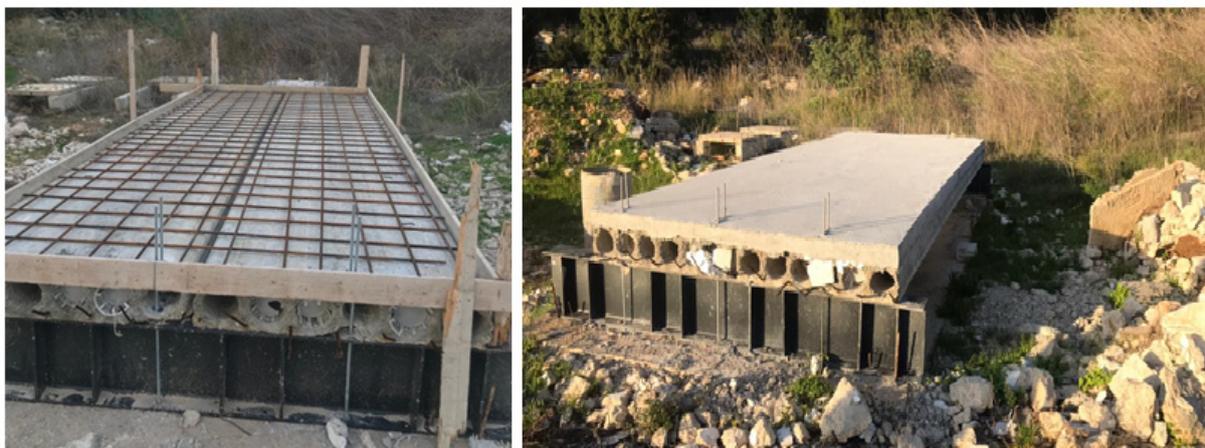
The slab system consists of two precast hollow core units. As illustrated in Figure 2 they were placed side by side to accomplish a width of 2400 mm, in addition to a 100 mm cast in place concrete topping.

Figure 2. Single span hollow core slab with concrete topping site execution.

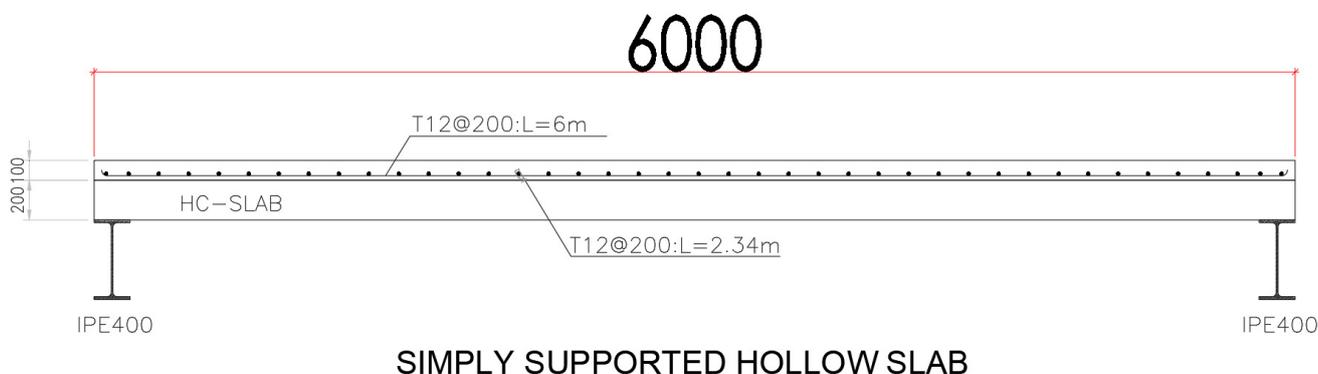
The topping slab is made of concrete with a 45 MPa compressive strength and includes steel reinforcement bars as illustrated in Figure 3.

The bars are of 12 mm diameter spaced at 200 mm in both directions with no use of shear connectors or any other type of shear reinforcement. They have an average modulus of elasticity and tensile strength of 200 GPa and 515 MPa, respectively.

Figure 3. Layout and cross-section details of hollow core with concrete topping. Construction materials properties were grouped in Table 1.

Item	HC Slab	Topping Slab
Compressive Strength (MPa)	48	48
Reinforcement	6 ϕ 9.53 1 ϕ 12.5	6 ϕ 12/m
Reinforcement Tensile Strength (MPa)	1860	420

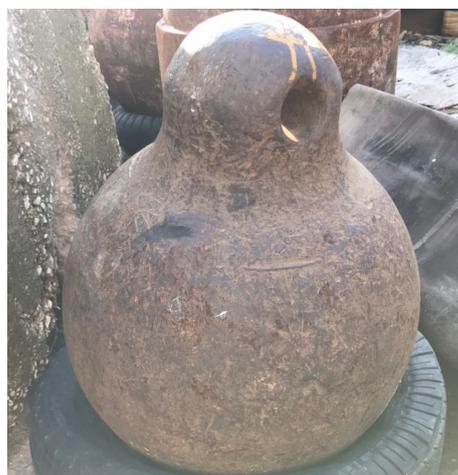
The mass of the drop-weight used in the experimental program is 600 kg (Figure 4). The drop-weight is a steel ball to ensure that the striking surface of the drop-weight is consistent and to avoid the inconvenience that can take place in case of cube striker with sharp edges and corners.

Figure 4. The slab Impactor used: 600 kg Steel Ball.

The impact loads were generated by what was essentially a free-fall condition of the drop weight. The cable of the moving crane attached to the steel ball ran through the center of the drop-weight and was used to guide the weight during the fall.

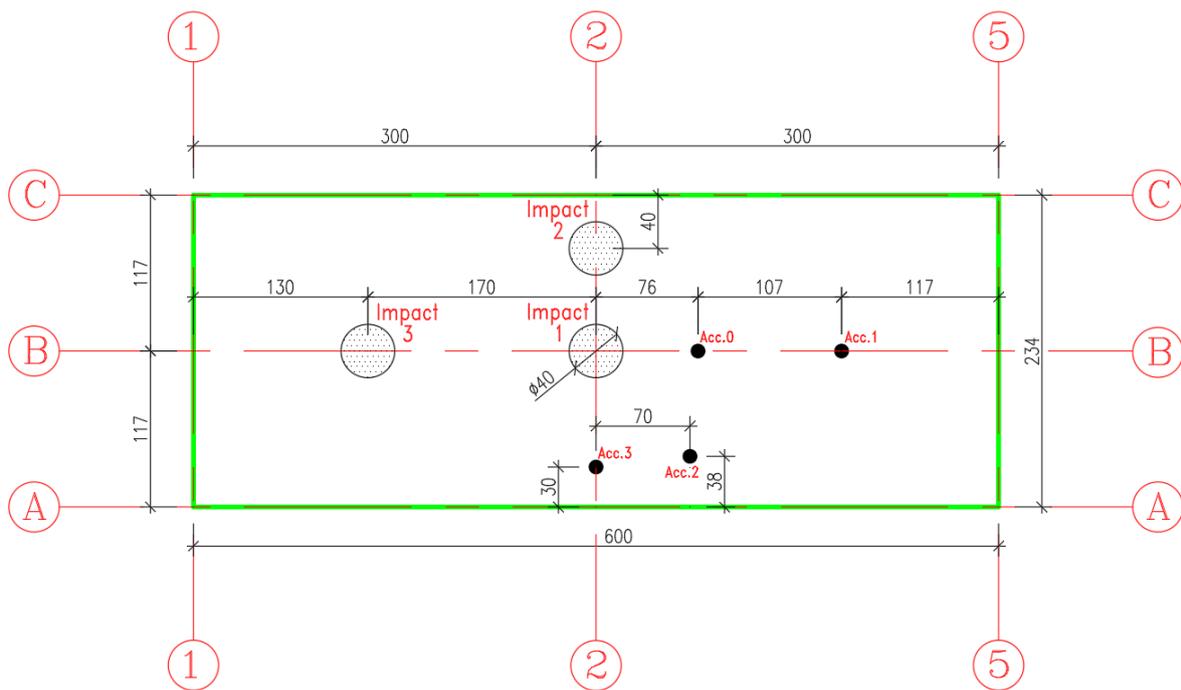
The hollow core slab was tested under successive impact loading at three different locations: Slab center, edge, and near the support as illustrated in Figure 5.

Figure 5. Successive impact locations, layout, and positioning of accelerometers.

The experimental analysis consists of simulating a slab subject to a series of successive impacts. The tests involve dropping a steel ball of 600 kg as illustrated in Figure 5 from a given height of 14 m. The steel ball velocity just before impact is about 16.57 m/s. The impact energy (E) and block velocity (v) just before impact are approximated by mean of the relation:

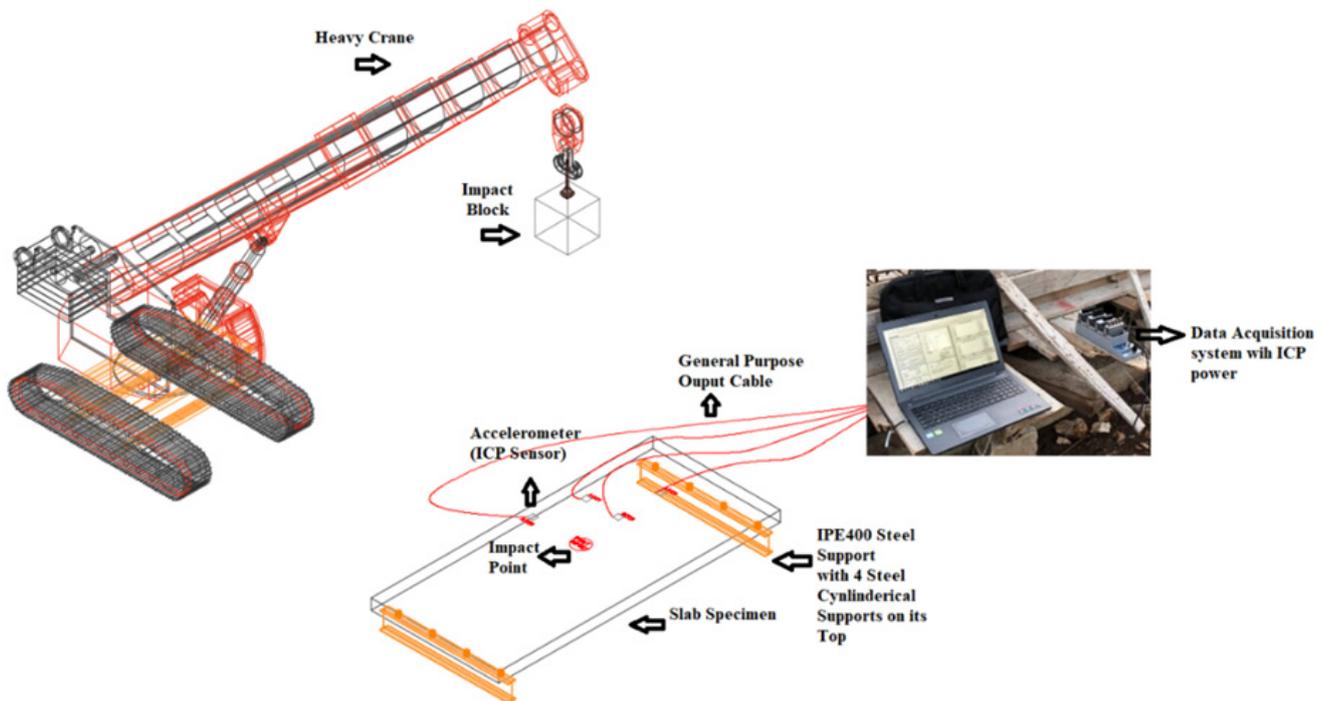
The hollow core slab was mounted by four electronic accelerometer fixed at different positions as shown in Figure 6. The choice of accelerometers’ locations is selected to be excluded from the impacted area to avoid any damage in this sensors which may generate nonrealistic readings. These sensors were attached to a data acquisition system to register readings during the impact

Figure 6. Test setup with all experimental components.

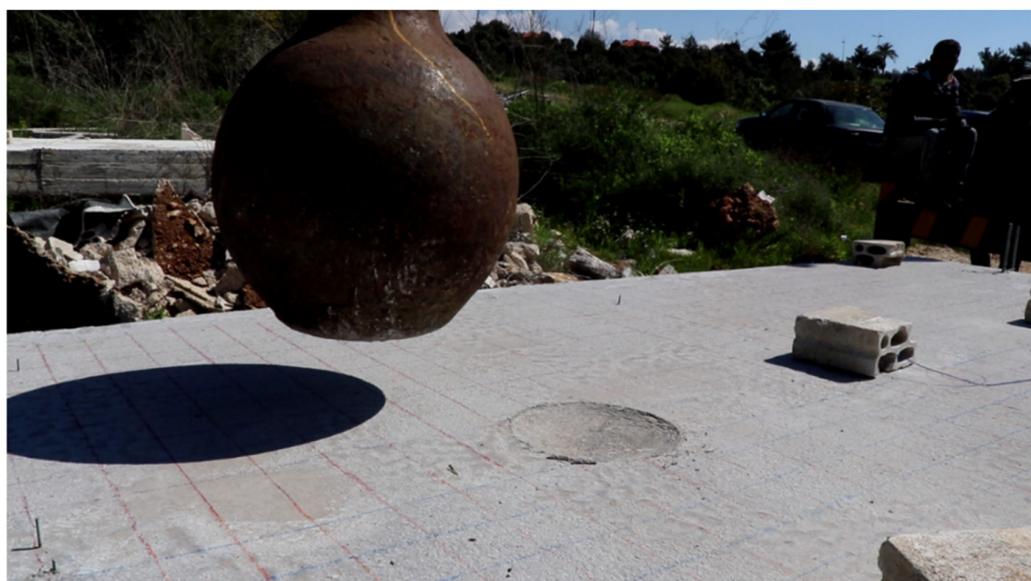
Figure 7. Structural damage in the concrete topping from the first impact.

- Impact crater diameter 28 cm;
- No cracks in the topping slab;
- No punching with a 2 cm impact penetration through the slab thickness.

The drop weight is lifted to the dropping height by a crane as shown in Figure 7. A specific device is used to release the impact weight without any initial speed.

- First Impact Experimental Observations (Figures 7 and 8):

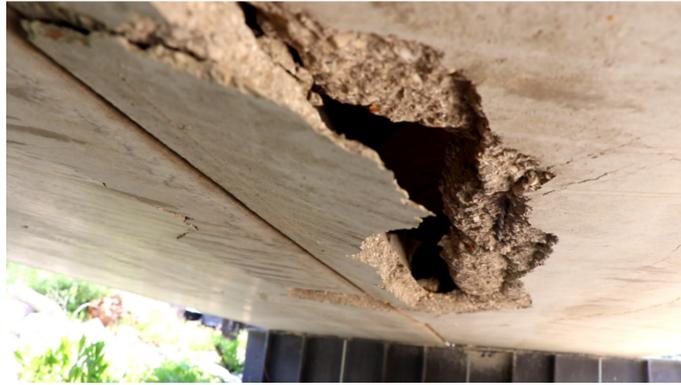
- No global failure in the hollow core units;
- Local damage directly beneath the impact represented by the spalling of the 25 mm concrete cover from the bottom side as illustrated in the figure below;
- Overall damages were concentrated in the lower unreinforced flange of the hollow core unit;
- No damage in the upper flange of the hollow core unit was assessed (Topping slab and hollow core unit worked compositely);
- There is no separation between the concrete topping and the hollow core unit;
- No de-bonding between the embedded strands and the concrete host.

Figure 8. Closed view for the structural damage in hollow core slab from the first impact.

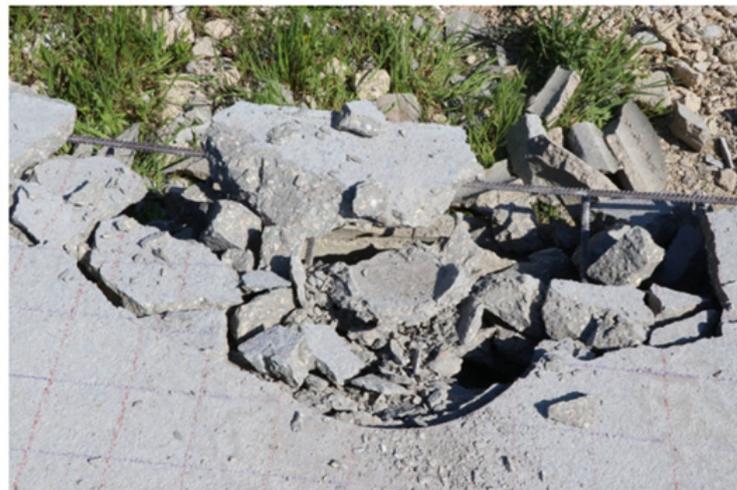
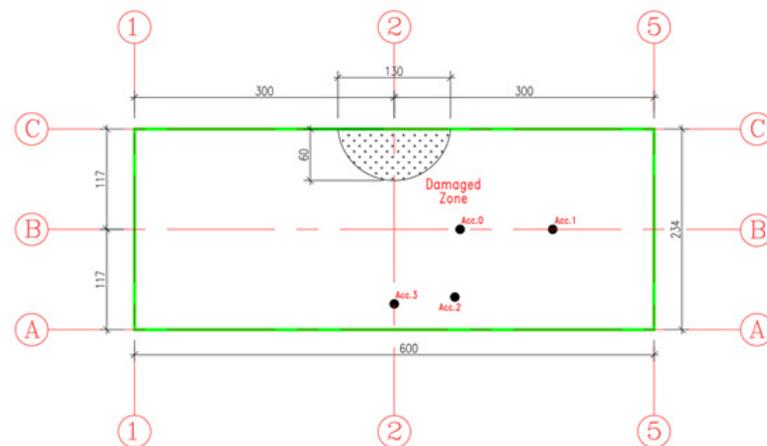
- Concrete fracture at the impact location with damaged zone;
- Transversal crack passing through the depth was initiated in the topping slab and the hollow core unit;

- Severe shear damage normal to the slab caused a cut off for the first three cores of the hollow core unit;
- Total concrete failure of the web, top, and bottom flanges of the hollow core unit;

- Normal and transversal contact separation between the concrete topping and the hollow core units;
- The first three tendons were de-bonded from the hollow core unit because of the concrete failure of the web, top, and bottom flanges of the hollow core;

- The total stiffness of the hollow core unit was highly reduced by the loss of three of its cores with their strands;
- The composite behavior between the concrete topping and the hollow core unit in terms of flexural rigidity was highly reduced because of the surface contact separation;

- As expected, the edge impact caused a much higher damage in both the concrete topping and hollow core unit as compared to the one done by the first impact at the center.

Figure 9. The damaged zone in concrete topping after the second impact.

- Second Impact Experimental Observations (Figure 9):

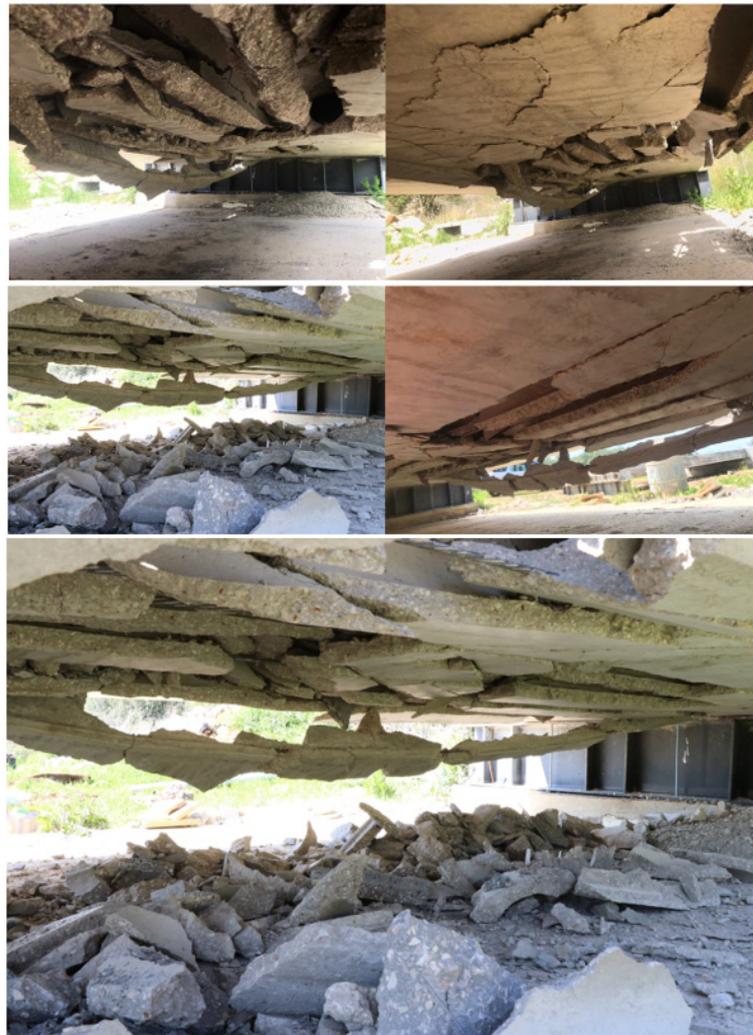
- Impact crater diameter 35 cm;
- No cracks in the topping slab;
- Concrete topping was punched through its depth (high shear force near the support);

- Large damage distributed along the whole parts of the hollow core units;
- Major concrete failure of the web, top and bottom flanges of the hollow core unit;
- The brittle damage in the top and bottom thin flanges connecting the webs leads to a total loss of hollow core slab stiffness;

- The brittle damage in the web connecting the two flanges leads to a total loss of hollow core slab stiffness mainly when the lower part where the pre-stressing strands are embedded separates from the gross the section of the slab;
- The brittle failure of the top and bottom thin flanges governs the global behavior of the slab.

Figure 10. Structural damage from the bottom side after the third impact.

- Third Impact Experimental Observations (Figure 10):

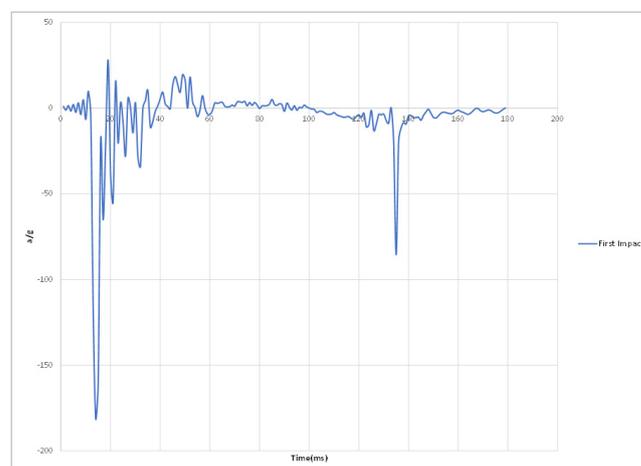
Figure 11. First impact peak accelerations response plot.

Impact	Peak Acceleration	Damping Ratio (%)	Impact Force (KN)	DMF
First Impact	−182 g	16.1	1498.25	12.35
Second Impact	−31 g	5	1008.61	8.317
Third Impact	−21 g	8.5	1275.6	10.52

Experimental results of the three impacts are summarized in Table 2 where peak acceleration for each impact was extracted from the accelerometer readings illustrated in Figures 11–14.

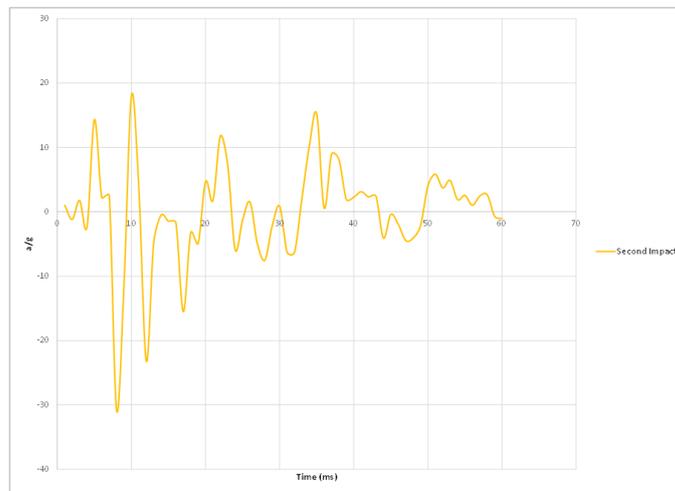
Figure 12. Second impact peak accelerations response plot.

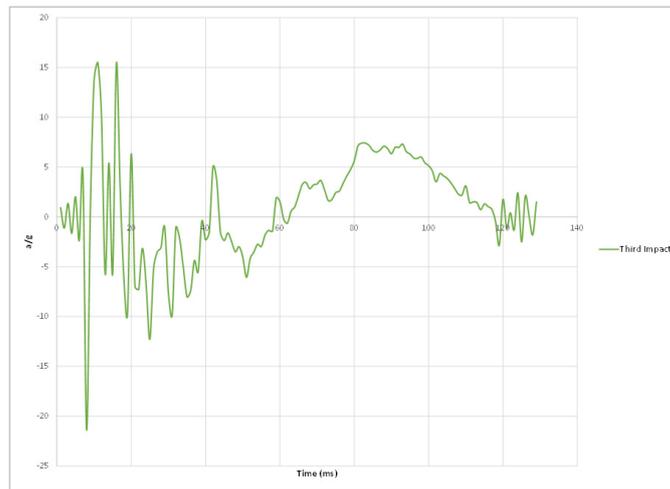
Figure 13. Third impact peak accelerations response plot.

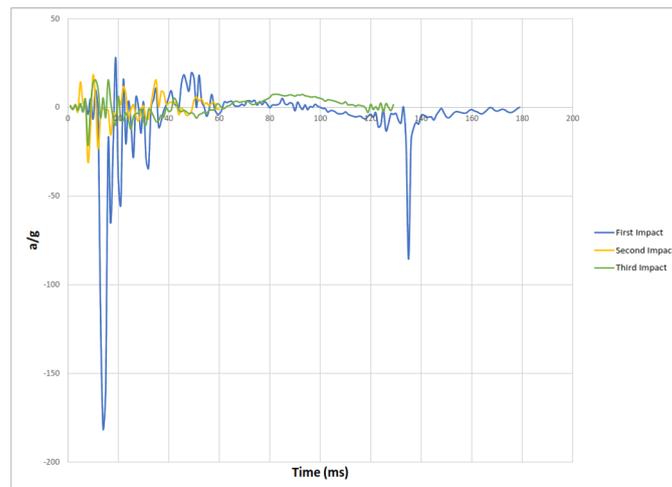
Figure 14. Peak accelerations response plots.

- The decaying function of the acceleration response represented by the accelerometers readings indicate an unconventional damped vibration. This response can be explained by the following reasons:

- The reduction in slab capacity to resist impact can be demonstrated by the ratio of the maximum acceleration response between the first and the third impact $\frac{182 * g}{21 * g} = 8.667$.
