# Magnetic resonance imaging features of complications following hip replacement: A pictorial review

## Abstract

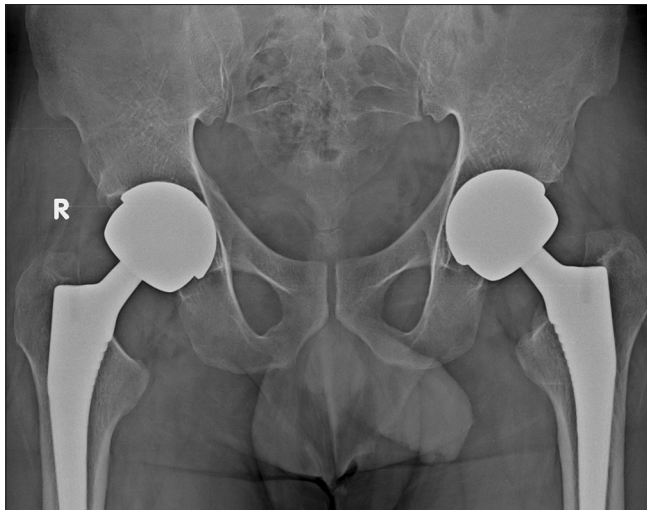
**Figure 1:** Frontal radiograph shows bilateral total hip replacement

Total hip arthroplasty (THR) involves either total replacement of the femoral head as well as neck and the acetabulum by separate prostheses [Figure 1] or a surface replacement or a “double cup” resurfacing arthroplasty [Figure 2] where only resurfacing of the femoral and the acetabular articular surfaces with metal cups is done.

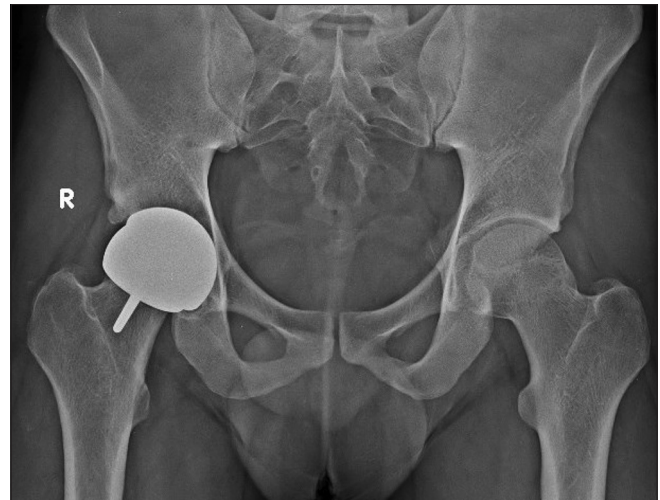
**Figure 2:** Frontal radiograph shows resurfacing arthroplasty of the right hip

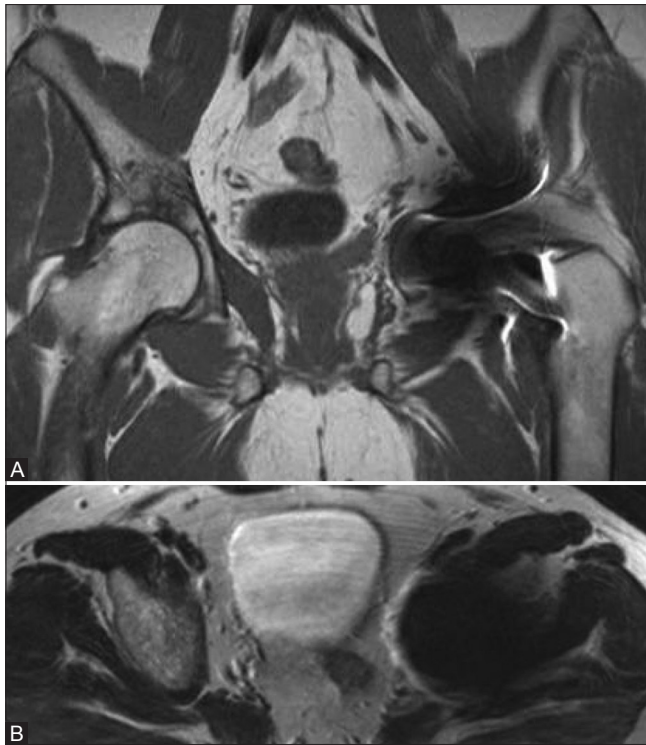
**Figure 3 (A and B):** Conventional coronal T1W (A) and axial T2W (B) images in a patient with left hip resurfacing show extensive artefacts, obliterating soft tissue details

artefacts on magnetic resonance imaging (MRI) [Figure 3] and beam hardening on computed tomography (CT) and positron emission tomography (PET)/CT scan, which prevents accurate evaluation of regions of interest near the implants.<sup>[2,3]</sup> Although PET/CT scan provides both functional and anatomic details and can diagnose a problem with high sensitivity,<sup>[1]</sup> it lacks specificity in differentiating periprosthetic infection from loosening or inflammation. Dual energy CT scanners with metal artefact reduction sequences (MARS) protocols reduce artefact considerably and in the future may likely be a viable alternative to MRI.

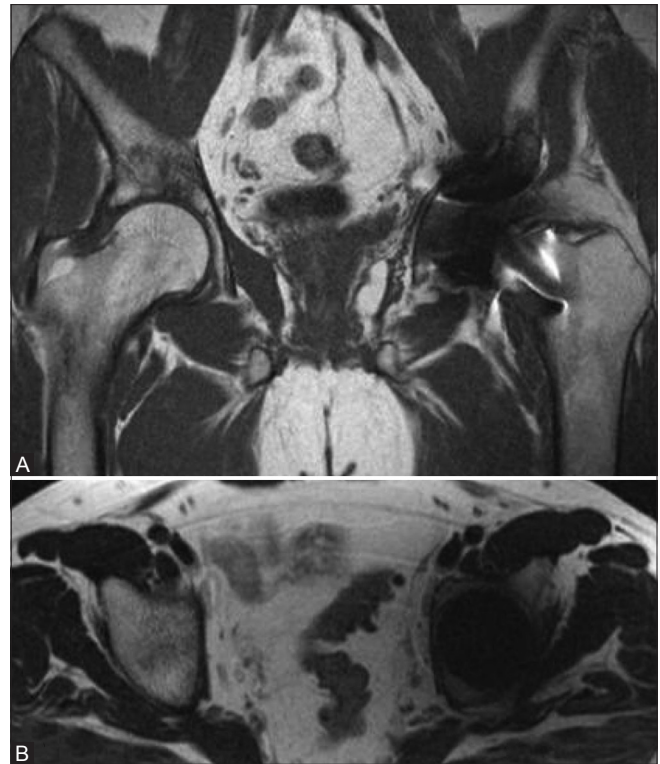
**Figure 4 (A and B):** Images corresponding to Figure 3 after the application of the MARS sequences show significant reduction in the metal artifact and better visualisation of the soft tissue details

Lately, with the advent of MARS and newer instrumentation, the challenge of susceptibility artefacts due to metal implants has largely been overcome.<sup>[4,5]</sup> [Figure 4]. Through this article, we intend to provide an insight into the MRI features of various associated complications.

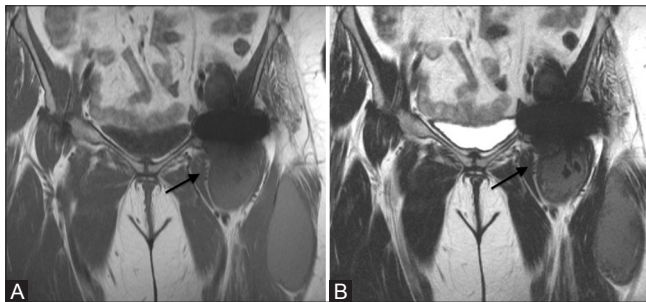
**Figure 5 (A and B):** Coronal T1W (A) and T2W (B) MARS images show a large multiloculated, low T2 signal intensity periprosthetic soft tissue mass (arrow) on the left

Periprosthetic soft tissue [Figure 5] is defined as abnormal fluid/intermediate-to-low signal intensity

lesion adjacent to the prosthesis on T1W and T2W images. The low signal on T2-weighted images reflects metal deposition<sup>[6,7]</sup> [Figure 5]. This was found in 80 hips. These are reactive masses also known as pseudotumors<sup>[6,7]</sup> and have been labelled histologically “aseptic lymphocyte-dominated vascular-associated lesions.”<sup>[6]</sup> The proposed pathophysiology behind formation of these masses/fluid collections include elements of delayed hypersensitivity reactions as well as direct toxic effects of metal ions.

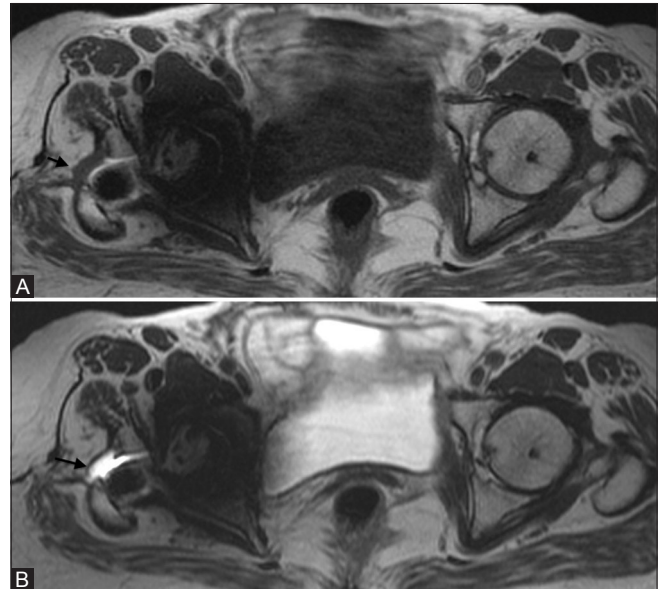
**Figure 6 (A and B):** Axial T1W (A) and T2W (B) MARS images show a thin-walled type 1 collection (arrow) anterior to greater trochanter on the right

The periprosthetic soft tissues are classified into three types based on MRI findings: Type 1 [Figure 6], cystic masses with wall <3 mm; type 2 [Figure 7], cystic masses with wall >3 mm but less than the diameter of the cystic component; and type 3 [Figures 8 and 9], predominantly solid masses.<sup>[13]</sup> The size of the mass and its relationship to surrounding structures is meticulously defined. Careful inspection for communication of collection with joint is done to avoid erroneously labelling a thickened non-communicating trochanteric bursa as a “reactive mass.” [Figure 10].<sup>[6]</sup>

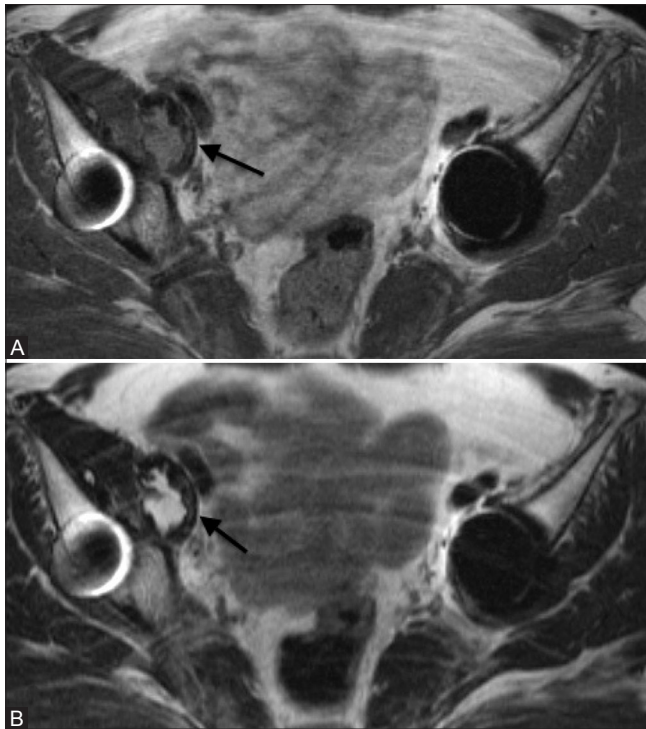
**Figure 7 (A and B):** Axial T1W (A) and T2W (B) MARS images show a thick-walled type 2 collection (arrow) within the right iliopsoas muscle

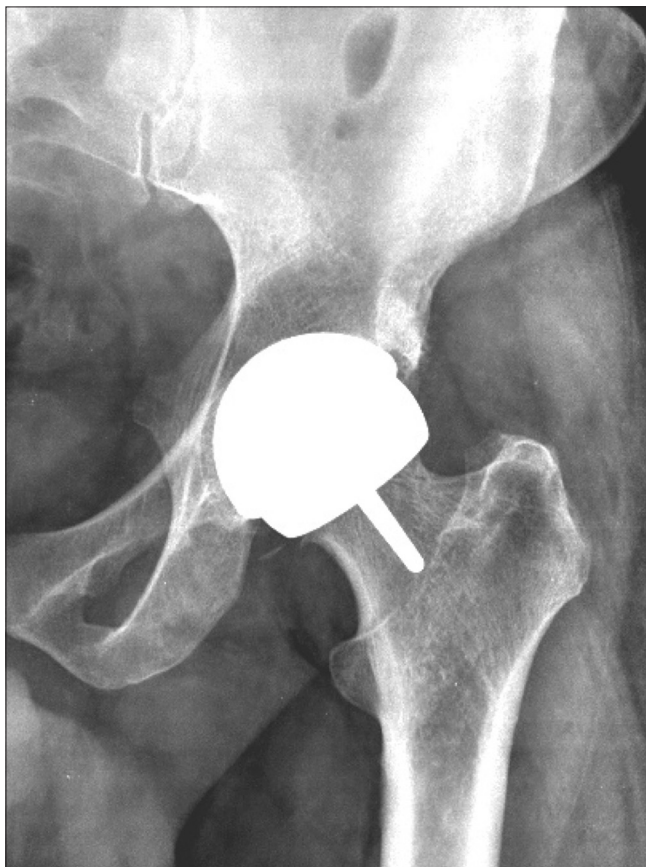
**Figure 9:** Frontal radiograph of the same patient shown in Figure 8 showed no abnormality

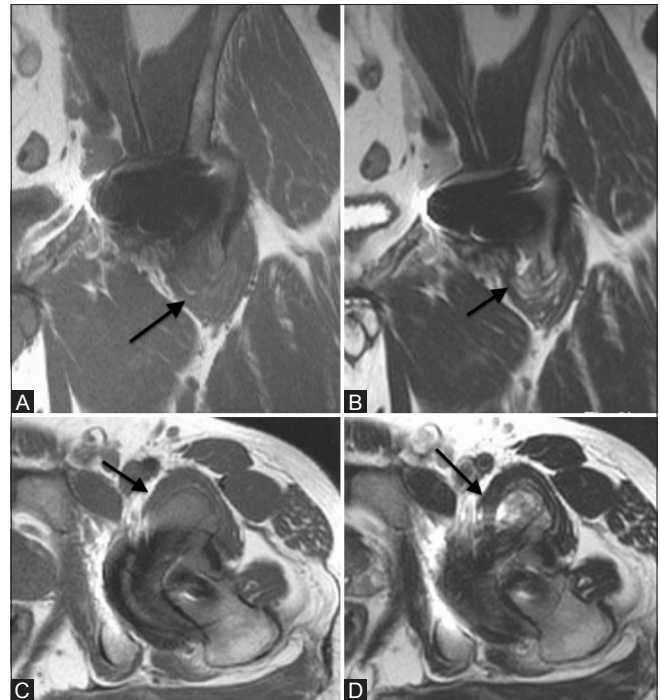
**Figure 8 (A-D):** Coronal T1W (A), T2W (B) and axial T1W (C) and T2W (D) images show a heterogenous thick-walled periprosthetic soft tissue (arrow) in the left iliopsoas bursa

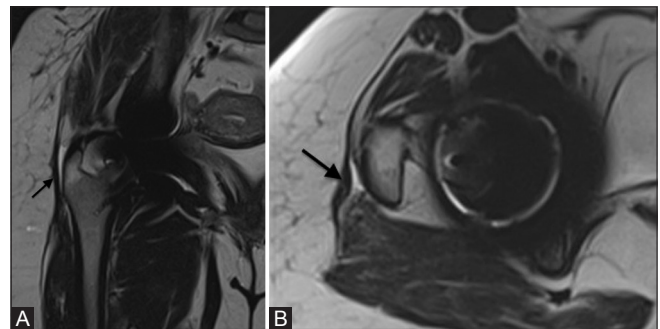
**Figure 10 (A and B):** Coronal (A) and axial (B) T2W images show fluid in the right trochanteric bursa not communicating with the joint space (black arrow)

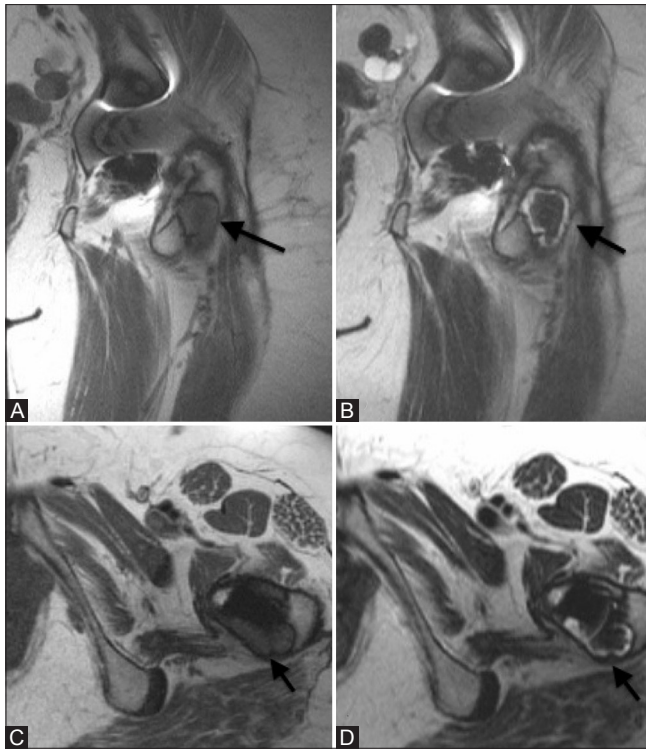
**Figure 11 (A-D):** Focal particle disease. Coronal T1W (A) and T2W (B) and axial T1W (C) and T2W (D) images show a well defined focal areas of osteolysis with low T2 signal soft tissue (arrow), at the proximal bone prosthesis interface posteriorly

[Figure 11]. The presence, location (acetabular, femur or both), as well as size are recorded. The pathophysiology behind this periprosthetic osteolysis is essentially the same as that described for the reactive masses.

A focal well-defined area of osteolysis without the surrounding edema is usually labelled as focal particle disease [Figure 11]. Linear, long segment, fluid signal-intensity marrow replacement of >2 mm width,

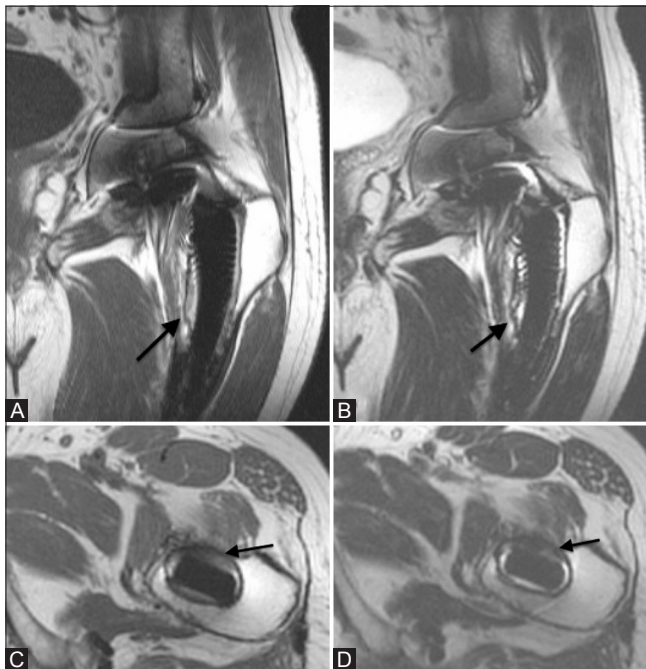
**Figure 13 (A-D):** Loosening. Coronal T1W (A), T2W (B) and axial T1W (C) and T2W (D) images of the same patient with bilateral THR show linear fluid signal (arrow) tracking along the bone prosthesis interface on the left. Obvious marrow edema is not seen

along the bone prosthesis interface, without significant marrow edema, is suggestive of aseptic loosening of the prosthesis [Figures 12 and 13]. An irregular ill-defined area of osteolysis with marrow edema is usually seen in cases of infection [Figures 14 and 15]. Presence of enlarged lymph nodes adds to the level of confidence.

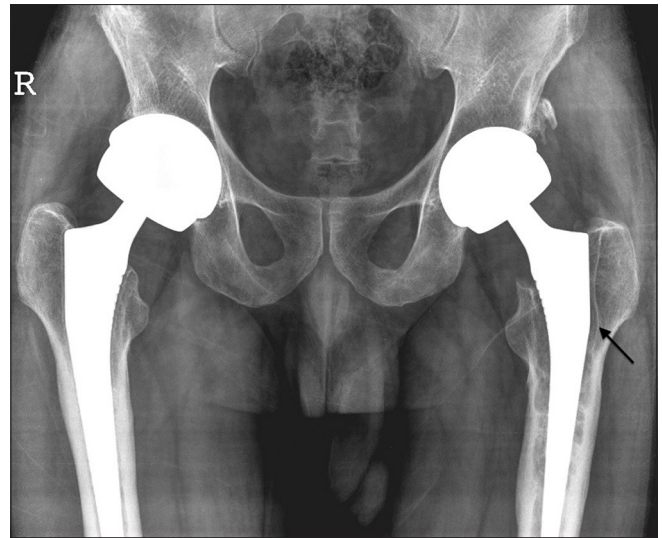
**Figure 12:** Frontal radiograph of the pelvis shows linear lucency (arrow) along the bone prosthesis interface on the left

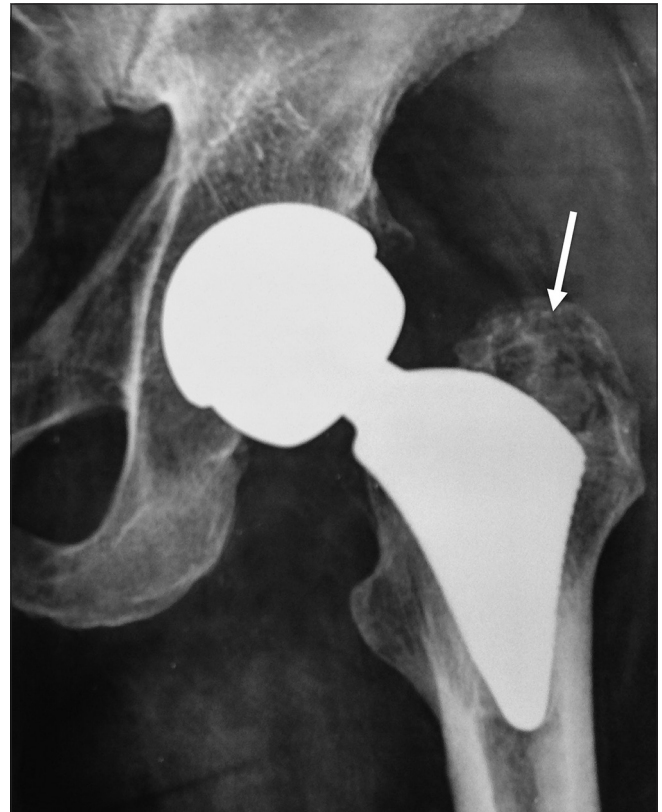
**Figure 14:** Osteomyelitis. Plain radiograph of a patient with left THR and swelling of the left thigh, shows an ill-defined osteolytic area with possible sequestrum (arrow) in the left greater trochanter region

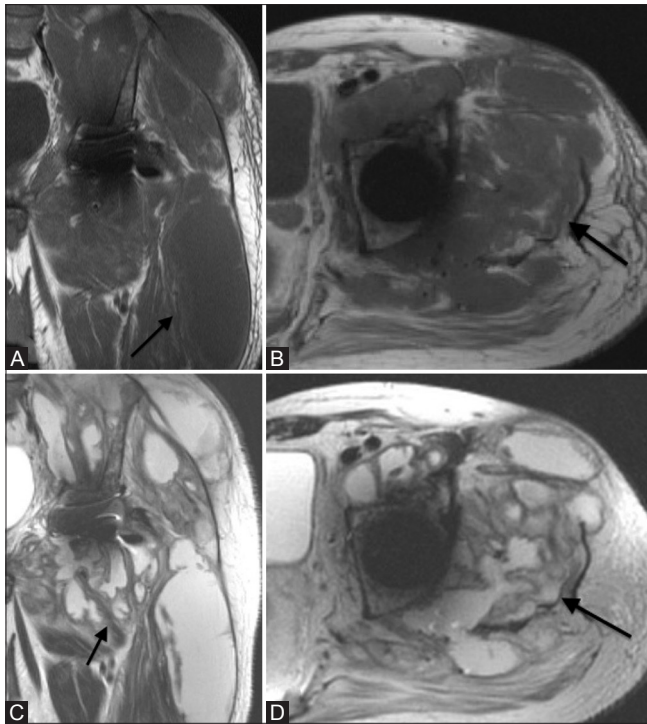
**Figure 15 (A-D):** Coronal and axial T1W (A,B) and T2W (C,D) images of the same patient show associated large multiloculated abscesses (arrow)

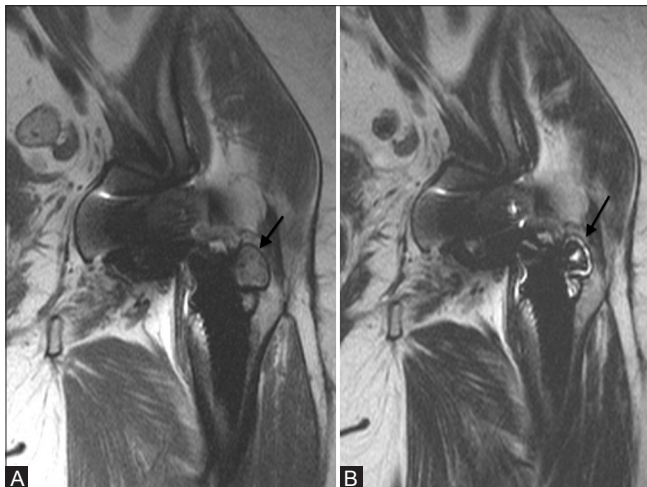
**Figure 17 (A and B):** Coronal T1W (A) and T2W (B) images of the same patient shown in Figure 16, show a well defined focal area of osteolysis (arrow) at the bone prosthesis interface laterally, confirming the radiographic lucency to be focal particle disease

Three patients in whom radiographs were suggestive of periprosthetic osteolysis involving the greater trochanter, were found to have no osteolysis on MR, and thus MR helped in differentiating normal periprosthetic osteopenia that occurs in areas of stress shielding from particle disease

[Figures 16 and 17]. Calcar resorption is also sometimes mistaken as pathological osteolysis and absence of marrow edema on MR adds to the diagnostic confidence of this being a normal post-arthroplasty appearance. Stress loading distally may result in cortical thickening and bridging sclerosis at the tip of the prosthesis (called pedestal). Understanding of these normal post-arthroplasty appearances has become important with the increasing use of bone ingrowth prosthesis, which results in more reactive changes in the native bone due to the altered stress distribution.

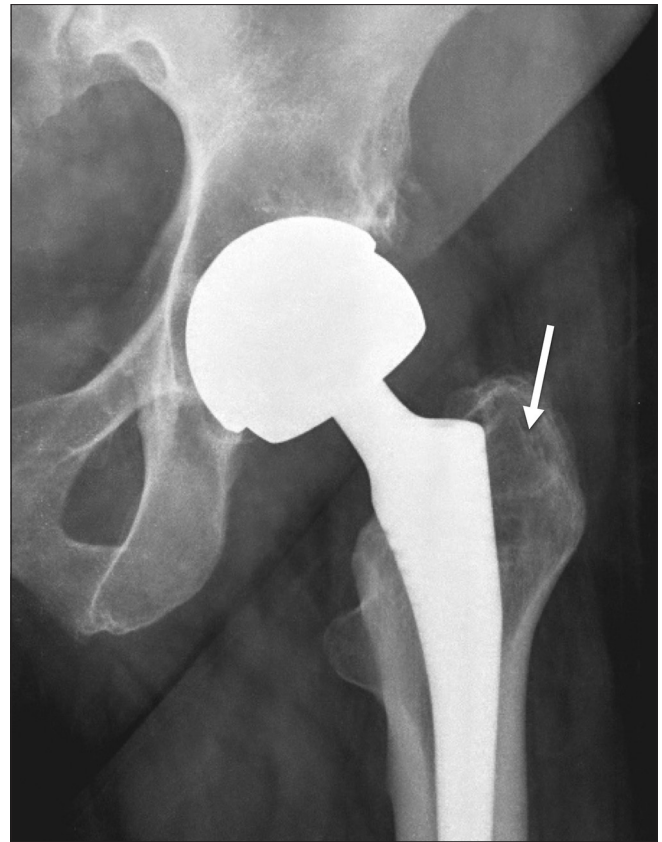
**Figure 16:** Frontal radiograph of a patient with left THR shows periprosthetic lucency (arrow) in the left greater trochanter. It is difficult to confidently differentiate periprosthetic osteopenia due to stress shielding from osteolysis due to particle disease

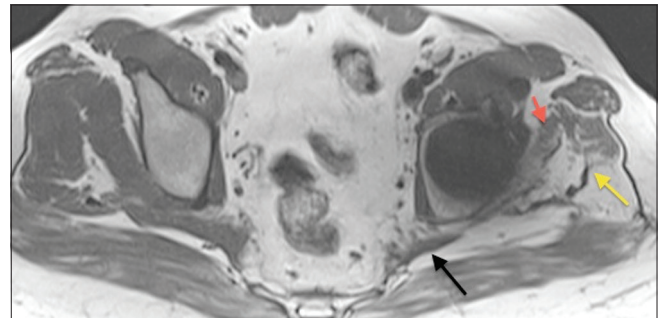
**Figure 18:** Axial T1W image shows severe atrophy of the left gluteus minimus (red arrow) and medius (yellow arrow) with fatty infiltration. Moderate atrophy of the left piriformis (black arrow) is also seen

time, however, still remains the most important factor differentiating between the two. The gluteus, piriformis, and iliopsoas muscles are assessed for the presence of atrophy [Figures 18 and 19], defined as loss of volume and the presence of fatty replacement, as well as for the presence of muscle edema [Figure 20], defined as the presence of high signal intensity on inversion recovery images. Gluteal maximus atrophy—moderate-to-severe was appreciated in 10 hips, gluteus medius, and minimus atrophy was seen in 25 hips. 39 of 179 hips had iliopsoas atrophy and 41 had atrophy of the piriformis.

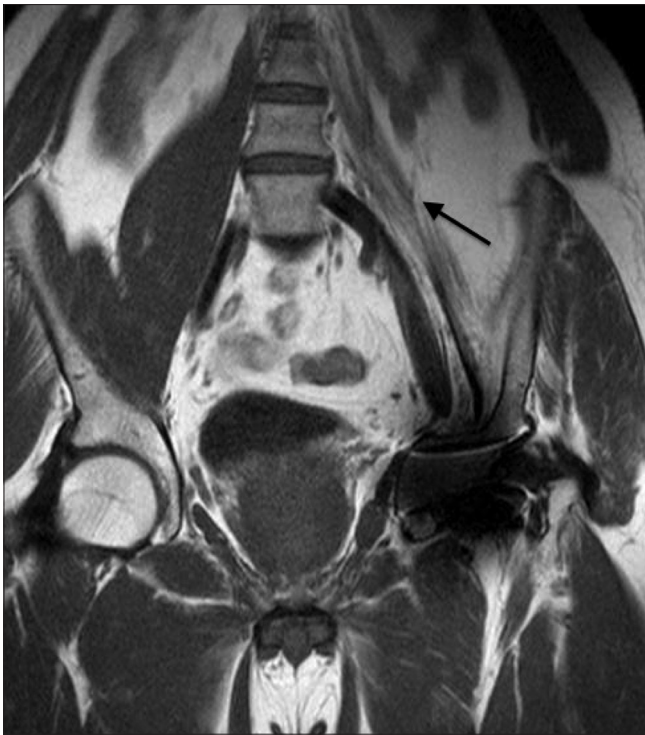
**Figure 19:** Coronal T1W image shows severe atrophy (arrow) of the left iliopsoas muscle

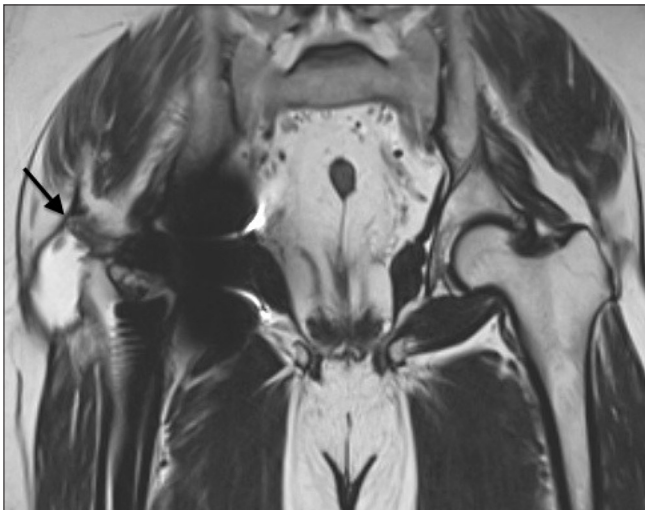
**Figure 21:** Coronal T1W image shows a tear of the tendinous insertion of the right gluteus medius from its insertion on the greater trochanter (arrow)

The presence or absence of a tear [Figure 21] is graded as follows: 1, no tear; 2, partial-thickness tear; or 3, full-thickness tear.

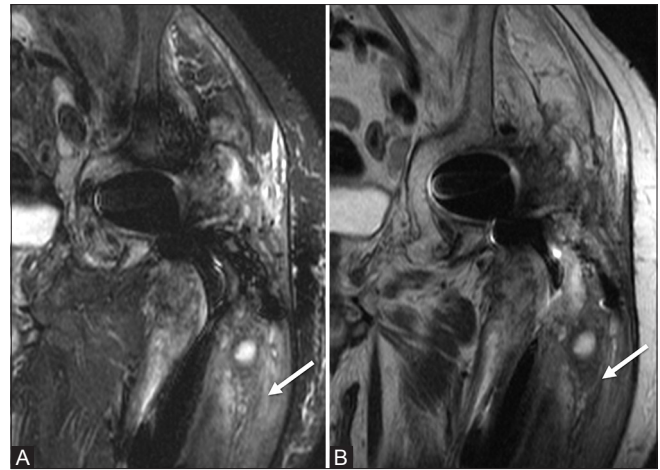
**Figure 20 (A and B):** Coronal STIR (A) and T2W (B) images show edema (arrow) of the muscles of the left thigh

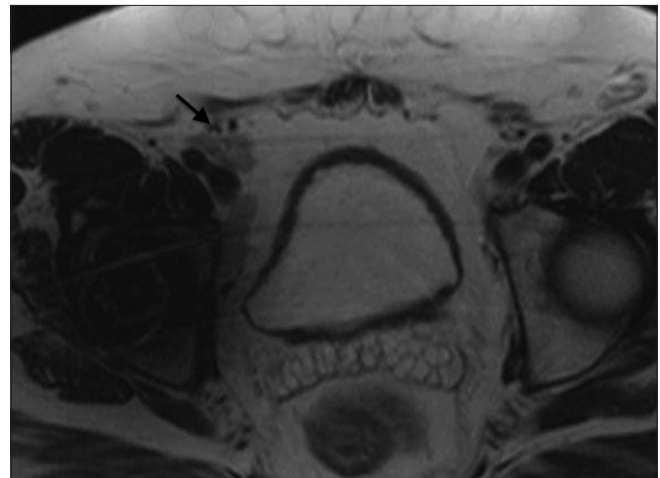
**Figure 22:** Axial T2W image shows an enlarged right external iliac lymph node (arrow)

The pelvic region is assessed for enlarged lymph nodes [Figure 22] with enlargement being defined as >1 cm in short axis diameter. Lymphadenopathy was reported in 12 patients. Abductor tendon tear was seen in 3 and muscle edema in one hip.
