Article

Flexural Behavior of Ultra-High-Performance Fiber-Reinforced Concrete Beams after Exposure to High Temperatures

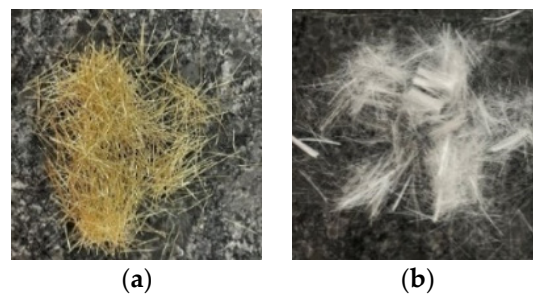
Figure 1. The appearance of the fibers: (a) steel fibers and (b) polypropylene fibers.

- Fiber: purchased from Gulili Co. Ltd., short micro steel fiber (according to ASTM A820) with a length of 13 mm and a diameter of 0.2 mm and polypropylene fiber with a length of 12 mm and a diameter of 0.05 mm, as shown in Figure 1. The basic properties of the two fibers are shown in Table 4.

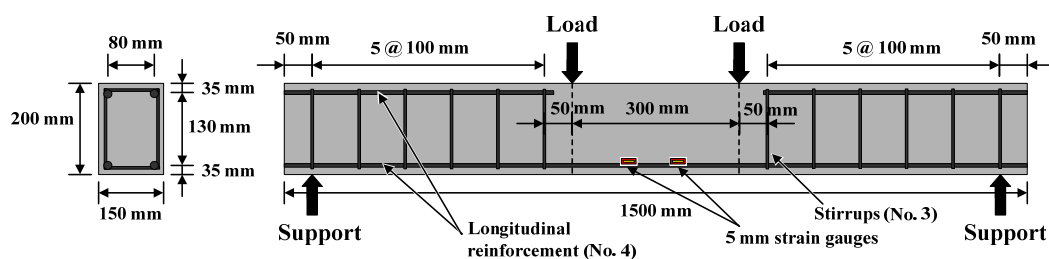
Figure 2. The details of the reinforcement used for the beam specimens.

The flexural and shear designs of all beam specimens were carried out in accordance with the ACI 318M-14 design code. All the beams were singly reinforced with two #4 rebars (minimum reinforcement ratio) as a longitudinal tensile reinforcement at the bottom of the specimen and at an effective depth of 165 mm. In addition, two #4 rebars at the top were used for fixing stirrups (#3 rebar), and they were cut at the mid-span of the specimen. The beam specimen was equipped with a suitable concrete protective layer and the length from the center of the longitudinal steel bar to the surface of the specimen was 35 mm. The specimen was designed to resist shear failure when the longitudinal tensile reinforcement yielded so as to obtain pure flexural failure in the center of the beam span. For this reason, from the beam end support point to one-third of the span of each side, #3 was used as stirrups with a spacing of 100 mm. The size of the beam specimen and the detailed configuration of the steel rebars are shown in Figure 2. In addition, thermocouples were embedded 3.5 and 7 cm from the side surface of the specimen in the midpoint of the beam span, as shown in Figure 3. Before the concrete beam was poured, the thermocouple was fixed at the planned buried position with a temporary steel support. When pouring, the mixture was poured in slowly to avoid damaging the thermocouple. In this study, a four-point loading method was used and a shear span ratio (a/d) of 3.33 was used.

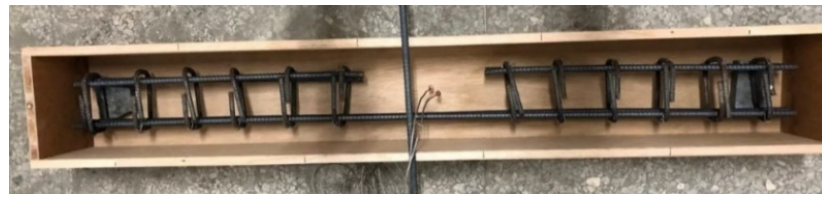
Figure 3. The configuration of the steel rebar and thermocouple.

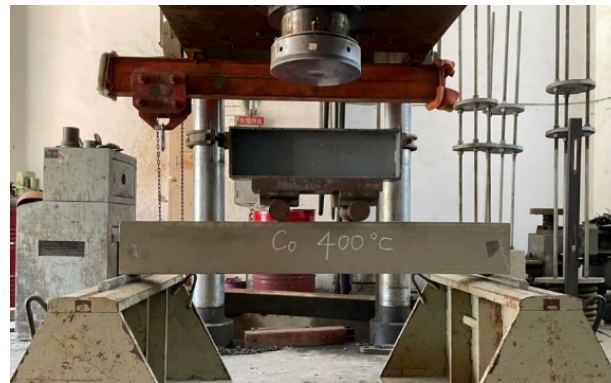
Figure 4. The general flexural test setup for the beam specimens.

At each target temperature, the control group and the experimental group have two beam specimens for flexural tests. The installation of the specimen is shown in Figure 4. An electro-hydraulic servo actuator with a maximum load of 6000 kN was used to apply a monotonic load, and an additional force sensor was installed to ensure the accuracy of the load data. The beam specimen was placed on the two supports of the testing machine and the load was applied using the three-point load method (with the use of the transfer steel beam to create the load position shown in Figure 4; the load was added 15 cm from the center to the left and right). The load was gradually applied at a constant rate of 0.98 kN/s. Each loading time was ten seconds, and the load was maintained at a fixed value for five

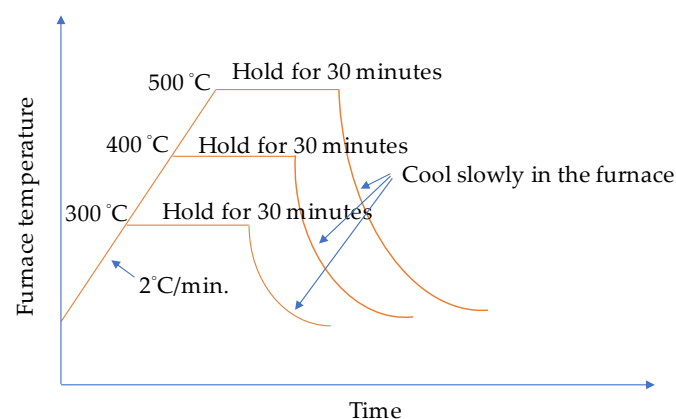
Figure 5. The heating process of the high-temperature test.

Furthermore, there were three types of designed target temperatures: 300, 400, and 500 °C. In order to prevent the beam specimen from spalling during the high-temperature heating, the specimen was pre-dried in a constant temperature furnace at 105 °C before high-temperature heating took place to evaporate part of the moisture inside the specimen. After drying, the specimen was placed in a high-temperature furnace. Only three sides (bottom and two sides) of the specimen were exposed to high temperatures, and the top surface of the beam was insulated with an insulating layer of refractory bricks. This is similar to the actual situation, where there is a concrete slab on the top side of the beam which prevents heat from penetrating from the top. According to literature [29], when high temperature was applied, the heating rate of all samples was set to a fixed value (2 °C/min). Once the target temperature was reached, the holding time was maintained at 0.5 h, so that the entire specimen reached a better thermal stability. Then, the specimen was allowed to cool naturally in the high-temperature furnace to a normal temperature of 23 °C. The schematic diagram of the temperature change in the furnace is shown in Figure 5.

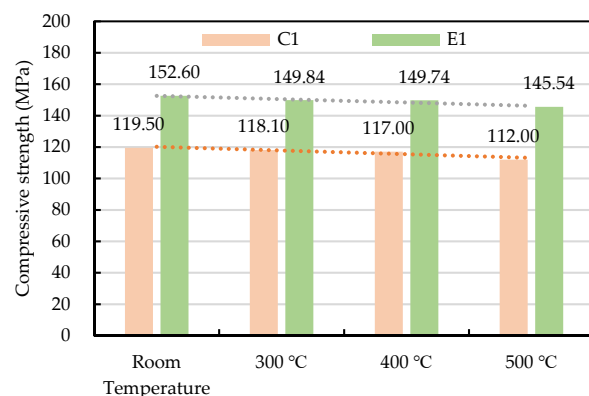
Figure 6. The trend of the residual compressive strength of the concrete after being subjected to high temperatures.

On the other hand, at 56 days of age the HSC and UHPC were tested to determine their compressive strength at room temperature. It can be seen from Table 7 that, due to the low ratio of W/B and the large amount of pozzolanic reaction in the active mineral mixture, the 56 day compressive strength of the UHPC was 152.6 MPa, which already met the requirements for common UHPC. As for the HSC, its 56 day compressive strength was 119.5 MPa. Moreover, a residual compressive strength test was performed on cylindrical specimens exposed to heat from 300 to 500 °C and cooled to room temperature. The results are shown in Figure 6. In general, after experiencing a high temperature of 300–500 °C, the residual compressive strength of the HSC and UHPC only slightly decreased.

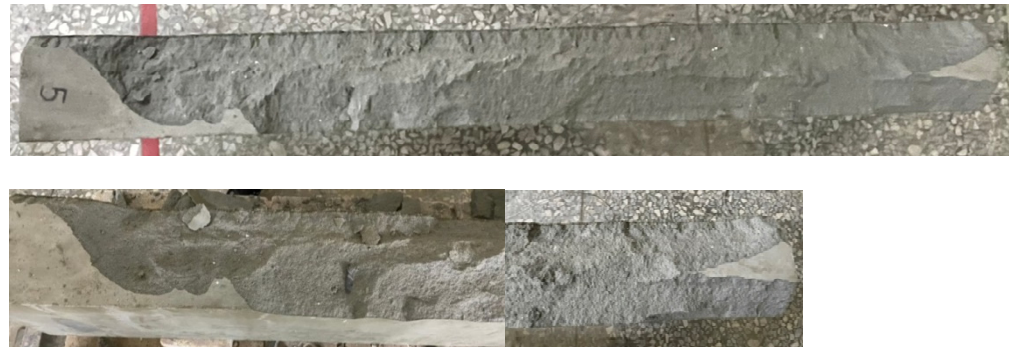
Figure 8. The spalled surface of the HSC beam specimen after being subjected to 500 °C.

It can be seen from the remaining fractions of concrete shown in Figure 8 that the bottom surface of the HSC specimen was simply the corner of the protective layer flake-off, and its range was relatively small. The spalling behavior of the bottom of the UHPC specimen was different. Due to the addition of steel fibers, when the steam pressure inside the beam was sufficient to produce explosive spalling the steel fibers inside the protective layer could provide tensile strength. However, in the case of excessive vapor pressure, the force and range of explosive spalling would also be much larger than that of the HSC specimen without steel fibers, as shown in Figure 9. In other words, the bottom protective layer of the UHPC specimen was completely collapsed. In contrast, the bottom protective layer of the HSC specimen dropped from the tiny corners. As the HSC specimen lacked the bridging effect of the steel fiber, it flaked off separately rather than at the same time. A subsequent three-point load test on the explosively spalling concrete beams was carried out to examine the degree of performance degradation after the fire spalling. In order to improve the excessive internal vapor pressure of the concrete beam at the target temperature of 500 °C, the second specimens of the HSC and UHPC beam were dried in a furnace at 130 °C for 48 h and the highest internal temperature recorded was 67.2 °C. After finishing the 48 h drying operation, the beam specimen was subjected to a high temperature of 500 °C, after which it was found that no more destructive spalling occurred. The study by Shorter and Harmathy [43] shows an important result; when a sample made of concrete that is known to spall is properly pre-dried to produce a thickness of about 50–65 mm, it will not spall at high temperatures. Therefore, they believe that it is reasonable to assume that for each type of concrete, a critical water content or water content distribution could be found, and no spall would occur below the critical water content or water content distribution. The results of this study are similar to this.

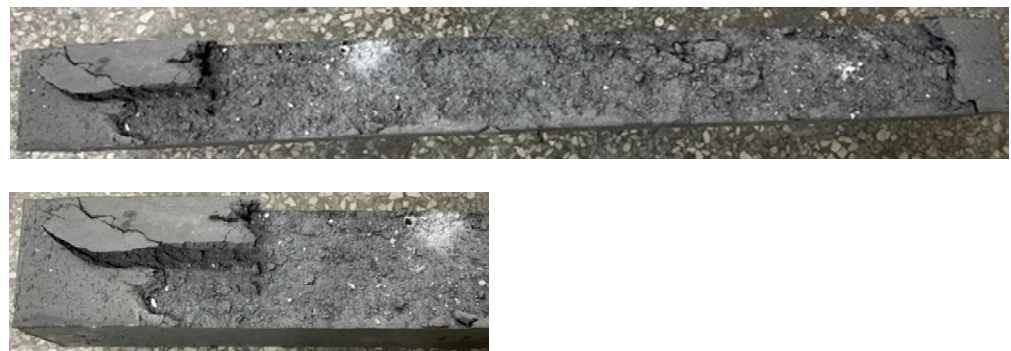
Figure 9. The spalled surface of the UHPC beam specimen after being subjected to 500 °C.

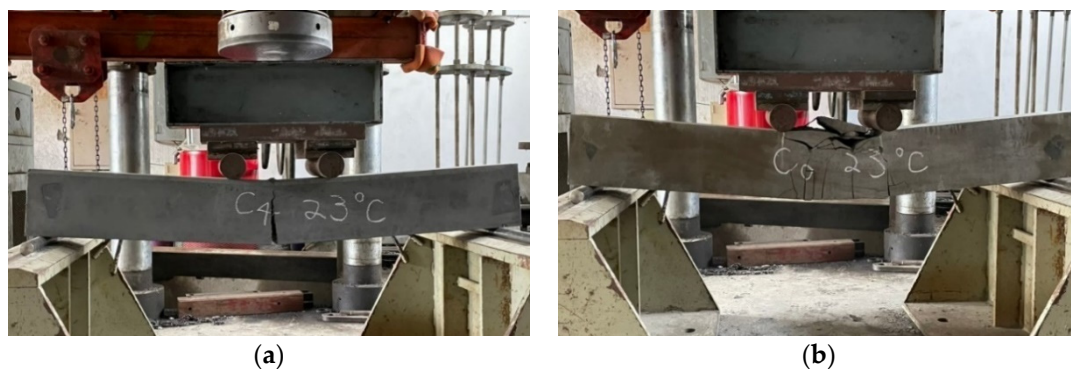
Figure 10. The tensile failure in the flexural test of beam at room temperature: (a) the experimental group and (b) the control group.

The configuration of the stirrups of the beam specimen was limited to the shear span. Its purpose was to prevent the specimen from being damaged by shear failure and cause the specimen to fail in tension so as to compare the flexural behavior of different concrete beams. As the HSC and UHPC beam members were designed to have a relatively low reinforcement ratio, the two groups of beam specimens were a tensile failure, as shown in Figure 10. When the load reached the flexural cracking load of the beam, vertical cracks began to appear in the pure bending moment area at the mid-span of the specimen, and the width was about 0.1–0.2 mm. As the load continued to increase, the steel fibers were pulled out one after another, the vertical cracks continued to extend upward, and their widths continued to increase to become obvious cracks. In addition, we could even hear the sound of fibers being pulled out, and we observed concrete fragments falling from the cracks. When the load exceeded the peak load, the load-bearing capacity of the specimen decreased significantly, while the crack width continued to increase and then penetrate the concrete on the compression side. The test results showed that when the surface of the concrete on the compression side in the pure moment zone flaked off, the residual load of the HSC beam could still be maintained for a period of time. The concrete strength of the UHPC was higher and steel fiber and polypropylene fiber were mixed. Therefore, the peak load and residual load of the UHPC specimen were significantly higher than those of the HSC. However, due to the configuration of the minimum reinforcement ratio, the failure of the UHPC beams was rapid, with a characteristic brittle cracking. The test results of the average peak load of the HSC and UHPC specimens at room temperature are shown in Table 8. It can be seen from Table 8 that, at room temperature, the 56-day-old average peak load of the UHPC beam was significantly higher than that of the HSC beam, with a gap of 27.4 kN. This result shows that the UHPC beam specimens made full use of the high tensile strength of the ultra-high-performance fiber-reinforced concrete, which benefited from the presence of steel fibers.

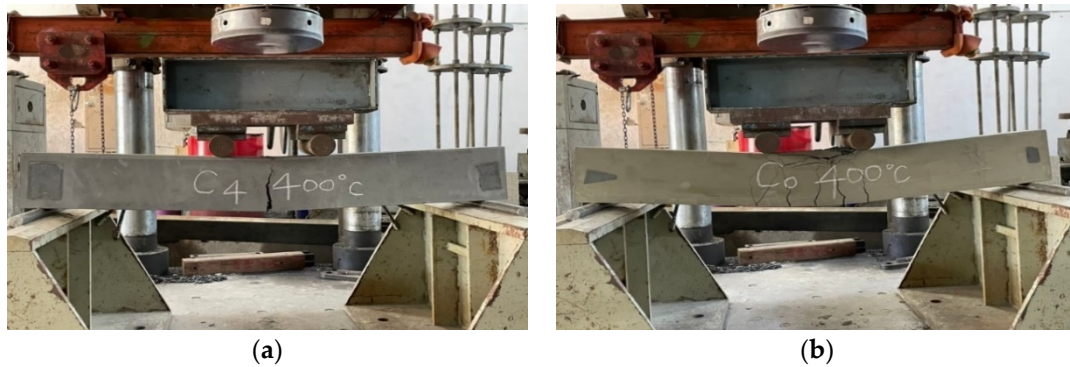
Figure 11. The tensile failure in the flexural test of beams after being subjected to 400 °C: (a) the experimental group and (b) the control group.

After the beam specimens were subjected to different thermal exposures and cooled, they were transported to the MTS universal testing machine in our large-scale structural laboratory for a three-point load test. After experiencing high temperatures, the beam specimens of the two groups of concrete still showed tensile failure. For example, Figure 11 shows the tensile failure of a beam in a flexural test after being subjected to 400 °C.

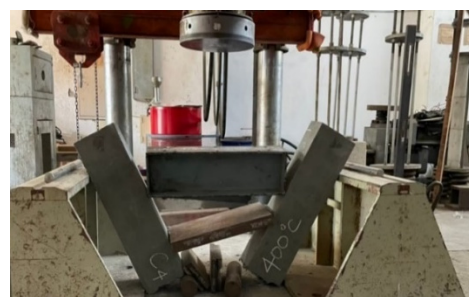
Figure 12. The fracture situation of the experimental group after being subjected to 400 °C.

The UHPC beams had a high compressive strength and were mixed with steel fiber and polypropylene fiber. There was only one vertical flexural crack in their pure bending moment zone, and there was no obvious crushing and flake-off of the concrete surface on the compression side. In addition, when the beam of the experimental group reached the ultimate load, the flexural cracks quickly passed through the pressure zone, causing the specimen to break into two halves, as shown in Figure 12. In contrast, the test results demonstrated that, due to the lower concrete compressive strength and the absence of steel fiber and polypropylene fiber in the HSC beam, there were many vertical flexural cracks in its pure bending moment zone. Furthermore, the concrete surface on the pressure side was obviously crushed and flaked off, as shown in Figure 13.

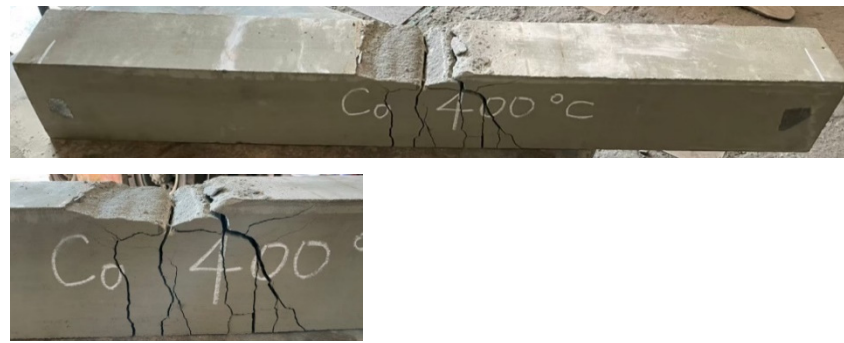
Figure 13. The distribution of the flexural cracks of the control group after being subjected to 400 °C.

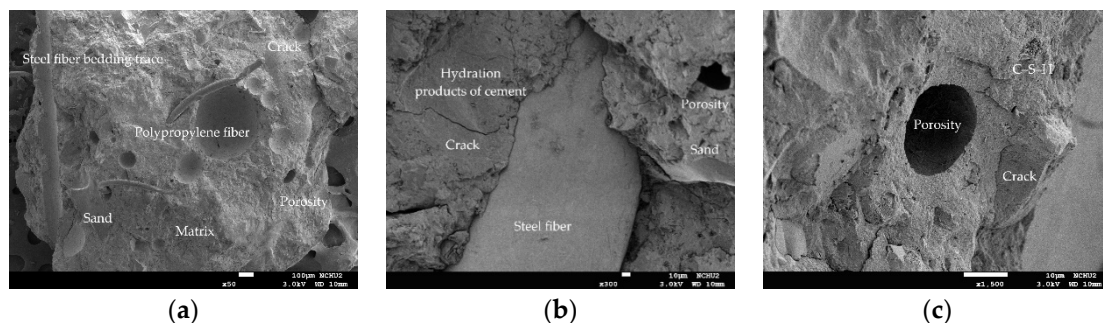
Figure 14. SEM observations of the UHPC sample at room temperature: (a) 50× magnification, (b) 300× magnification, and (c) 1500× magnification.

In order to further understand the changes in the microstructure of the HSC and UHPC specimens before and after high temperature exposure, a small amount of concrete fragment samples was collected from the surface of the beam specimen. The selected fragments were cleaned, dried, and gold-plated for scanning electron microscopy (SEM) observation at different magnifications. The micrographs of the UHPC sample at room temperature are shown in Figure 14. In the figure, steel fibers and polypropylene fibers distributed in the matrix can be observed. These fibers crisscrossed and formed a certain network structure which could effectively improve the tensile strength of the concrete. In addition, the higher magnification of Figure 14 reveals more or less connected crystal networks; the needles were hydration products of ettringite, the network flocs were hydrated calcium silicate (C-S-H) gels, and the black parts were the voids of the filler. Furthermore, it can be seen from Figure 14 that the fine aggregates were evenly distributed and well combined with the matrix, indicating that it had not undergone thermal degradation. In particular, the interfacial transition zone (ITZ) between the fine aggregate and the matrix was very dense with few air pores, and the thickness was very low. This is mainly due to the extra C-S-H produced by the pozzolanic reaction between ultra-fine silica powder and portlandite, which enabled them to fit between the grains of cement and the interface between paste and aggregate. Two main damage modes were identified in the ITZ. First, cracks of the matrix around the ITZ were observed. These cracks were caused by the stress transferred from the steel fiber to the matrix in the mechanical test. The cracks started in the matrix because the fracture strength of concrete was lower than that of the steel fiber. The other is that the steel fibers could also be observed to be debonded and pulled out of the matrix. At the position where the steel fibers were pulled out, no calcium hydroxide ($\text{Ca}(\text{OH})_2$) crystals were found. The reason is speculated to be that the interface area between the steel fiber and cement was filled with secondary hydration reaction products, meaning that the transition interface was not obvious [44].

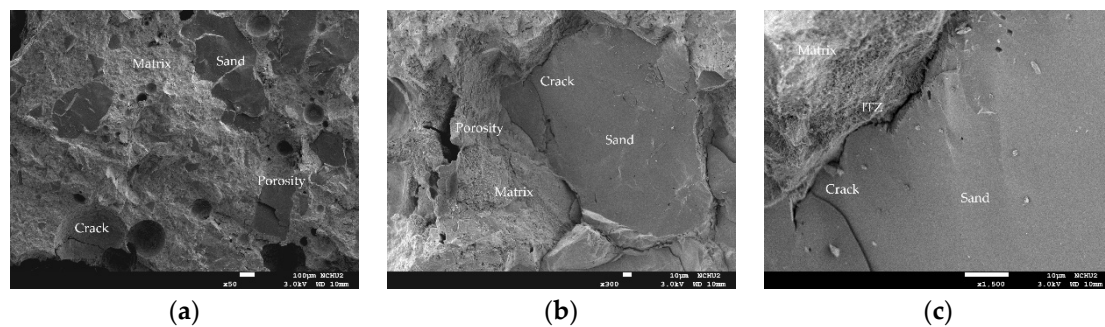
Figure 15. SEM observations of the HSC sample at room temperature: (a) 50× magnification, (b) 300× magnification, and (c) 1500× magnification.

As far as the room temperature condition is concerned, the micrographs of the HSC sample showed a typical concrete microstructure with dark gray aggregates and light gray unhydrated cement grains surrounded by cement paste, as shown in Figure 15. Compared with the UHPC sample, the HSC sample had more internal pores, which were characterized by the black cavities shown in the photomicrographs, indicating that their structure was relatively sparse. In addition, cracks and pores, which may have been caused during the mechanical test, appeared on the matrix in the sample.

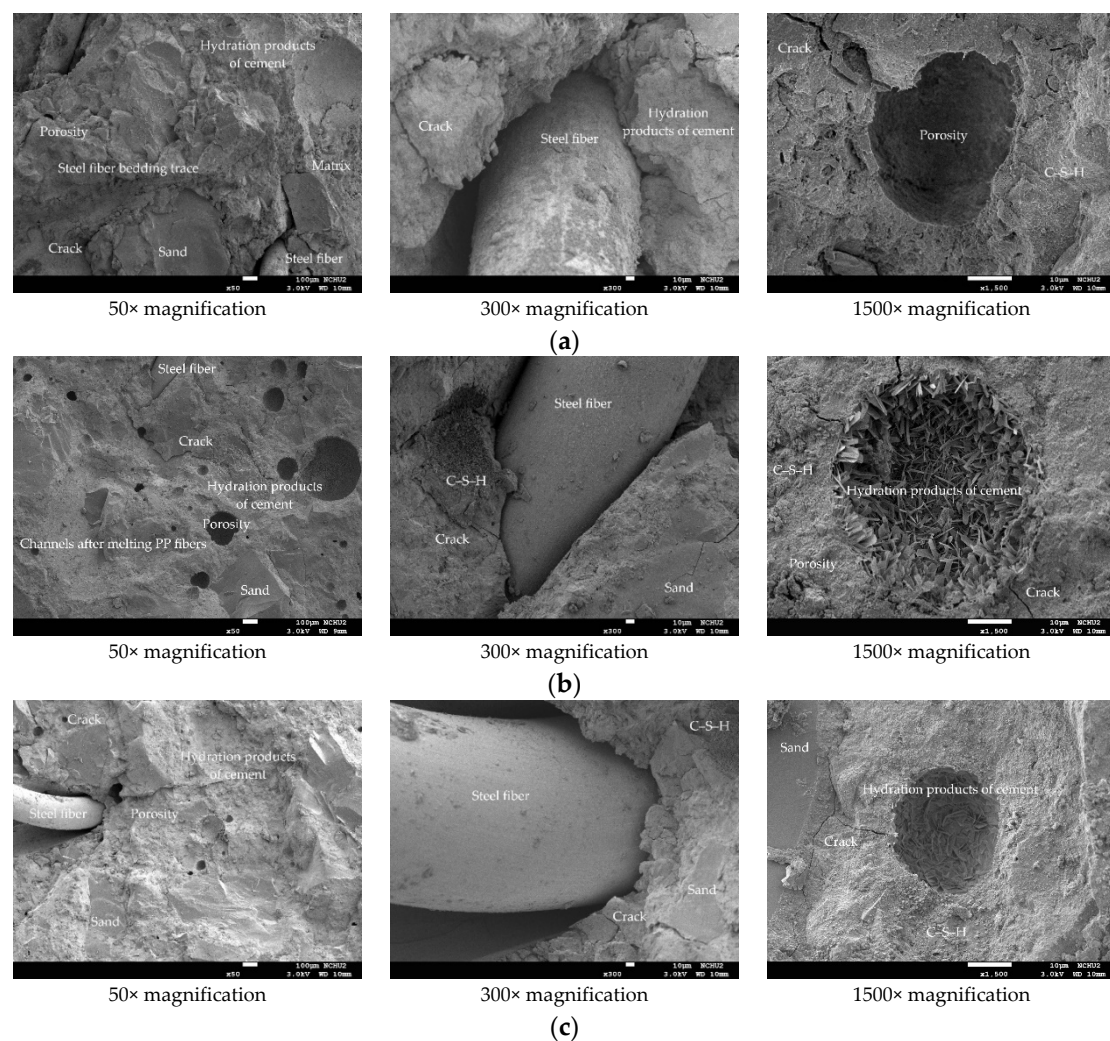
Figure 16. SEM observations of the UHPC sample after being subjected to high temperatures: (a) 300 °C, (b) 400 °C, and (c) 500 °C.

Figure 16 shows that under the action of high temperature, part of the ettringite and C-S-H gel in the sample was destroyed and dispersed. Moreover, acicular ettringite cracked due to thermal expansion and contraction. It can be seen from Figure 16a that at a target temperature of 300 °C, the polypropylene fibers in the matrix had already melted and could not be observed. When the target temperature was 400 or 500 °C, most of the internal bound water of the hydrate was lost. Taking C-S-H gel as an example, about 20% of bound water was lost [1,2]. At this time, from Figure 16b,c, the traces and holes left after the polypropylene fiber was melted could be clearly observed. The size of these holes was similar to that of the polypropylene fiber. This is mainly due to the melting of the polypropylene fibers at high temperatures, starting at about 150 °C and finishing at 176 °C [47,48]. Therefore, the polypropylene fibers could release the pore pressure to a certain extent to prevent the UHPC matrix from explosive spalling. In other words, polypropylene fibers melted at high temperatures and formed a pore network, which could not only effectively reduce the internal vapor pressure, but also maintained a certain residual strength. This is consistent with the research results shown in the literature [49,50].

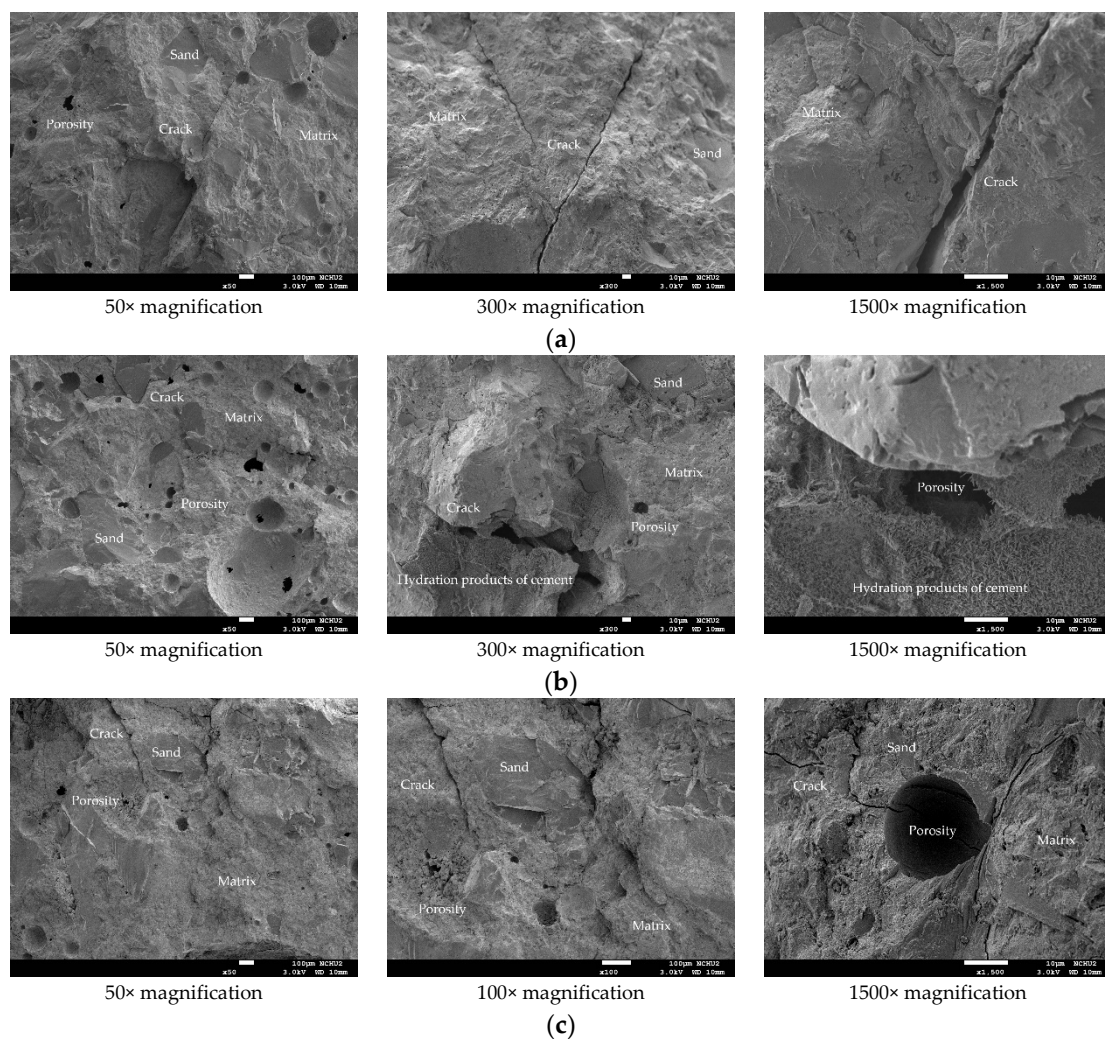
Figure 17. SEM observations of the HSC sample after being subjected to high temperatures: (a) 300 °C, (b) 400 °C, and (c) 500 °C.

After being exposed to different thermal exposures, the microstructure and performance of the HSC matrix also changed with the increase in temperature, as shown in Figure 17. Similarly, in the sample, it could be observed that the spherical pores were filled with cement hydrate. It can be seen from the sample shown in Figure 17 that when the target temperature reached 300 °C, the microstructure of the cement paste did not change

significantly and only micro cracks appeared. When the target temperature reached 400 °C, there was basically no obvious internal damage except for slight burns on the surface that had been in contact with the fire. In addition, some fine cracks were observed at the interface between the aggregate and the cement matrix. At this time, the concrete did not yet show signs of damage. When the target temperature reached 500 °C, the sample was completely dehydrated, causing cracks to appear on the internal bonding surface. At this point, the internal stress of the concrete began to increase and microcracks began to appear in the sample. Therefore, the crack density here was much higher than the crack density produced by the previous temperature. In addition, the porosity also increased, mainly due to the shrinkage of the matrix related to the dehydration of C-S-H gels. Compared with the UHPC samples, the HSC samples showed more internal cracks after reaching high temperatures.

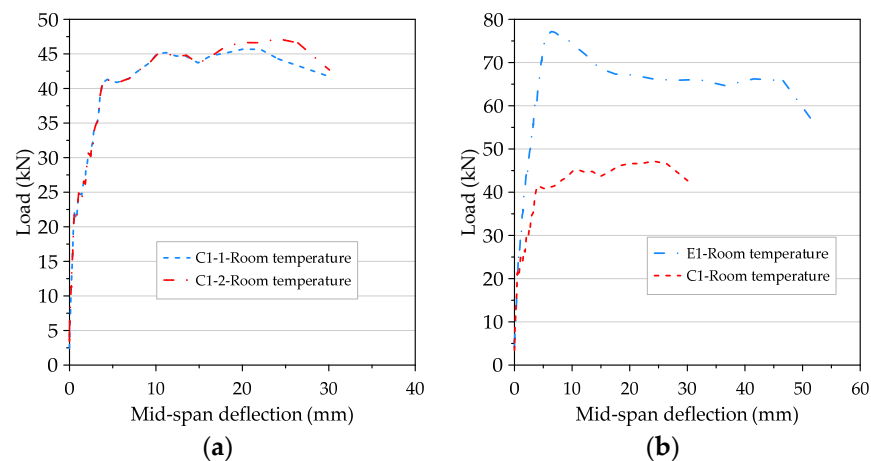
Figure 18. The load–deflection curve of beam: (a) the control group at room temperature and (b) comparison of the two groups at room temperature.

The load–deflection curves of the room temperature flexural testing of the HSC beams are shown in Figure 18a. Basically, the two beams showed several different response stages—namely, a linear elastic stage until the initial flexural cracking, a cracking stage after the initial flexural cracking and its progress, the beginning of the rebar yielding, a plastic deformation stage until the peak load was reached, then finally serious damage. It can clearly be seen from the figure that before the rebar reached the yield stress, the

load–deflection curves of the two beams almost overlapped. Even after the rebar reached the yield stress, there was still a short section of the curve that showed the same development trend. Overall, when the bending moment caused by the load was less than the cracking moment of the beam section, the bending stress of the beam was less than the tensile strength of the concrete. At this time, the entire beam section could bear the stress. Below the neutral axis, the concrete and rebar shared the tensile stress, while above the neutral axis the concrete resisted the compressive stress. This was the elastic stage. When the load gradually increased, once the resulting bending moment reached the cracking moment of the beam section the flexural stress on the section was greater than the tensile strength of the concrete, resulting in flexural cracks in the pure bending moment zone. As the load continued to increase, the flexural cracks extended up to the neutral axis and the neutral axis also moved up with the cracks at this time. At the cracked section, the concrete could not bear the tensile stress, but the rebar resisted the tensile stress. At this stage, the beam was converted from an uncracked state to a cracked state. When the bending moment caused by the load reached the yield bending moment of the beam section, the rebar first reached the yield stress and then began to plastically deform. At the same time, the flexural cracks of the concrete widened rapidly and moved upward while the rate of increase of the load was reduced. When the strain value of the protective layer at the top of the beam in the pure bending moment zone was between 0.004 and 0.0055, the concrete of the protective layer was flaked off due to crushing and the load was slightly reduced. After that, the load continued to increase, and after reaching the peak the concrete on the compression side of the pure bending moment zone was broken and penetrated by flexural cracks, as shown in Figure 10b. Immediately, the load-bearing capacity of the beam dropped sharply and failed. A careful inspection of the failed beam revealed that the crack widths were not constant, which gradually decreased from the bottom to the top of the beam. This is mainly because the variability of crack width is not only related to the bending effect of the beam cross-section, but also closely related to the shear force of the beam. This result is consistent with the literature [51,52].

The load–deflection curve of the UHPC beam at room temperature is shown in Figure 18b. In the case of a low load, as long as the maximum tensile stress in the concrete is less than the cracking modulus, the entire beam section can effectively resist the stress. One side of the neutral axis was compressed and the other side was under tension. In addition, the rebar with the same amount of deformation as the adjacent concrete also resisted tensile stress. At this stage, the ascending branch of the load–deflection curve was quite linear. That is to say that before the first crack was formed, the stress in the concrete was small in magnitude and proportional to its strain, as shown in Figure 19a. When the load was further increased, the tensile strength of the concrete was reached soon and then

Compared with the HSC beams (excluding steel fibers and polypropylene fibers), the UHPC beams had a relatively higher stiffness after flexural cracking (as shown in Figure 18b). Under clearly identifiable peak loads, the UHPC beam did not fail in a brittle and catastrophic manner when the first crack was formed. Before the material showed obvious signs of damage, the load–deflection relationship of the beam became nonlinear, and microscopic examination of the specimen showed that some small cracks had formed. This is because the steel fiber used in this study has a higher specific strength. In addition, the maximum and ultimate load of the UHPC beams increased significantly and the deflection under a given load was small. These improvements were attributed to the high bond strength between the fiber and the matrix, which was achieved by the densification of the silica powder of the matrix and the low water–cement ratio [53]. In particular, the behavior of steel fiber as a crack bridge enabled the UHPC beam to bear the load appropriately after cracks appeared in the concrete [54].

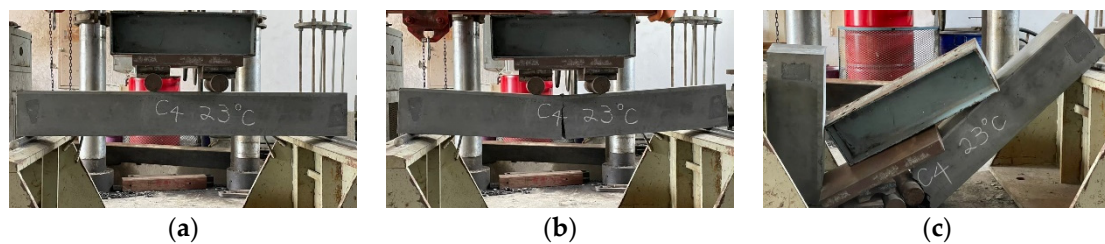
Figure 19. The failure process of the UHPC beam at room temperature: (a) elastic stage, (b) cracking stage, and (c) ultimate stage.

a tensile crack occurred. The formed cracks quickly propagated upward to or close to the level of the neutral axis, and the neutral axis moved upward as the crack grew. At the cracks, the concrete could no longer withstand the tensile stress, but the tension was resisted by the steel bars, as shown in Figure 19a,b. When the load increased further, the stress and strain increased accordingly and were no longer proportional. In other words, a nonlinear relationship between stress and strain was created in the concrete stress–strain curve. The reinforcement ratio of the beam members of the experimental group was quite close to the minimum reinforcement ratio required by the ACI code. Therefore, when the ultimate bearing capacity of the beam was finally reached, the crack quickly penetrated the concrete on the pressure side, causing the beam to break into two sections, as shown in Figure 19a.

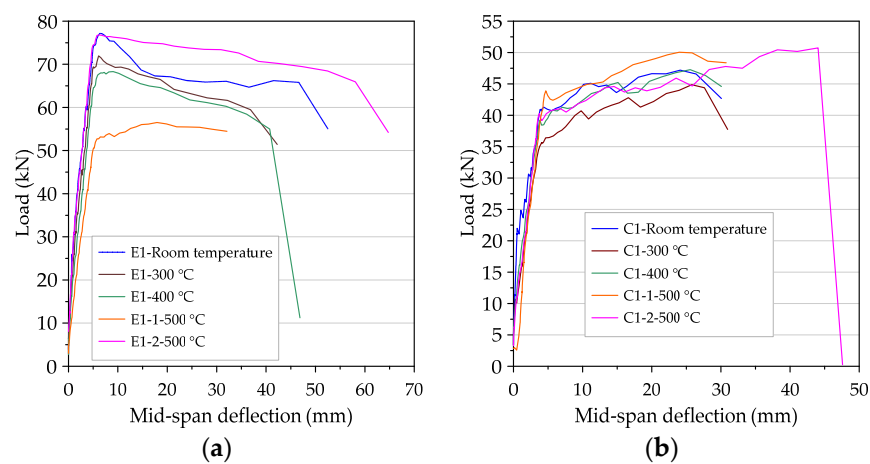
Figure 20. The load–deflection curve of the beam after being subjected to high temperatures: (a) the experimental group and (b) the control group.

As mentioned earlier, in order to improve the excessive internal vapor pressure of the concrete beam at the target temperature of 500 °C, the second specimens of the HSC and UHPC beam were pre-dried in a furnace at 130 °C for 48 h. After that, when the high-temperature application of 500 °C was performed again, it was found that the beam specimen did not destructively flake off. After exposure to different temperatures, the concrete performance was changed, but the flexural test results of the HSC and UHPC beams all showed tensile failures. Regarding the flexural test results of the beam specimens after exposure to different temperatures, the detailed load–deflection curves were compiled and are shown in Figure 20. It can be seen from Figure 20 that, according to the load, the load–deflection relationship curve of the beam specimen after experiencing high temperatures could be divided into the initial flexural cracking load, the rebar yielding load, the peak load, and the ultimate load. A similar pattern was reflected in the linear relationship between the load–deflection curve of the beam specimens before the flexural crack occurred. After the flexural crack occurred, it remained almost linear and its stiffness decreased slightly; however, when the longitudinal rebars yielded, its stiffness also decreased. It can be seen from Figure 20a that when the target fire temperature was between 300 and 400 °C, the stiffness of the UHPC beam (that is, the slope of the ascending branch

of the load–deflection curve) was only attenuated by a small amount, compared with room temperature conditions. However, when the target temperature was 500 °C, the UHPC specimen E1-1-500 °C was dried in a furnace at a lower temperature of 105 °C for only 24 h, and the slope of the rising branch of its load–deflection curve showed a significant attenuation. In contrast, the UHPC specimen E1-2-500 °C was dried in a furnace at a higher temperature of 130 °C for 48 h, and its stiffness only slightly decreased. Overall, the initial cracking load and rebar yield load of the UHPC specimens did not change significantly after high temperatures, but the peak load and ultimate load were significantly attenuated, as shown in Figure 20a. However, the UHPC specimen (E1-2-500 °C) that had been pre-dried in a furnace at a temperature of 130 °C for 48 h showed only a slight decrease in the peak load and a significant increase in the ultimate load. In addition, after reaching the peak load, the rate of load reduction was significantly lower than that at room temperature. This result shows that reducing the moisture content of the UHPC beams is an effective way to improve its spalling resistance, but can also increase its residual flexural load. Similarly, the peak load and ultimate load of the HSC specimens (C1-2-500 °C) that had been pre-dried in a furnace at 130 °C for 48 h were significantly improved, as shown in Figure 20b.

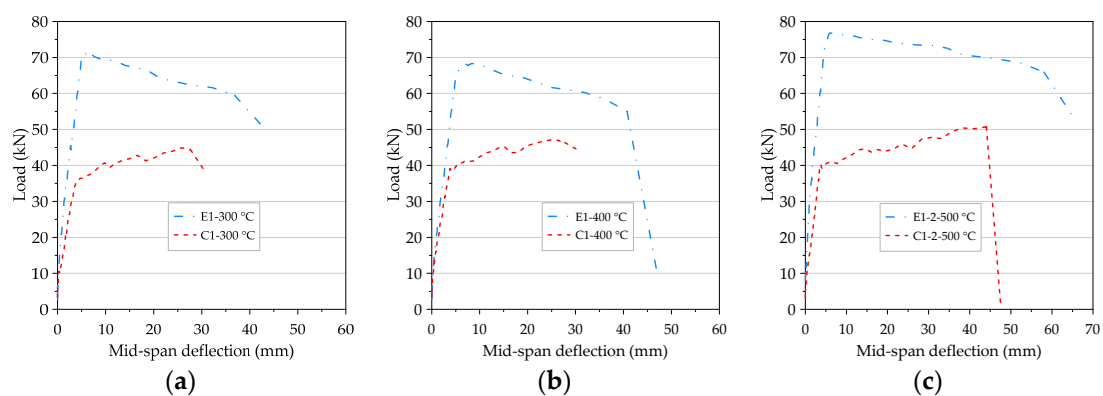
Figure 21. The comparison of load–deflection curves of two groups of beams after being subjected to high temperatures: (a) 300 °C, (b) 400 °C, and (c) 500 °C.

On the other hand, after different target temperatures, the initial cracking load, steel yield load, peak load, and ultimate load of the UHPC were significantly higher than those of the HSC, as shown in Figure 21. In addition, compared with the HSC specimens, the stiffness of the UHPC specimens in the post-cracking stage was relatively larger and the deflection under a given load was smaller.

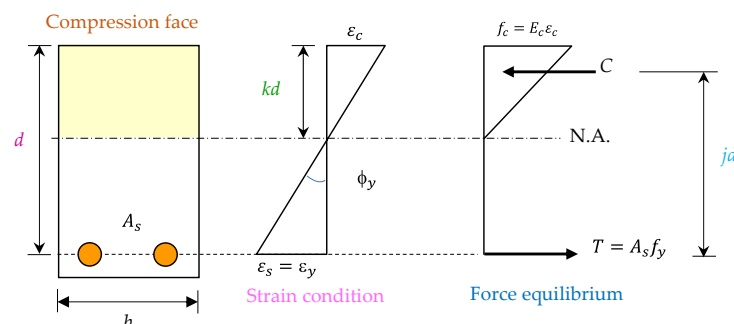
Figure 22. The stress and strain profiles of a typical reinforced concrete beam at the yielding state.

$$\phi_y = \frac{f_y}{E_s d (1 - k)}. \tag{4}$$

where f_y is the yield stress of steel rebar, E_s is the modulus of elasticity of steel rebar, d is the effective depth of beam section, and k is the ratio of neutral axis depth to effective depth.

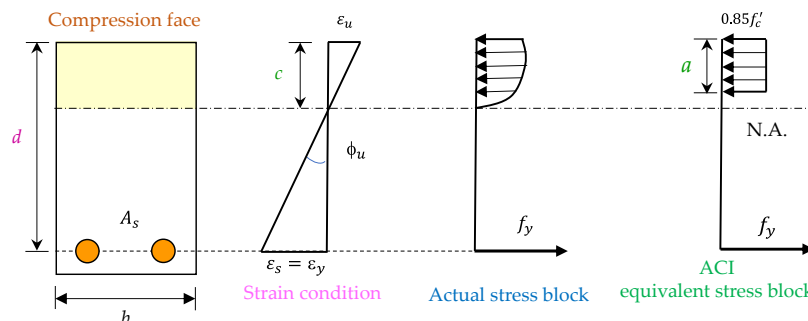
Figure 23. The stress and strain profiles of a typical reinforced concrete beam at the ultimate state.

The stress and strain distribution of the beam in the ultimate state is shown in Figure 23. The ultimate curvature (ϕ_u) of the critical section of the beam can be expressed as follows [61]:

where ϵ_u is the ultimate strain of concrete, c is the depth of the neutral axis of the beam section in the ultimate state, β_1 is the ratio of depth of equivalent rectangular stress block to depth of the neutral axis, and a is the depth of equivalent rectangular stress block of the beam section.

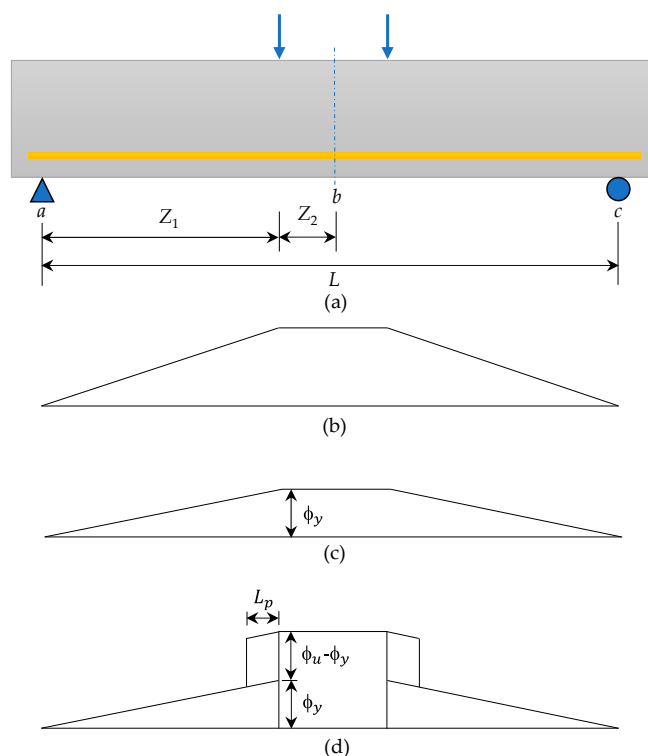
Figure 24. Schematic diagram of the curvature area theorem for obtaining a typical beam deflection: (a) load diagram, (b) bending moment diagram, (c) idealized curvature at the yielding stage, and (d) idealized curvature at the ultimate stage.

Consider a simply supported beam that bears two concentrated loads at the center of the span. Its bending moment diagram and curvature diagram are shown in Figure 24.

In reality, some cracks will be formed under the combined action of flexural stress and shear stress in the shear span of the beam [51,52]. Once a crack is formed, the bending stiffness of the beam will change along its axial direction. Due to the tension stiffening effect [62,63], the concrete between the cracks can withstand some tension. Therefore, the curvature fluctuates along the length of the beam. That is, each curvature peak corresponds to a crack position. In order to simplify the complexity of the calculation, the actual curvature distribution in the ultimate load stage can be idealized into elastic and inelastic (plastic) regions. According to the idealized curvature diagrams in Figure 24c, the relative
