Patella-Femoral Joint Revision Surgery Following a Rare and Interesting Case of Implant Failure: A Case Report and Retrospective Analysis of Our Hospitals Implant Data

Nadimi J K, Winson D, Roy W, et al. (March 07, 2022) Patella-Femoral Joint Revision Surgery Following a Rare and Interesting Case of Implant Failure: A Case Report and Retrospective Analysis of Our Hospitals Implant Data. Cureus 14(3): e22908. DOI 10.7759/cureus.22908

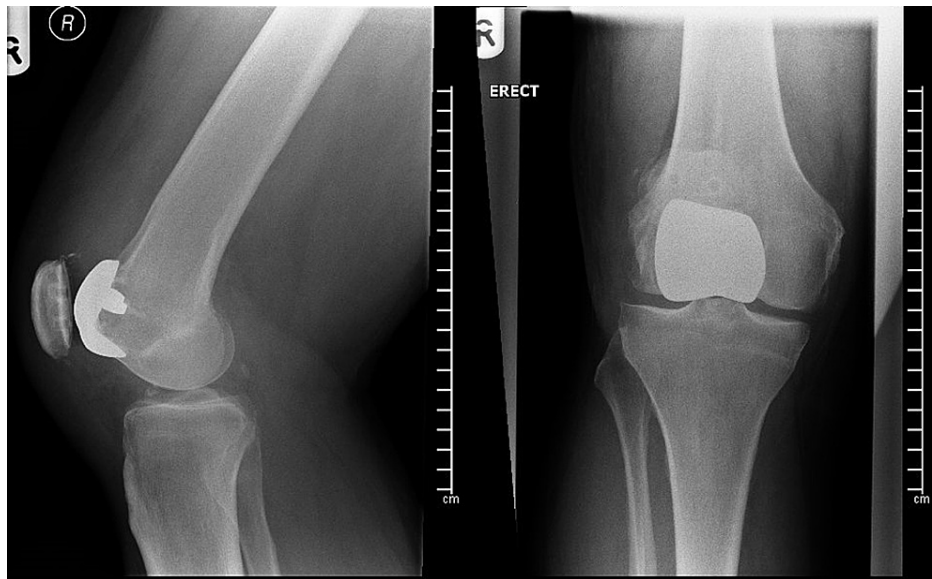
FIGURE 1: Post-operative radiographs of right knee following primary femoro patella vialla arthroplasty.

Antero-posterior (right) and lateral (left) non-weight bearing radiographs of the right knee following primary patellofemoral arthroplasty. The femoral FPV component is well positioned on the trochlea. The patella button is correctly positioned in the patella and congruent with the femoral implant component.

A 68-year-old mechanical engineer with isolated patellofemoral joint arthritis and a past medical history of gout, osteoarthritis, and gastroesophageal reflux disease underwent bilateral femoro-patella vialla joint arthroplasty (Wright Medical) in 2009 (Figure 1).

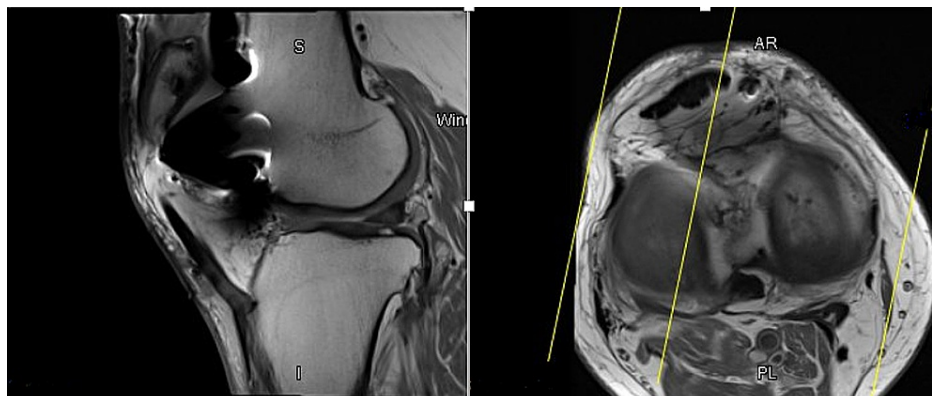
FIGURE 2: Magnetic resonance images of the right knee displaying lateral meniscus tear.

The left image is a sagittal proton density sequence slice of the right knee in the lateral compartment displaying a lateral meniscal tear and artefact from the patellofemoral implant. The right image is a proton density fat suppressed sequence axial slice at the level of the tibial plateau displaying a lateral meniscal tear.

This gentleman was satisfied with his surgery, and his short-term post-operative follow-up was unremarkable. Ten years following the primary surgery, the patient was walking up a hill when he had a sudden onset pain in his anterior right knee, associated with a large effusion 24 hours later. Investigations were negative for infection, and plain AP and lateral radiographs of the affected knee revealed no new bony pathology or implant loosening. Magnetic resonance imaging later revealed a lateral meniscus tear but no demonstrated abnormality in the implant (Figure 2).

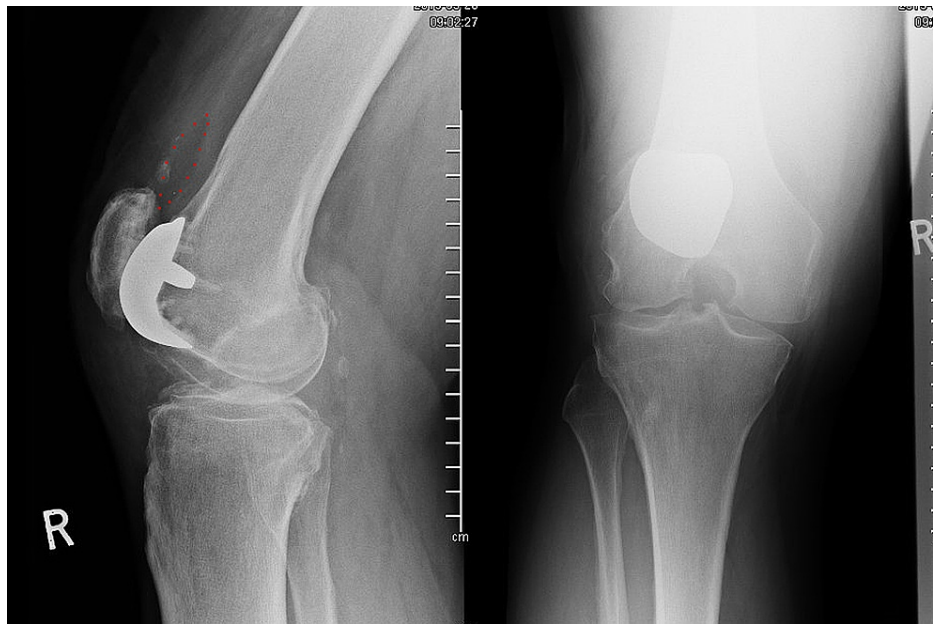
FIGURE 3: Pre-operative radiographs of the right knee displaying loose patella button (outlined on lateral view).

Anteroposterior (right) and lateral (left) non-weight bearing radiographs of the right knee. The patella is lying directly on the femoral component of the implant and outlined in red is the shadow of the dislocated patella button of the failed FPV arthroplasty, lying within the suprapatellar pouch.

appeared well fixed. The patient continued to complain of persistent anterior knee pain and recurrent effusions within the right knee. Radiographs following the initial arthroscopy were suspicious for failure and displacement of the patella button (Figure 3).

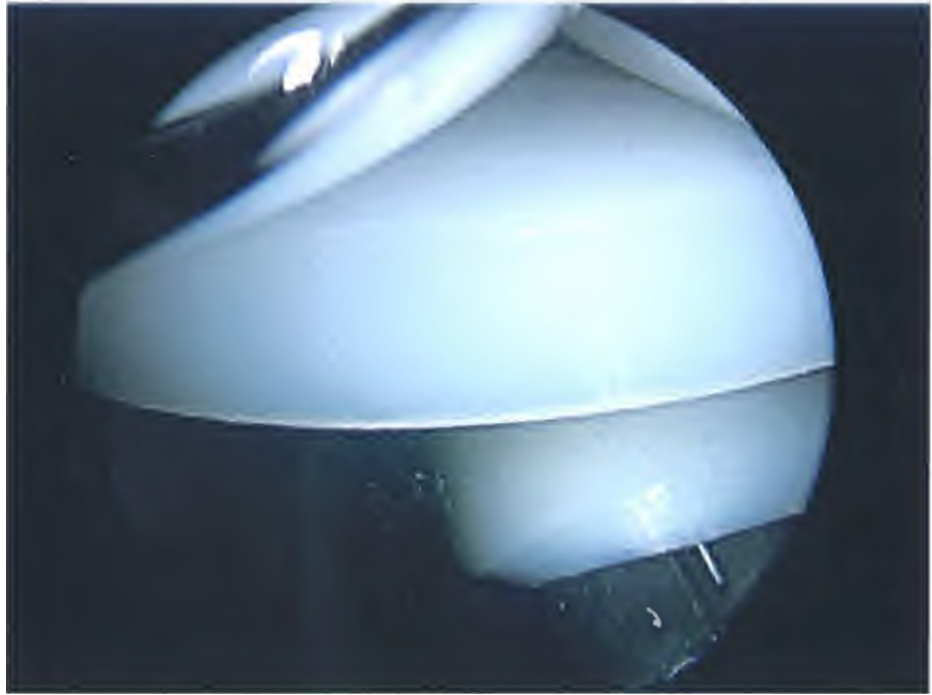
FIGURE 4: Arthroscopic image of displaced patella component.

Image taken on arthroscopy of the right knee displaying the FPV implant and displaced patella component loose within the suprapatella pouch.

A second arthroscopy was performed revealing that the patella button was loose within the suprapatellar pouch (Figure 4) and the decision was made to proceed to revision surgery by open arthrotomy.

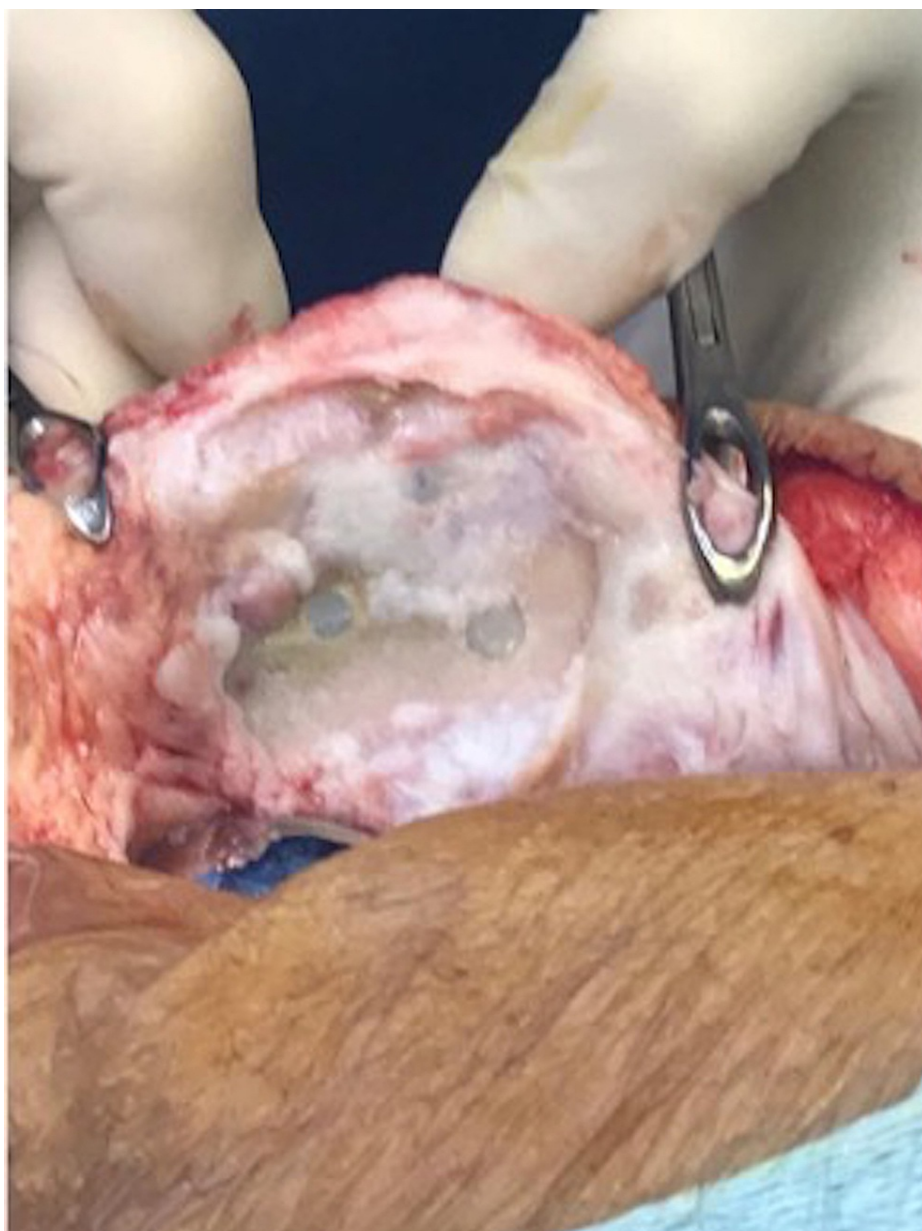
FIGURE 5: Intraoperative images during resurfacing procedure for a failed FPV patellofemoral implant.

An open arthrotomy of the right knee was performed, exposing the patellofemoral compartment. Intraoperatively, the failed patella button was found to have sheared from the base, leaving the pegs still within the patella (Figure 5). The femoral component remained well fixed and stable.

The intraoperative image displays the underside of the everted right patella during an open arthrotomy for patella resurfacing procedure. The three retained "pegs" from the failed patella button are visualised within the body of the patella.

It seems the most common mode of failure for the patella implant component specifically is the pull-out of facets from the bone (aseptic loosening). To the best of our knowledge, there is no reported mode of failure in the Femoro-Patella Violla implant whereby the facets of the patella shear away from the base of the implant (as shown in Figures 5-6).

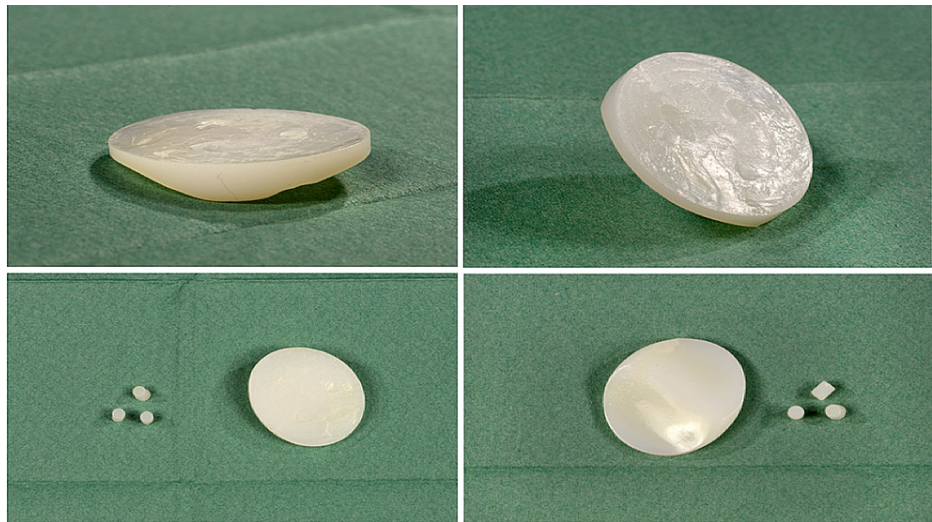
FIGURE 6: Photographs of the failed implant displaying separate implant base and pegs.

Figure 6 displays the failed patella implant and the sheared "pegs" from the base of the device.

Four clinical photographs show the failed patella button component of an Femoro-Patella Violla implant. The top two images show the patella component and footprints of the three broken "pegs." The bottom two images show the patella component and the retrieved "pegs" from the patient's patella.

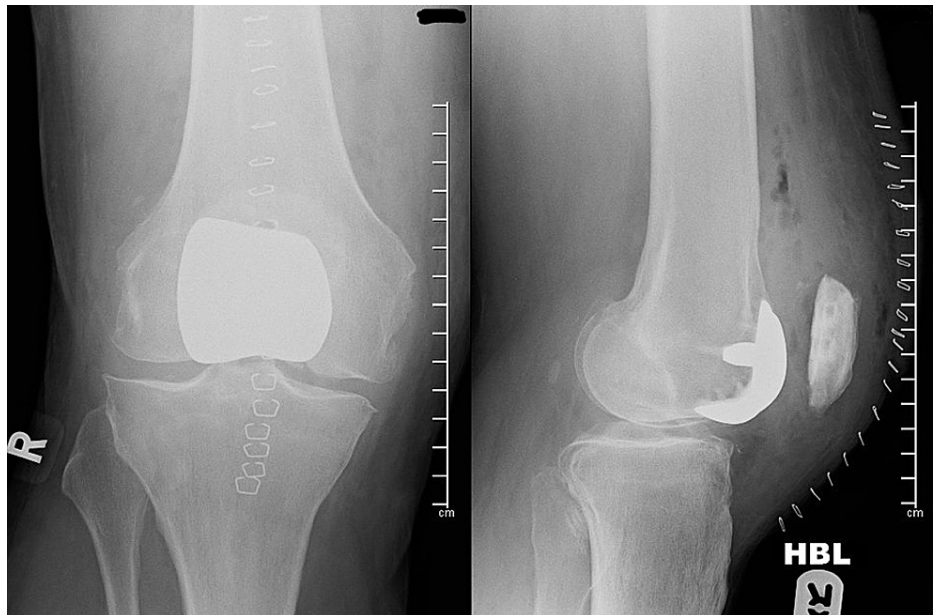
FIGURE 7: Post-operative radiographs of the right knee following revision of the patella component.

The left image is an anteroposterior radiograph of the right knee and the right image a lateral radiograph of the same (non-weight bearing). The patellofemoral joint is congruent following patella revision to an "Onlay Poly" (Microport Orthopaedics) and skin clips are visible over the anterior aspect of the knee.

The patella component was successfully revised to an "Onlay All-Poly" patella implant (Microport Orthopaedics, Inc., Arlington, TN). Patella tracking and on-table examination was stable in addition to satisfactory post-operative radiographs and a good post-operative outcome (Figure 7).
