Shearing of the sheaths: A case illustrating a rare complication of catheter ablation

KEYWORDS Catheter ablation; Closed-loop catheters; Complications; Mapping; Shearing
(Heart Rhythm Case Reports 2021;7:457–458)

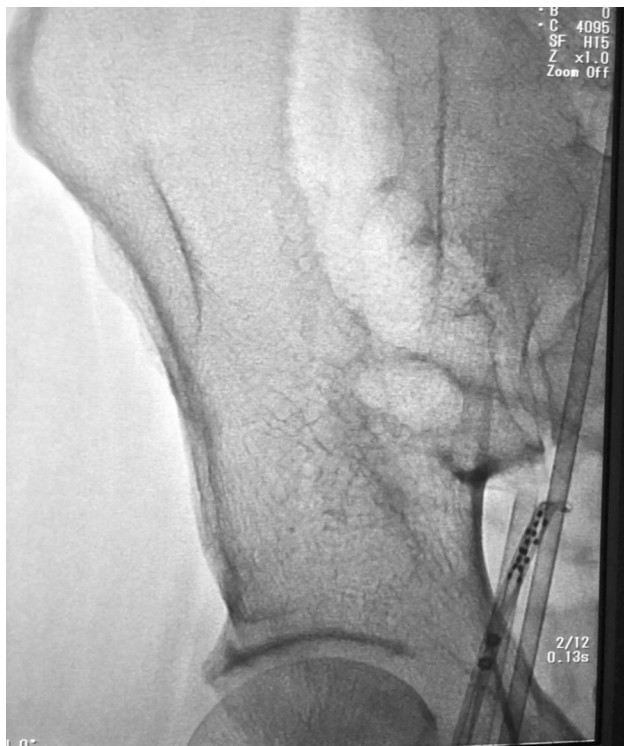
lines were performed at the isthmocaval junction and normal sinus rhythm was obtained. At the conclusion of the procedure, catheters were withdrawn and the HD grid catheter was pulled back under fluoroscopic guidance. Some resistance was noted proximally in the inferior vena cava, however, when the HD grid catheter was withdrawn. Fluoroscopy as shown in [Figure 1](#) illustrates the HD grid catheter wrapping around the long SR0 sheath. A manual tug was performed on the HD grid catheter under fluoroscopy, although the HD grid catheter and distal end of the SR0 sheath was not visualized in this process. This allowed the HD grid catheter to come out; however, in the process the SR0 sheath was severed in the middle aspect of the sheath and removed from the body as well. The presumed mechanism was the closed-loop catheter impaling the SR0 sheath. A subsequent fluoroscopy image showing the free-floating SR0 sheath is shown in [Figure 2](#). The large SR0 sheath was successfully snared and removed without complications, as noted in [Supplemental Video 1](#). After the SR0 sheath was removed,

Figure 1 The HD grid mapping catheter has impaled and wrapped around the long SR0 sheath.

- Large closed-loop catheters such as the HD grid mapping catheter have the risk of impaling and severing other sheaths.
- When resistance is noted with withdrawing closed-loop catheters, it is advisable to use fluoroscopy at the site of resistance and proximally in addition to advancing the catheter, rather than withdrawing under fluoroscopy.
- It may be advisable to advance closed-loop catheters using a long sheath or to remove other sheaths first prior to withdrawing a closed-loop catheter.

In this case, we observed a rare complication that has not been reported to have occurred in this manner. This case shows the importance of recognizing resistance during removal of a large, closed-loop catheter. The potential for the closed loop to sever a long sheath needs to be considered, especially if resistance is encountered. The presumed mechanism of the shearing of the SR0 sheath was due to the closed-loop nature of the HD grid catheter that wrapped around the SR0 sheath. It is important to note that during the removal of the HD grid catheter resistance was noted; however, the catheter was still removed with some manual force. Given this outcome, it is advisable that if such resistance is noted, fluoroscopy or cine imaging should be performed at the site of resistance and proximally. In addition, it is advisable to advance the catheter under fluoroscopy rather than to continue to apply manual traction force. Another alternative to avoid this complication may be to re-

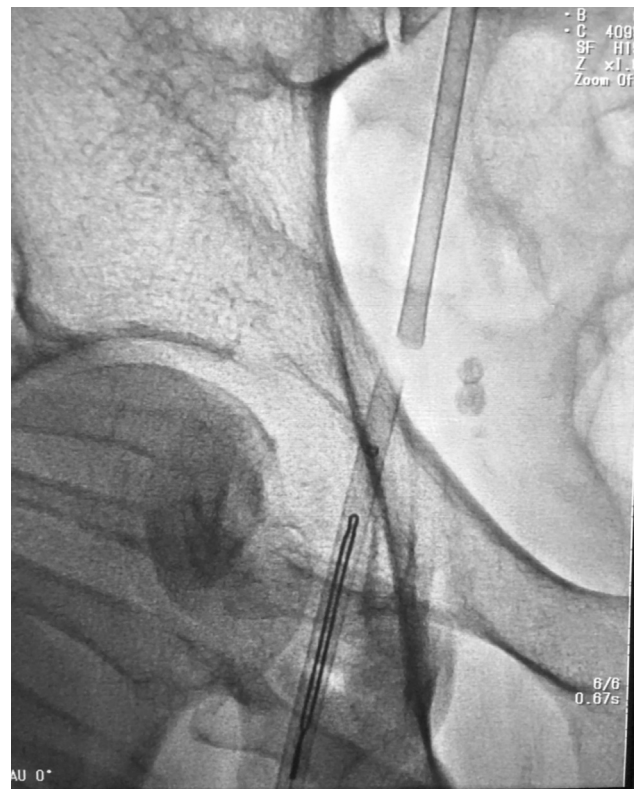
examination of the cut end revealed a clean appearance consistent with a uniform tearing force. No other complications were noted during the procedure or the remainder of the hospital course, and the patient was subsequently discharged with outpatient follow-up.

Figure 2 After manual force the HD grid mapping catheter was removed with shearing the middle of the SR0 sheath.

move long and short sheaths first (when feasible) prior to removing the closed-loop catheters such as the HD grid catheter. Lastly, advancing closed-loop catheters such as the HD grid catheter through a long sheath would provide additional support for the catheter and likely prevent any impaling of the closed-loop catheter with other sheaths.
