Artificial aortic valve dysfunction due to pannus and thrombus – different methods of cardiac surgical management

Stanisław Ostrowski, Anna Marcinkiewicz, Anna Kośmider, Andrzej Walczak, Radosław Zwoliński, Ryszard Jaszewski

Department of Cardiac Surgery, Medical University of Lodz, Poland

Kardiologia i Torakochirurgia Polska 2015; 12 (3): 199-203

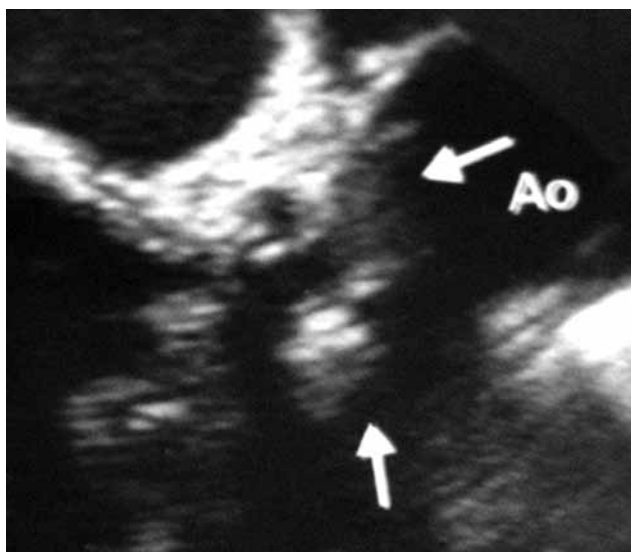
Fig. 1. Transthoracic echocardiography – image of a mass resembling a slightly attached thrombus and obstructing the artificial aortic valve

confirmed the obstruction of the posterior half-disc. Additionally, TEE showed a large mass slightly attached to the prosthesis, whose echogenicity was lower. This view was suggestive of a thrombus. Kuniyoshi *et al.* [13] emphasized the value of multimodal diagnostics in precisely imaging the changes on a prosthesis that manifest poorly. The clinical condition of our patients correlated relatively well with the echocardiographic image. According to some authors [14], echocardiographic data and clinical criteria are not sufficient to differentiate between pannus and thrombus. The subject literature also underlines the value of spiral tomography and fluoroscopy in diagnosing the cause of prosthesis dysfunction (pannus or thrombus) [15, 16]. The risk of thrombus development on an aortic prosthesis is estimated at 0.2-6% per year per patient. The embolic event rate is reported at 1.8% of patients per year [1]. In such cases, surgery is the preferred treatment of choice. According to some authors [12], thrombolytic treatment should be chosen in the case of small thrombi, regardless of circulatory failure (which is also in accordance with the recommendations of the American College of Chest Physicians). However, according to the recommendations for managing left heart thrombi, thrombolysis should be applied: in patients classified as NYHA functional class III or IV with high operative risk and in patients classified as functional NYHA class I or II when the thrombus is immobile or situated in the left atrium [17]. In our second patient, considering the previous stroke and age, thrombolysis would have been associated with a greater risk of complications.

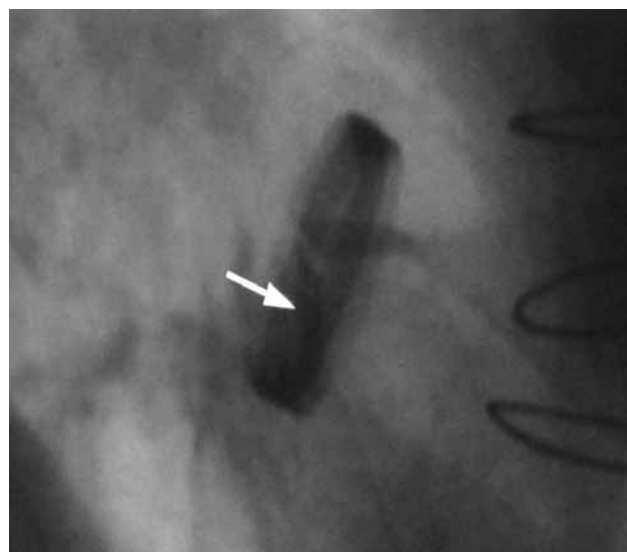
Fig. 2. Fluoroscopy image – the arrow points to the outline of the structure impairing the mobility of the prosthetic valve disc

Pannus is more closely connected with the prosthetic surface, so its removal is related to a greater risk of mechanical valve damage. Studies report good results of pannus removal, instead of prosthesis reimplantation [6]. Song *et al.* [7] also described positive effects of pannus removal after mitral valve ring annuloplasty. However, we have not found any case involving the removal of both pannus and thrombus from an aortic prosthesis. In the case of our first patient, well-formed pannus was closely connected to the prosthesis, completely excluding the possibility of its removal; reimplantation was the only solution. In the second case, the balloting thrombus and minor soft pannus were easy to remove. Considering the patient's age, the operative risk was high. Additionally, both women were in poor biological condition. Moreover, redo procedures are always associated with higher risk [8]. On the other hand, some authors have proved that reoperation is not an independent risk factor for operative mortality. The mortality of elective redo procedures is estimated at 1.4%, which is comparable with the mortality associated with primary aortic valve replacement [9, 10]. The clinical course of prosthesis dysfunction can sometimes prove to be serious and may include pulmonary edema and cardiogenic shock [11]. In the case of our first patient, the circulatory failure was severe. However, the patient was stable enough to be adequately prepared for surgery. In contrast, the second patient was almost asymptomatic. However, a thrombus could have been suspected just after the stroke; it could have resulted from an embolic event, especially as it developed during the cessation of oral anticoagulation and clopidogrel. The presence of both pannus and thrombus could have suggested that the discontinuation of oral anticoagulation resulted in thrombus formation around the previously present pannus despite LMWH treatment (enoxaparin). The recently formed thrombus was susceptible to fragmentation and associated with a high embolic risk. Embolic events, inadequate oral anticoagulation, and deterioration of circulatory condition are the primary indications of the presence of a thrombus on a valvular prosthesis [12]. Transesophageal echocardiography is commonly used to diagnose thrombus or pannus on an artificial valve. Barbetseas *et al.* [3] evaluated the sensitivity of TEE in diagnosing prosthesis dysfunction at 83%. Only small structures posed problems, especially if the dysfunction was caused by pannus interfering with the hinges of the prosthesis. In our observation, echocardiography in combination with the patient's medical history allowed a final diagnosis to be established. In both cases, TTE was the first line in the examination process. It gave indirect evidence of a mass blocking the prosthetic valve. During the examination of the first patient, a mass of higher echogenicity than a thrombus was visualized. It extended from the suture line to the discs' surface and beneath. The final diagnosis was made considering the time period from the primary operation (6 years) and aortic prosthesis involvement. The patient's history suggested good compliance with oral anticoagulation. The second patient's history also suggested this diagnosis. Fluoroscopy

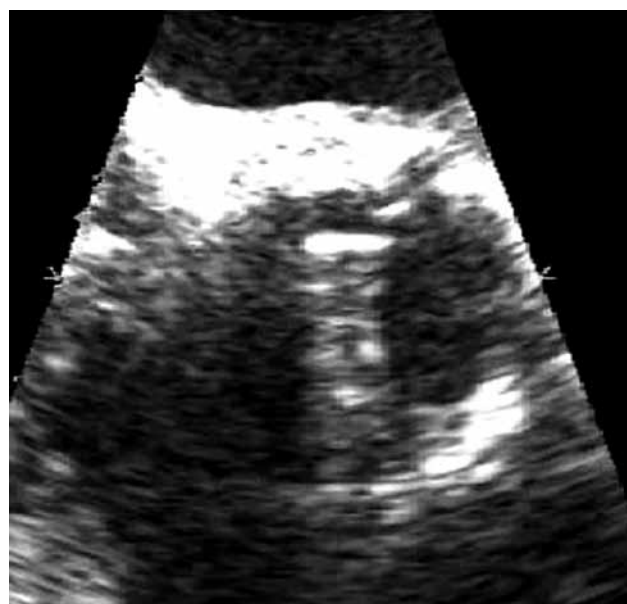
Fig. 3. Transesophageal echocardiography – intraoperative image of the properly functioning aortic prosthetic valve: visualized open discs (after removal of the pannus with thrombus)

formed on the 4th and 12th postoperative days. Their results confirmed the success of the removal of the pannus and thrombus from the aortic prosthesis, showing a maximal gradient of 30 mmHg. Slightly worse global contractility of the myocardium, especially of the postero-inferior wall, with a decreased EF of 52%, was also observed.
