# Failure of volar locking plate fixation of an extraarticular distal radius fracture: A case report

Jue Cao<sup>1</sup>, Kagan Ozer<sup>2\*</sup>

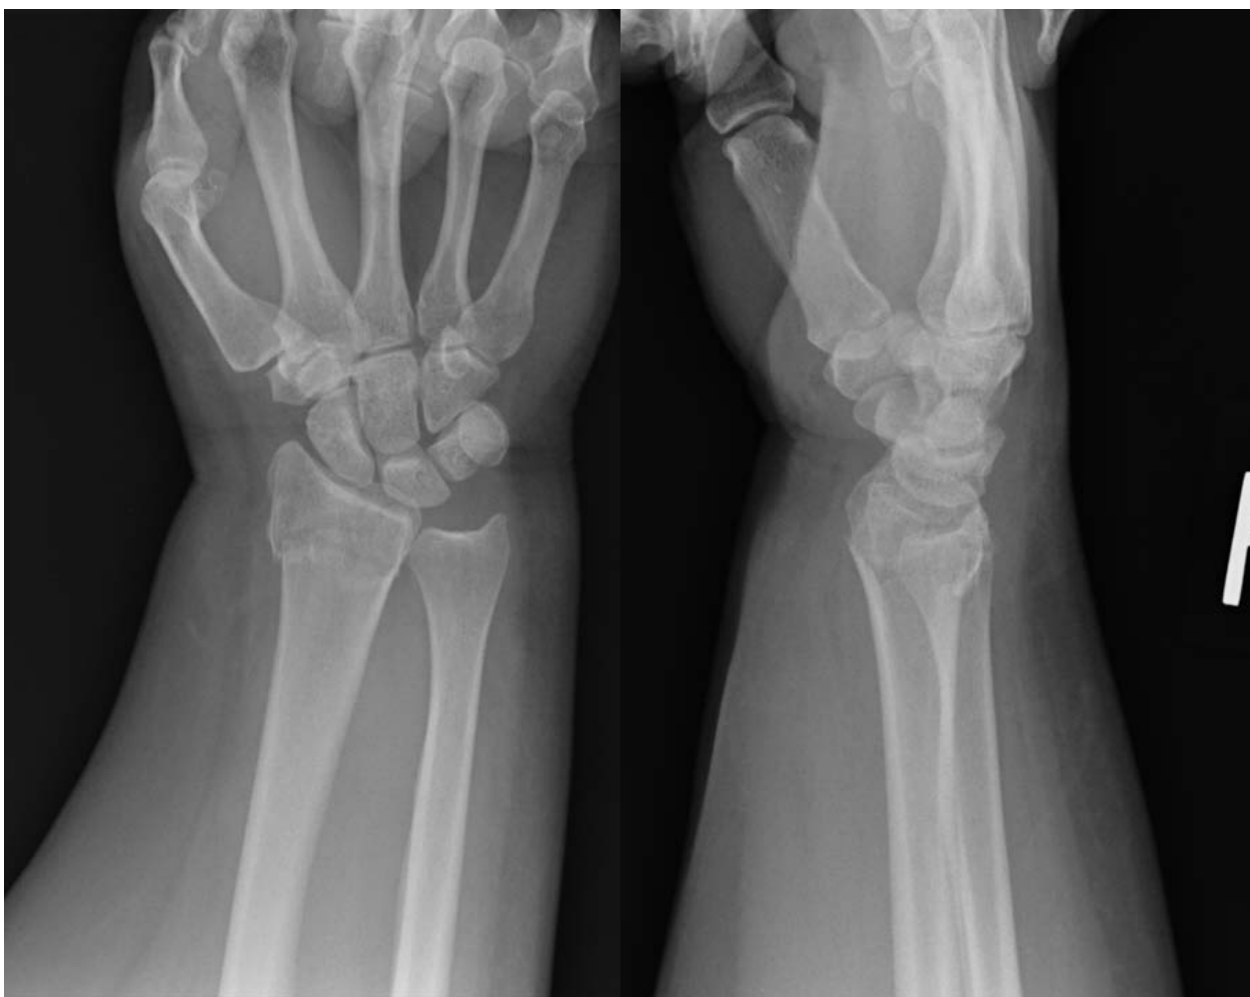
**Figure 1** Initial radiographic view of the right wrist following failure of reduction in 1 week.

A 40-year-old, right hand dominant, unemployed, female presented to the emergency department with right wrist pain following a fall onto her right outstretched hand. She had a past medical history of smoking (30 pack/years), hypertension, adult obstructive sleep apnea, depression, bipolar disorder, and anxiety. Her body mass index (BMI) at that time was 39. Initial evaluations revealed a swollen wrist, no ecchymosis and a 2+ radial pulse. Radiographs demonstrated a right intra-articular distal radius fracture (AO, type 23-A3) in AP and lateral views. Following reduction, patient was placed in a sugar tong splint and was instructed to return for follow-up in one week. At 7 days, radiographs showed -20 degree of dorsal tilt (Figure 1). At that point, she chose to undergo surgery.

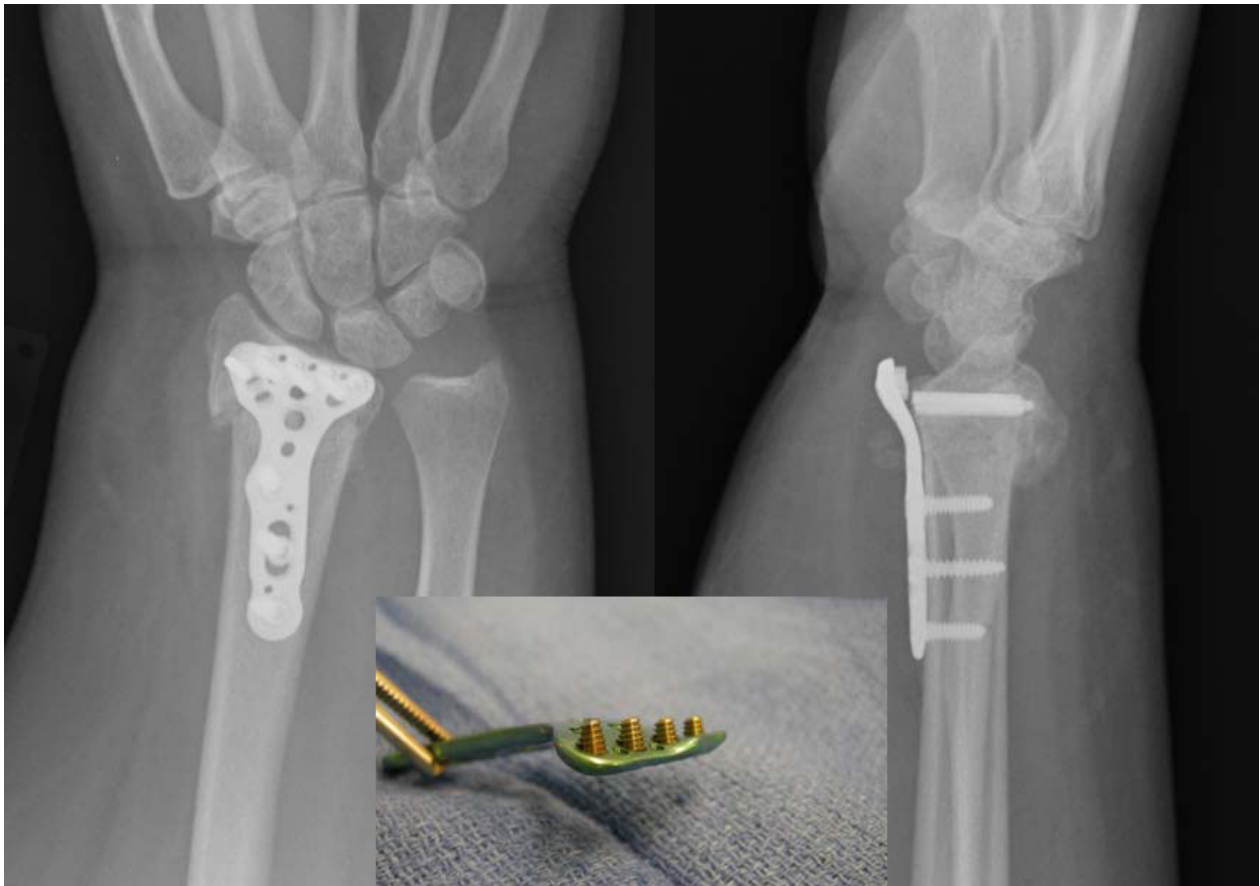
At 10 weeks after the surgery, she presented with new onset of pain following a popping sensation while trying to push a revolving door. She denied any falls or acute trauma, however admitted to have repeatedly used her arms to push herself up from a seated position. On physical examination, she had no obvious edema, erythema and ecchymosis. She did have tenderness to palpation over the distal radius and ulnar styloid process. She had decreased range of motion secondary to pain in flexion, extension, ulnar deviation, and radial deviation. The sensations to light touch in the distribution of radial, median, and ulnar nerves were intact. Radiographs showed 4 broken screws (Figure 2). No immediate action was taken to revise the surgery as radiographs showed only

2 mm shortening with neutral lateral tilt. Due to her tenderness, we placed her in a cast for 3 weeks, followed by a removable splint for 3 additional weeks.

**Figure 2 Radiographs show collapse of the fracture following failure of screws.** Despite the collapse, the lateral radiograph showed neutral alignment of the distal radius articular surface with minimal shortening on the posteroanterior (PA) plane.

Repetitive bending forces accumulated within a distal radius plate over time may lead to hardware failure if bone healing is delayed. As in our case, the initial delayed healing along with repetitive use of the wrist likely caused an increase in force accumulation in the implant over time and once the force accumulated

surpassed the screw strength, failure of the hardware was inevitable. Although nonunions of the distal radius with plate failure are relatively rare, our case is a good example of the race between bone healing and hardware failure [4].

As for the placement of the plate on the bone, it has been shown that there is a significant decrease in axial stiffness and tensional rigidity that becomes evident at a distance of 5 mm between plate and bone [12]. Also poor contact between the plate and the anterior cortex of the distal radius is a factor leading to plate failure [5]. In our case, post-operative X-rays showed a 3 mm gap between the most distal section of the volar plate and the distal radius. In this situation, the screws may have had to take on more torque and stress over time.

Another factor that may have strengthened the fixation is the number and the diameter of screws used to fix the fracture. We only used 4 distal locking screws. The plate however was designed to accommodate up to 7 screws distally. Increasing the number of distal fixation screws could potentially have improved the stability and provided more time for the fracture to heal. On the other hand, the surgeon was also unable to control the screw diameter. Commercially available distal radius plating systems offer a range of distal screw diameters between 2.3 and 2.7 mm. Although, there have not been any biomechanical studies comparing the relationship between the number of distal screws/screw diameters and force to failure ratio, all 4 screws in our case failed at the shaft-bone juncture (Figure 2). This is known as the weakest point in force transfer between the volar plate and the distal radius fragment [3,13,14]. Therefore, increasing the number of screws and/or their diameters could potentially have increased the stability of the construct.

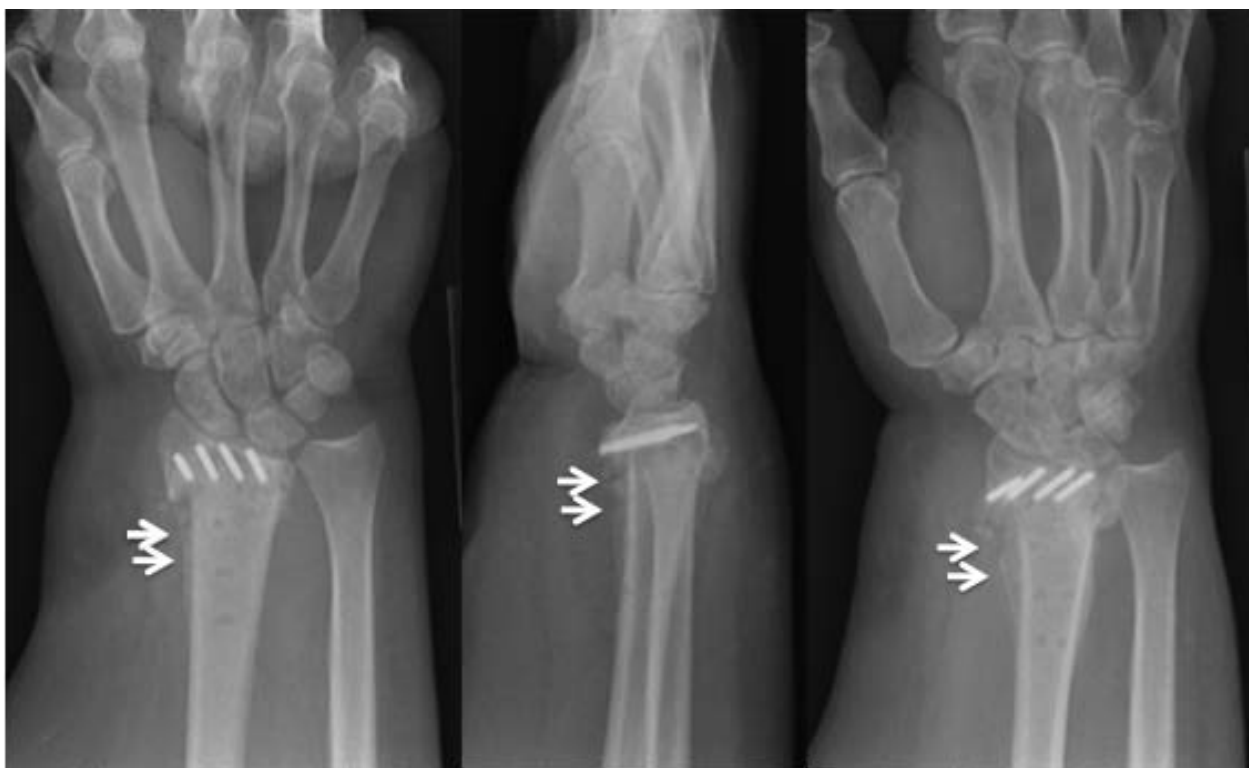
**Figure 3** Twelve months after the removal of the plate, patient continued to have symptoms. Patient refused to have CT scan of her wrist as she had severe claustrophobia. Radiographic view obtained at the time showing bridging callus (arrows), however the diagnosis of nonunion was still not excluded before the surgery.

Six months following failure of the hardware, she continued to have ulnar sided wrist pain as well as impingement of the plate on the volar aspect of the wrist. She then elected to undergo plate removal. Following removal of the plate, she stayed relatively asymptomatic for 2 weeks and was lost to follow-up for 12 months. Eighteen months after the first surgery, she presented with significant pain, collapse of the radius relative to the ulna (4 mm), and a nonunion of the distal radius despite the bridging callus seen on the x-rays (Figure 3). She denied any major traumas since her fall, but her wrist pain had gradually worsened. Due to her significant pain, we took her to the OR for a revision surgery.

During the surgery, a significant degree of bone loss and nonunion were noted at the fracture site. The distal end of the radius had a significant bone defect,

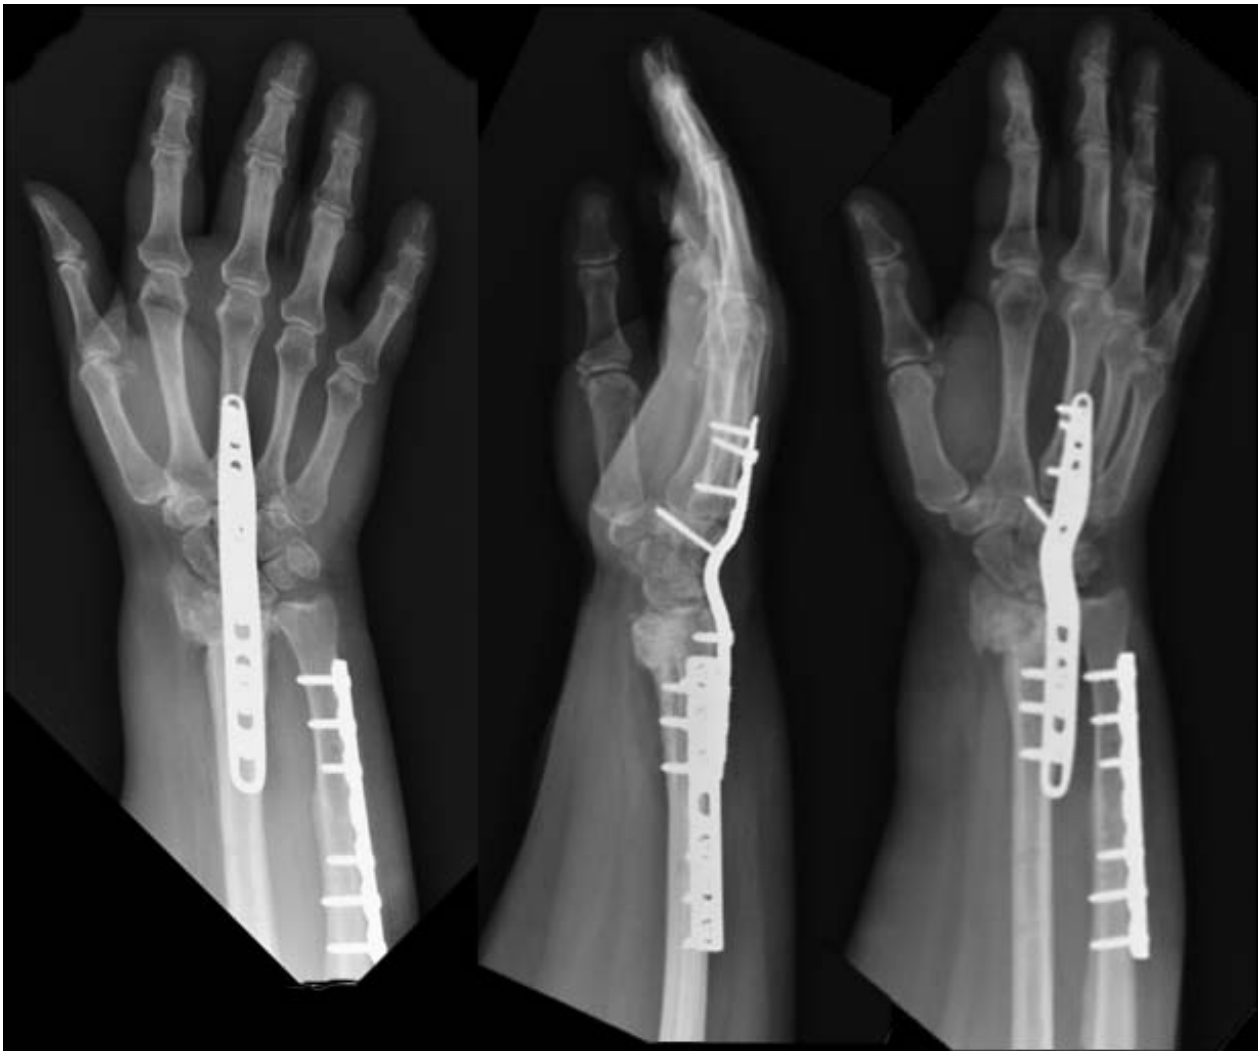
**Figure 4** Twelve months after the last surgery, radiographs show consolidation at the nonunion site. Patient at this point is pain-free and has full forearm rotation.

approximately 2.5 cm in length, between the metaphyseal and the subchondral areas of the bone. In the absence of any bony support, the decision was made to span the joint with an AO wrist fusion plate. This plate was preferred over conventional plates since it contained a combination of 3.5 mm screws on the radius and 2.7 mm screws on the metacarpal shaft. A total of 10 cc of demineralized bone matrix chips were placed at the fracture site. During the application of the fusion plate, we noted that the proximal carpal row was still impinging on the head of the ulna. Therefore, we decided to perform an ulnar shortening osteotomy at the same time. Final radiographic views obtained 12 months after the wrist fusion surgery is shown on Figure 4.

Following significant collapse of the distal radius, we chose to perform a total wrist fusion over alternative methods such as a radioscapulohumeral fusion. This decision was mostly based on the fact that this patient had

poor bone quality at the time of surgery and the need to have a stable construct which will withstand a great deal of deforming forces such as when she pushes herself out of a chair. In the absence of good bony support, the three screws that potentially would have been placed on scaphoid and lunate in a radioscapholunate fusion would not have been able to provide the kind of stability this patient required. We therefore chose to lengthen the lever arm of the fixation by passing the wrist joint and performing a total wrist fusion.
